HSE Bulletin 26in 2019

Uncontrolled move of a Road Rail Vehicle (RRV)

Date of issue: 03 July 2019
Expiry date: December 2019

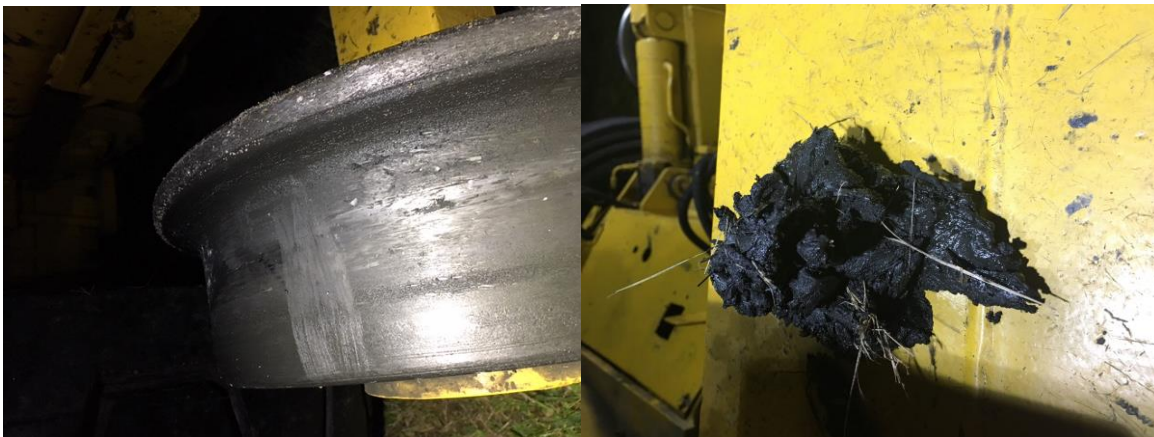
Upon inspection of the RRV wheels, a significant build-up of grease was identified and early indications are that this contamination came from the embedded rail on the highway road crossing.

Image 1. Contaminated RRV wheel

Image 2. Grease removed from one wheel

- check the plant is approved for use, (i.e. Plant Approval List for the business area)
- check maintenance inspection records are up to date
- check all vehicle and equipment wheels before and after use to confirm they are not contaminated with any substance that could impair their braking performance

For RRVs, you must also check the rail-head and wheel condition following a change in track feature i.e. where there is an increased likelihood of grease/contamination build up.
