Bank Station Capacity Upgrade

15 Abchurch Lane Heritage Statement

September 2014

LUL Document Reference:
LUL-8798-STT-G-002114

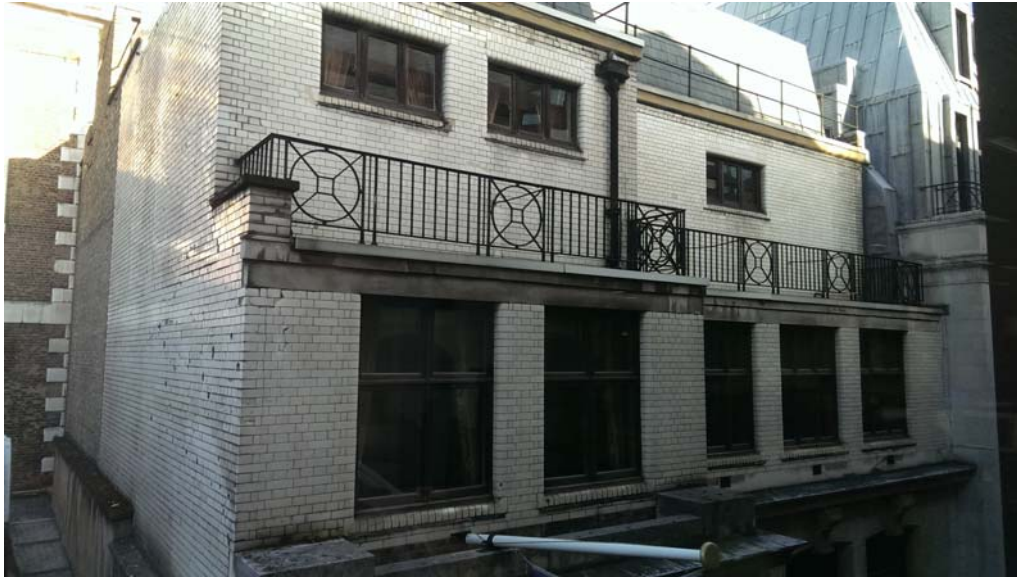
- 4.1.3 Designed by William Campbell Jones and constructed in 1914/1515, 15 Abchurch Lane is a private members club. The building was previously known as the Gresham Club, and has functioned as a private members club since it was constructed.
- 4.1.4 The building consists of five stories above ground level and two basement levels. It is constructed of a combination of brick and structural steel frame which supports a Portland masonry façade to ground, first and second floor level on Abchurch Lane, above which are two storeys of glazed brickwork (photo 2). The Abchurch Lane façade incorporates both tightly jointed ashlar masonry and stone dressings richly carved in a style partially adopted from the adjacent St Mary Abchurch. This façade shows some existing cracking through stone and brickwork, for example as seen in photos 2 and 3.

Photo 2: Damage to glazed brickwork on the upper levels of the Abchurch Lane façade

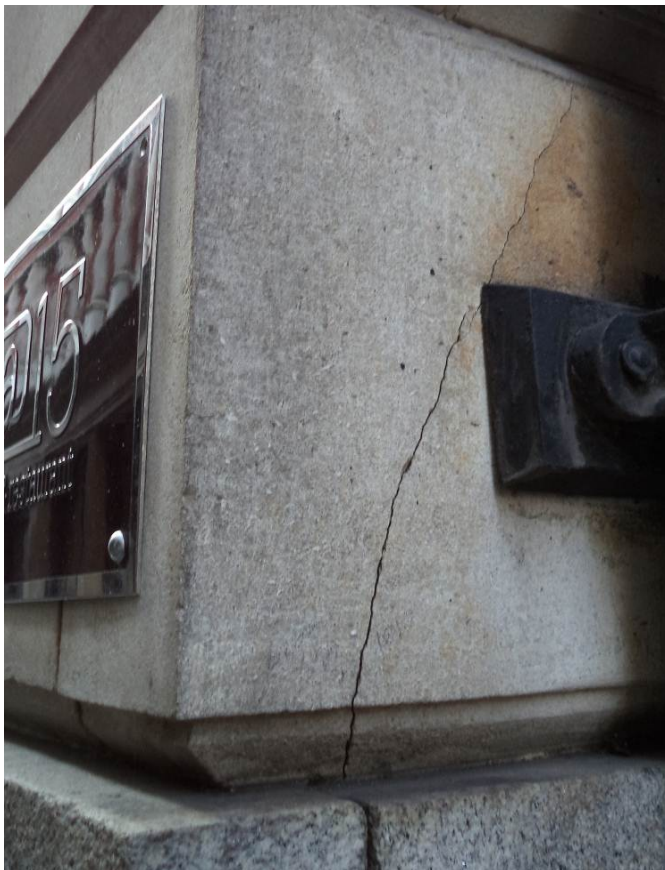
Photo 3: Detail of existing vertical cracks to the right hand side of the entrance foyer

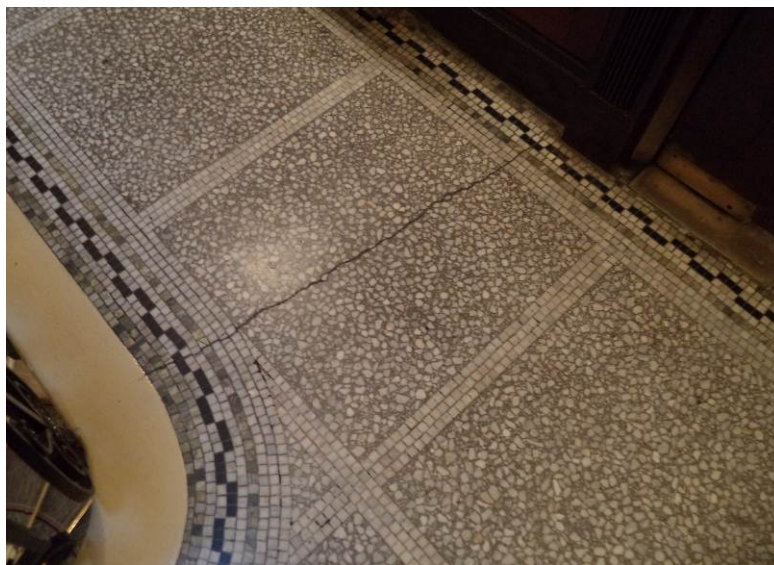
Photo 4: Example of internal historic floor finish showing signs of previous movement

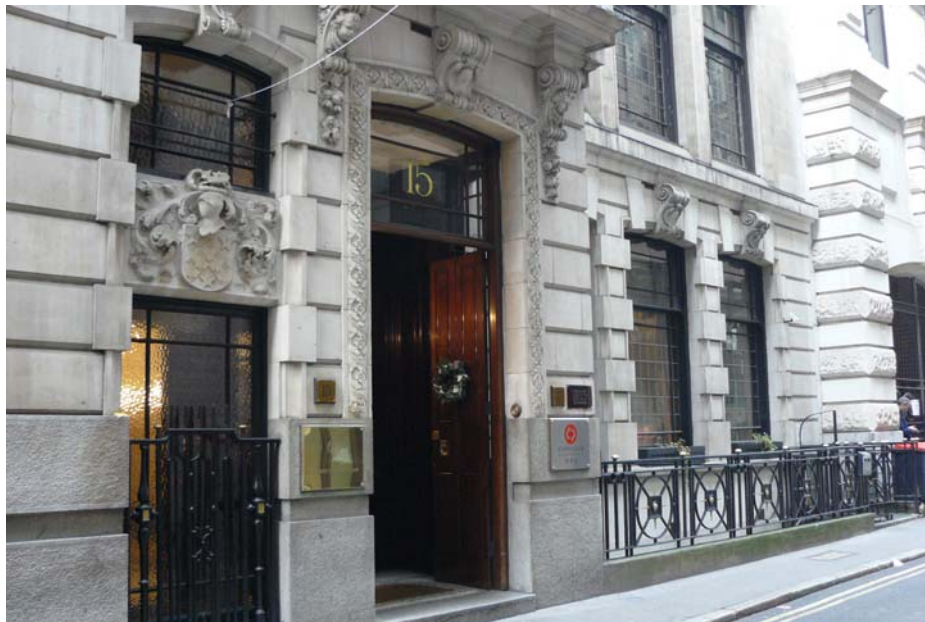
Photo 5: View of decorative façade details to the ground floor

and/or at openings. Differential movement also has the potential to damage decorative details (photo 5). Additional cracking will affect the aesthetic significance of the building which is, in large part, displayed in the quality of the architectural masonry.

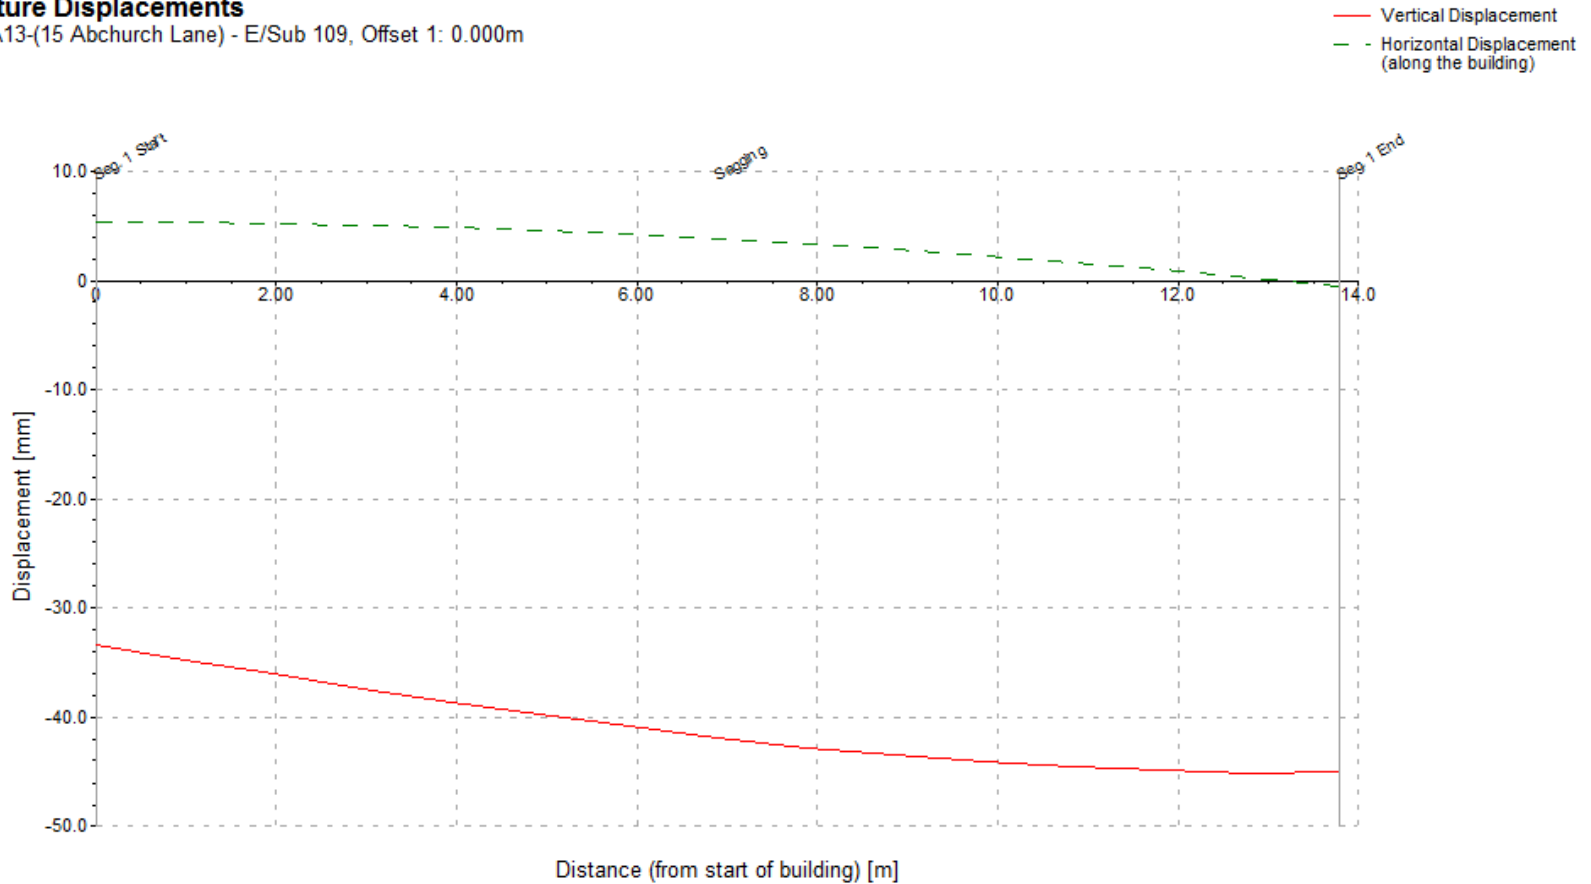
Line #	Strains in section (Curvature)	Position from start (m)	Length (m)	Average* Horizontal Strain (%)	Maximum Tensile Strains (%)	Damage Category
(line 1) (Stage 2)	Sagging	0.0	13.8	-0.042	0.015	Negligible
(line 2) (Stage 4)	Sagging	0.0	17.6	-0.13	0.005	Negligible
	Sagging	17.9	2.5	0.002	0.002	Negligible
(line 3) (Stage 4)	Sagging	0.0	11.7	-0.021	0.006	Negligible
	Hogging	11.8	20.2	0.030	0.048	Negligible

The Stage 2 engineering assessment has predicted that the maximum tensile strain falls within damage category 0 for 15 Abchurch Lane (A13). This corresponds to Negligible damage in accordance with Table 2.

Figure 4: Building displacement at founding level of (line 1) at stage 2 of worst case for tensile strains

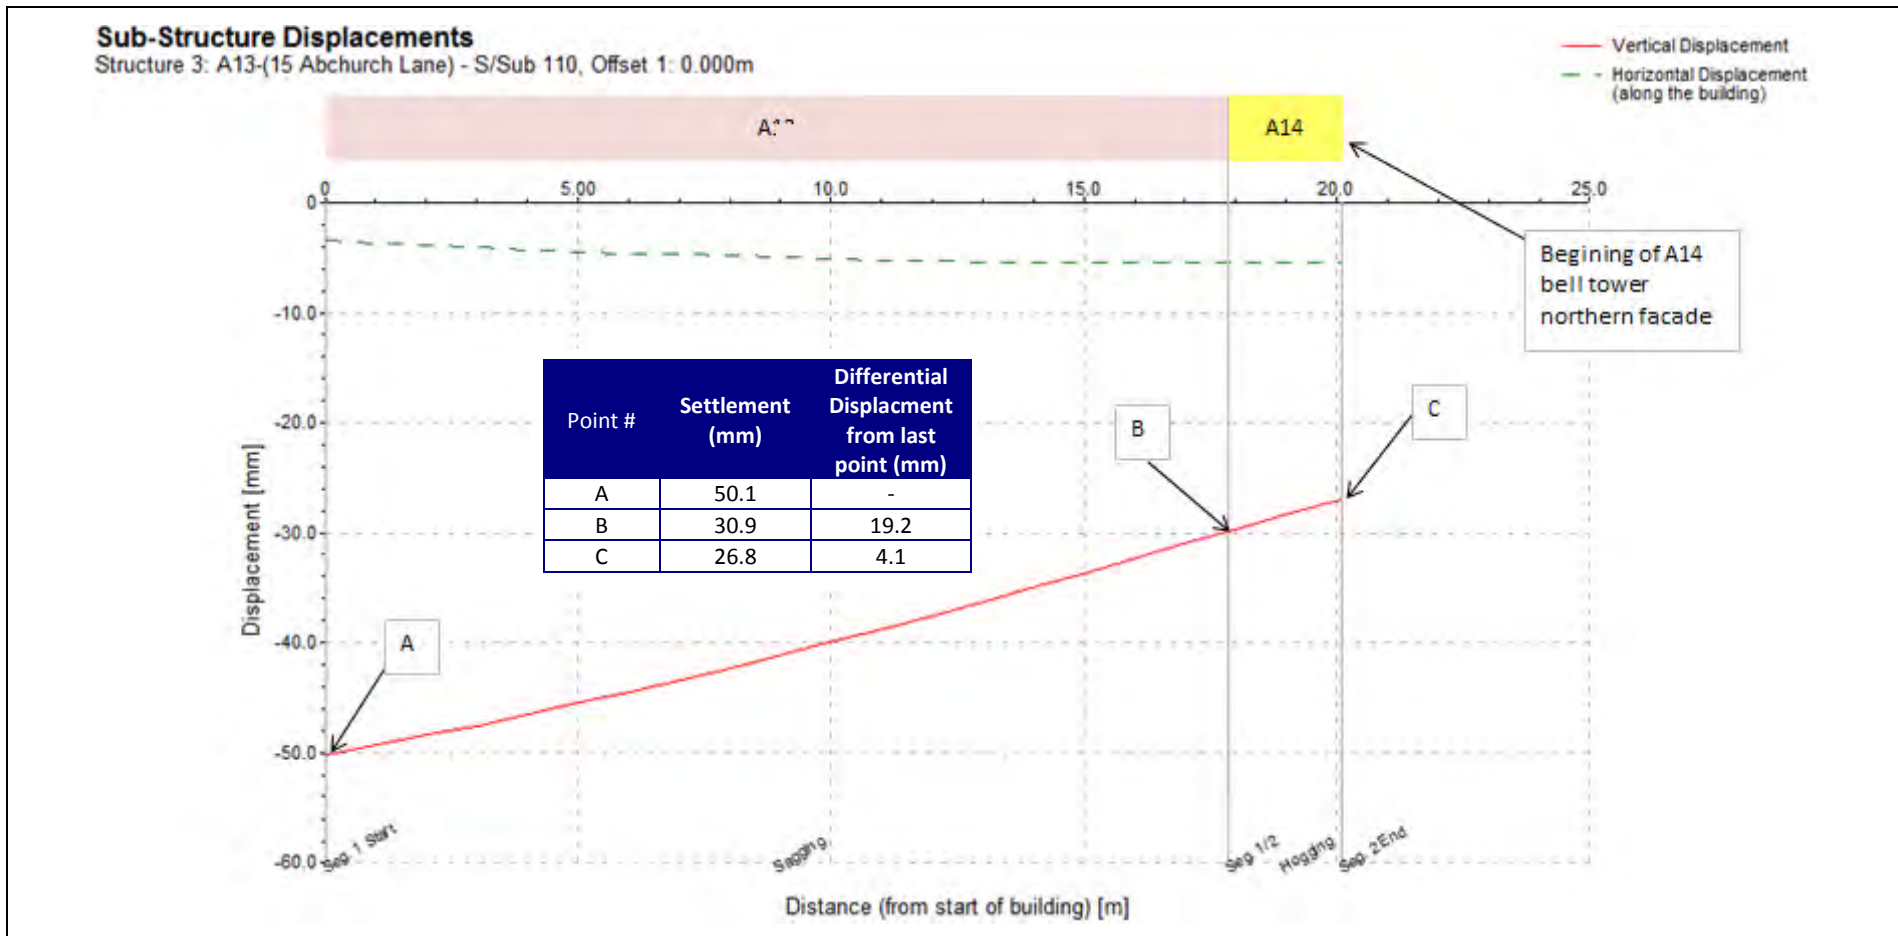
Figure 5: Building displacement at founding level of (line 2) at stage (4) of worst case for tensile strains

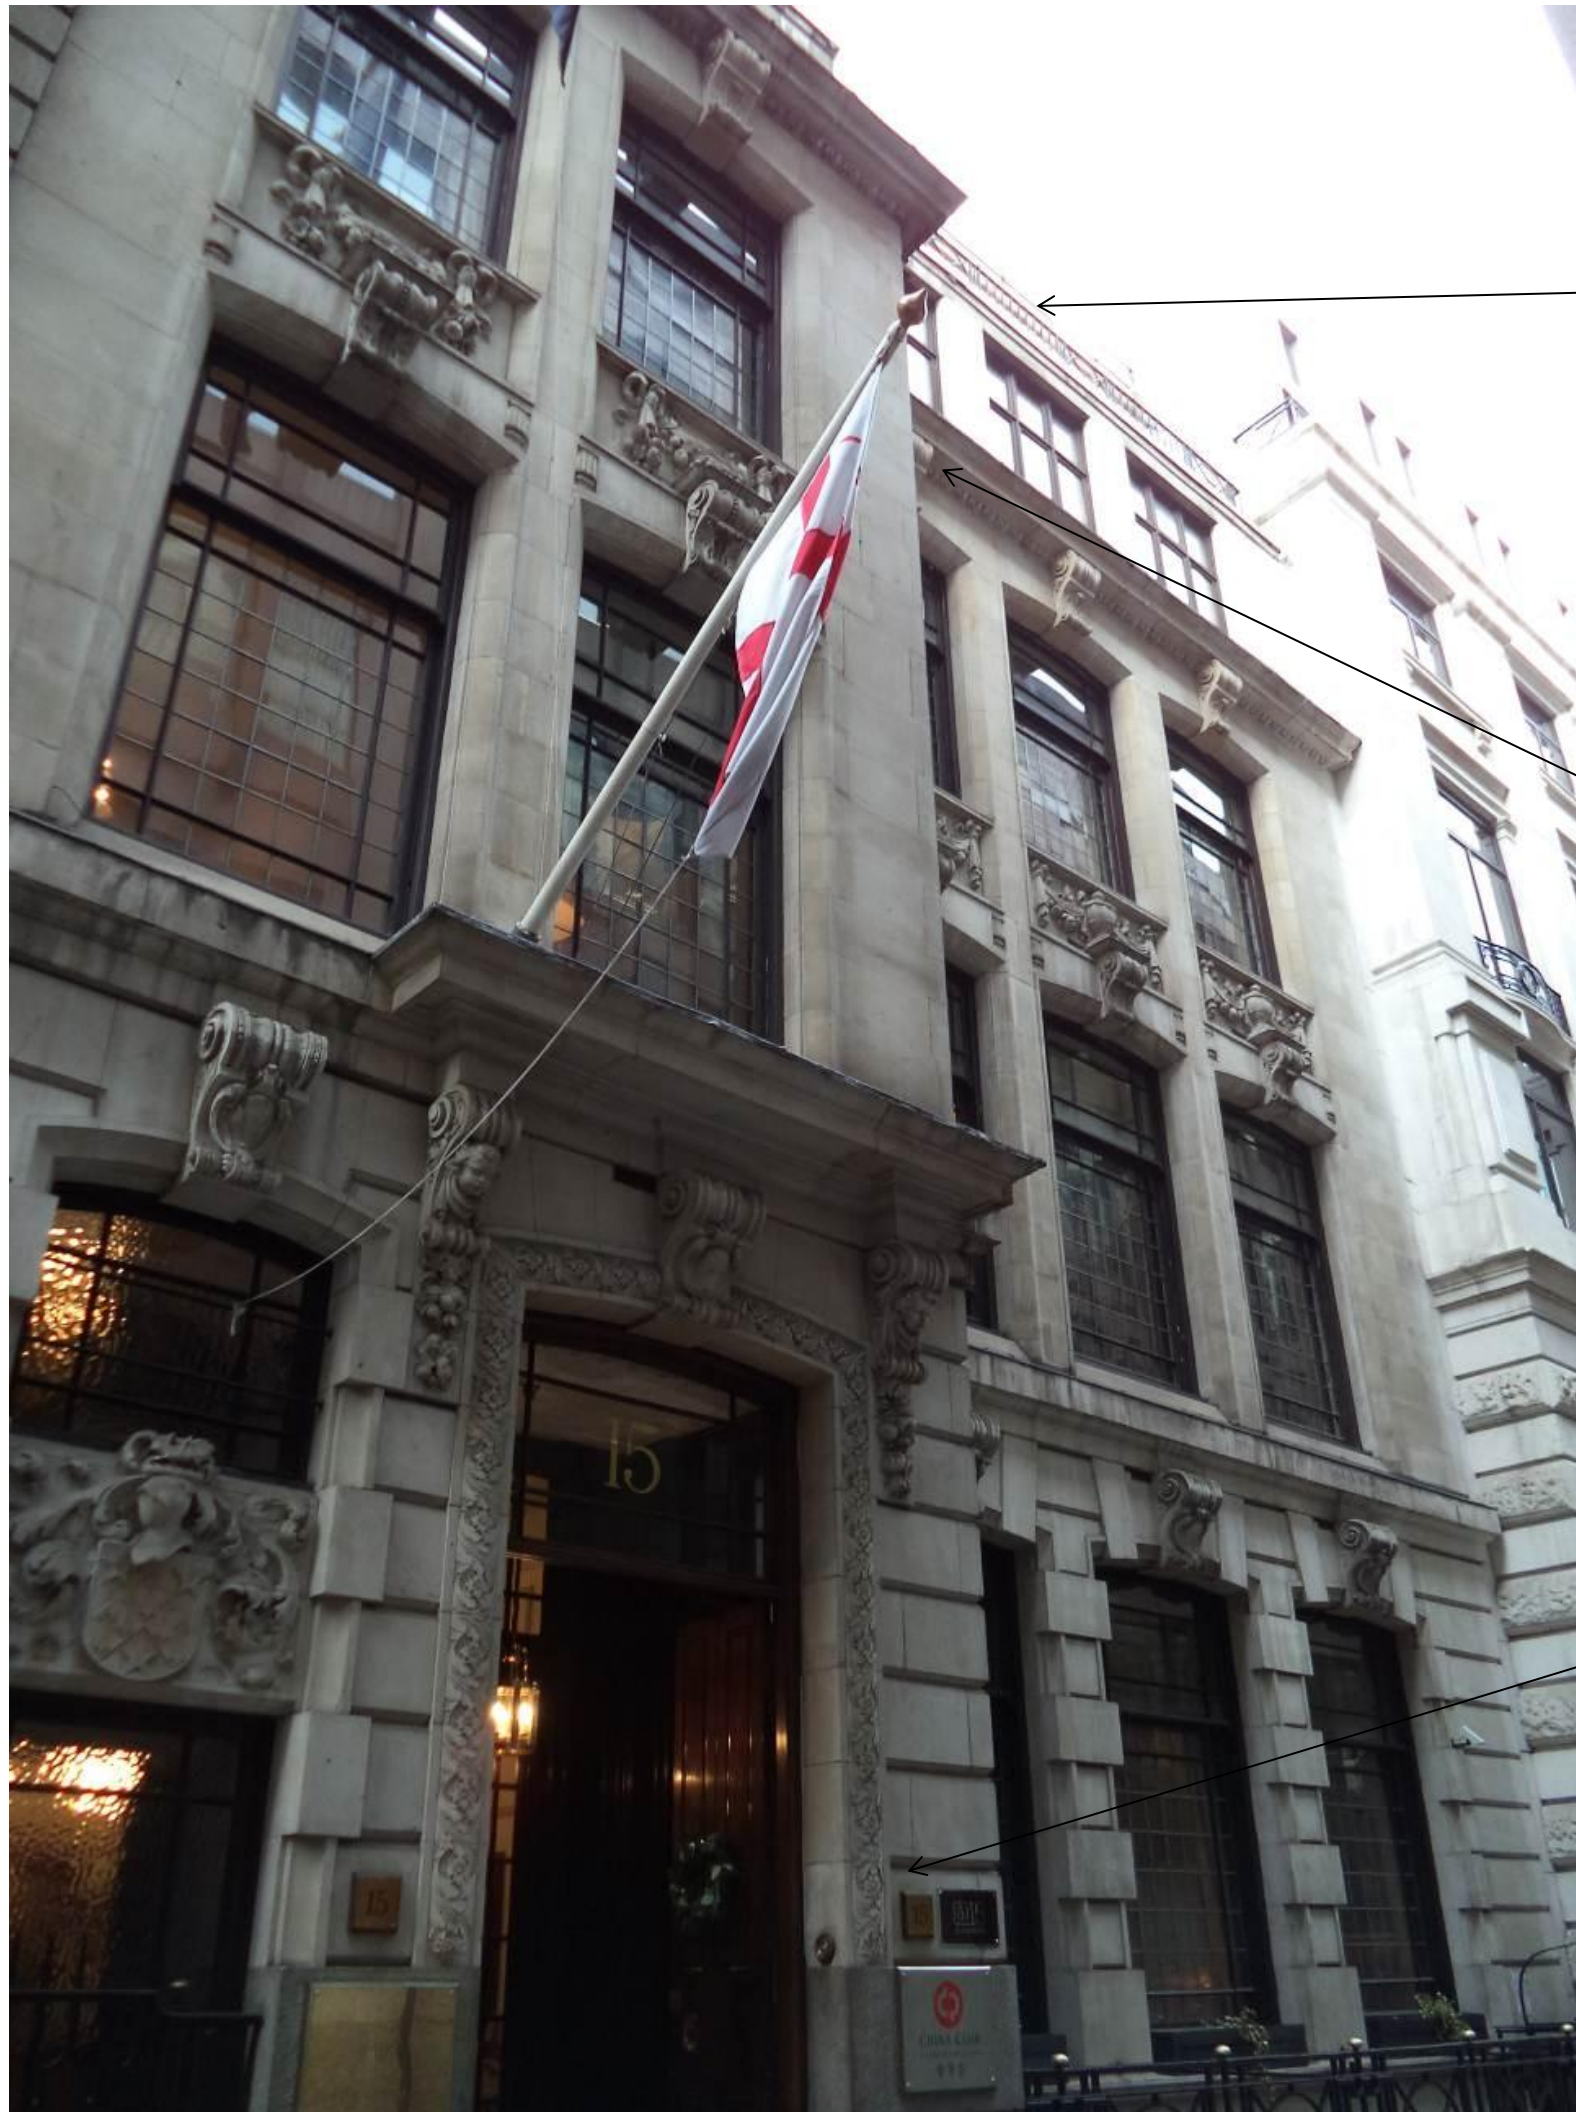
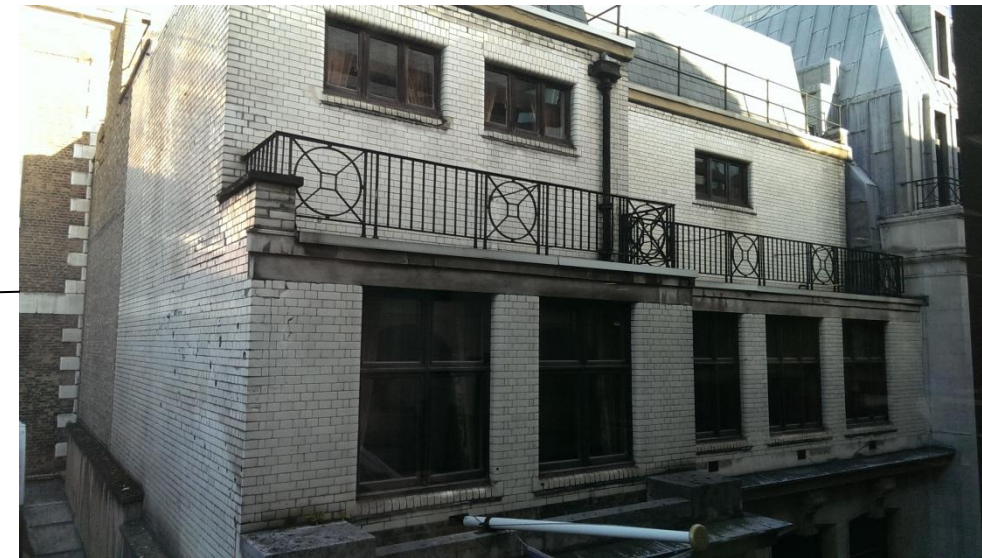
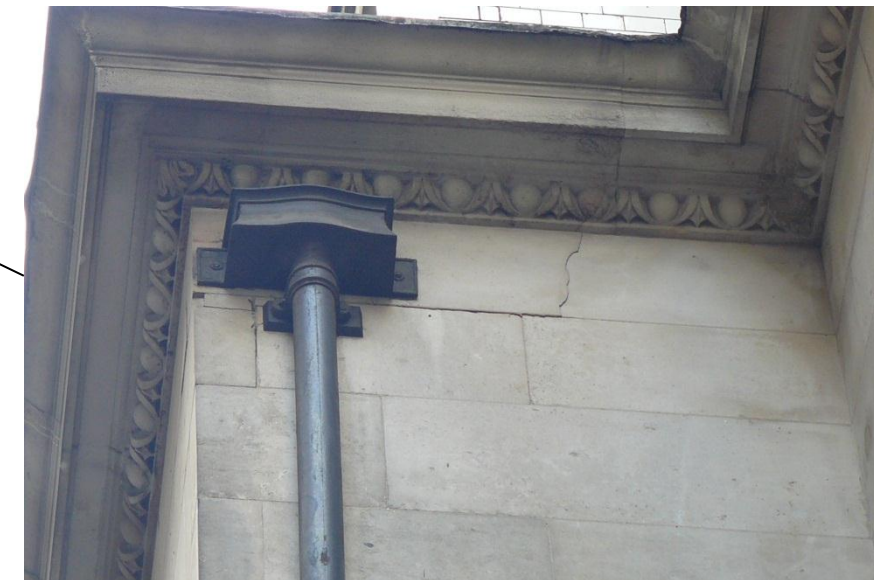
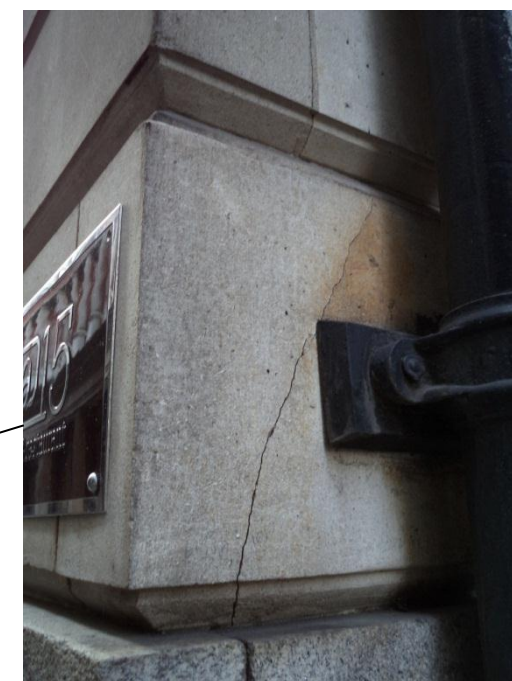
Appendix 7: Areas of interest potentially affected by ground movement

- 6.1.4 Ground movement may cause existing cracks in the Abchurch Lane façade to open up and new cracks to develop. Example areas of cracked stone and their location on the façade are shown in Appendix 7. Subject to detailed investigation, the area displaying evidence of previous damage will be consolidated by enhancing façade fixings and by repairing damaged stone masonry and glazed brick elements. This may necessitate the removal of sections of façade stonework and glazed brickwork to facilitate investigation, repair and consolidation works. Photographs annotated to indicate the areas where works will be required are located at Appendix 8.

Areas of cracked stone and brick, and their location on the façade. Exact locations of the most vulnerable stone in need of repair to be verified by detailed condition survey

- 6.1.5 The extent of repair and consolidation will be determined from the Stage 3 Building Damage Assessment, and may involve localised removal of stonework or glazed brickwork. Opening up will avoid carved finishes. The impact on the building will be temporary and minimal, as stonework or glazed brickwork will be repaired or replaced on a like for like basis. This will reduce the aesthetic impact, and the temporary removal of fabric will not have a long term effect on the heritage significance of the building.

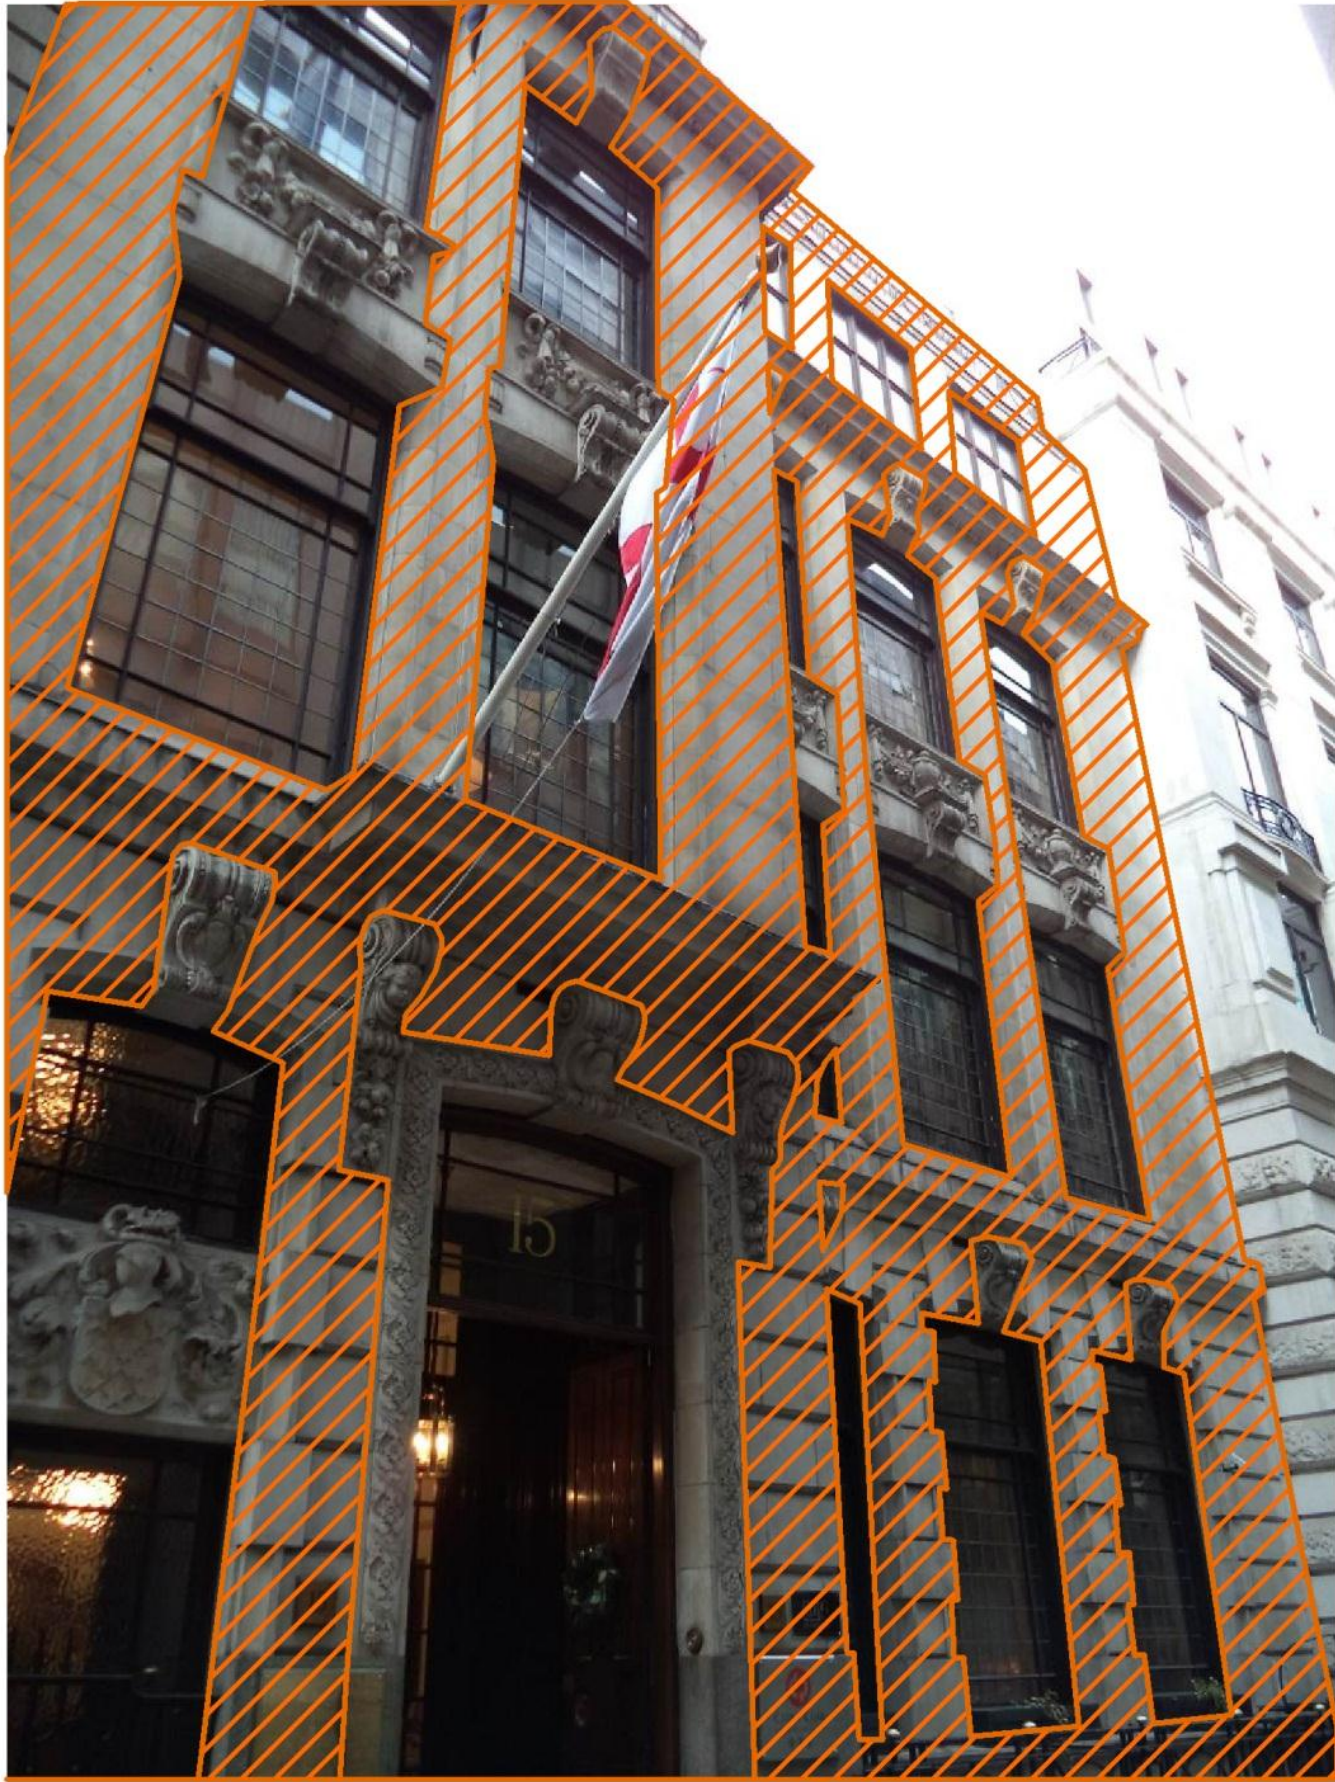
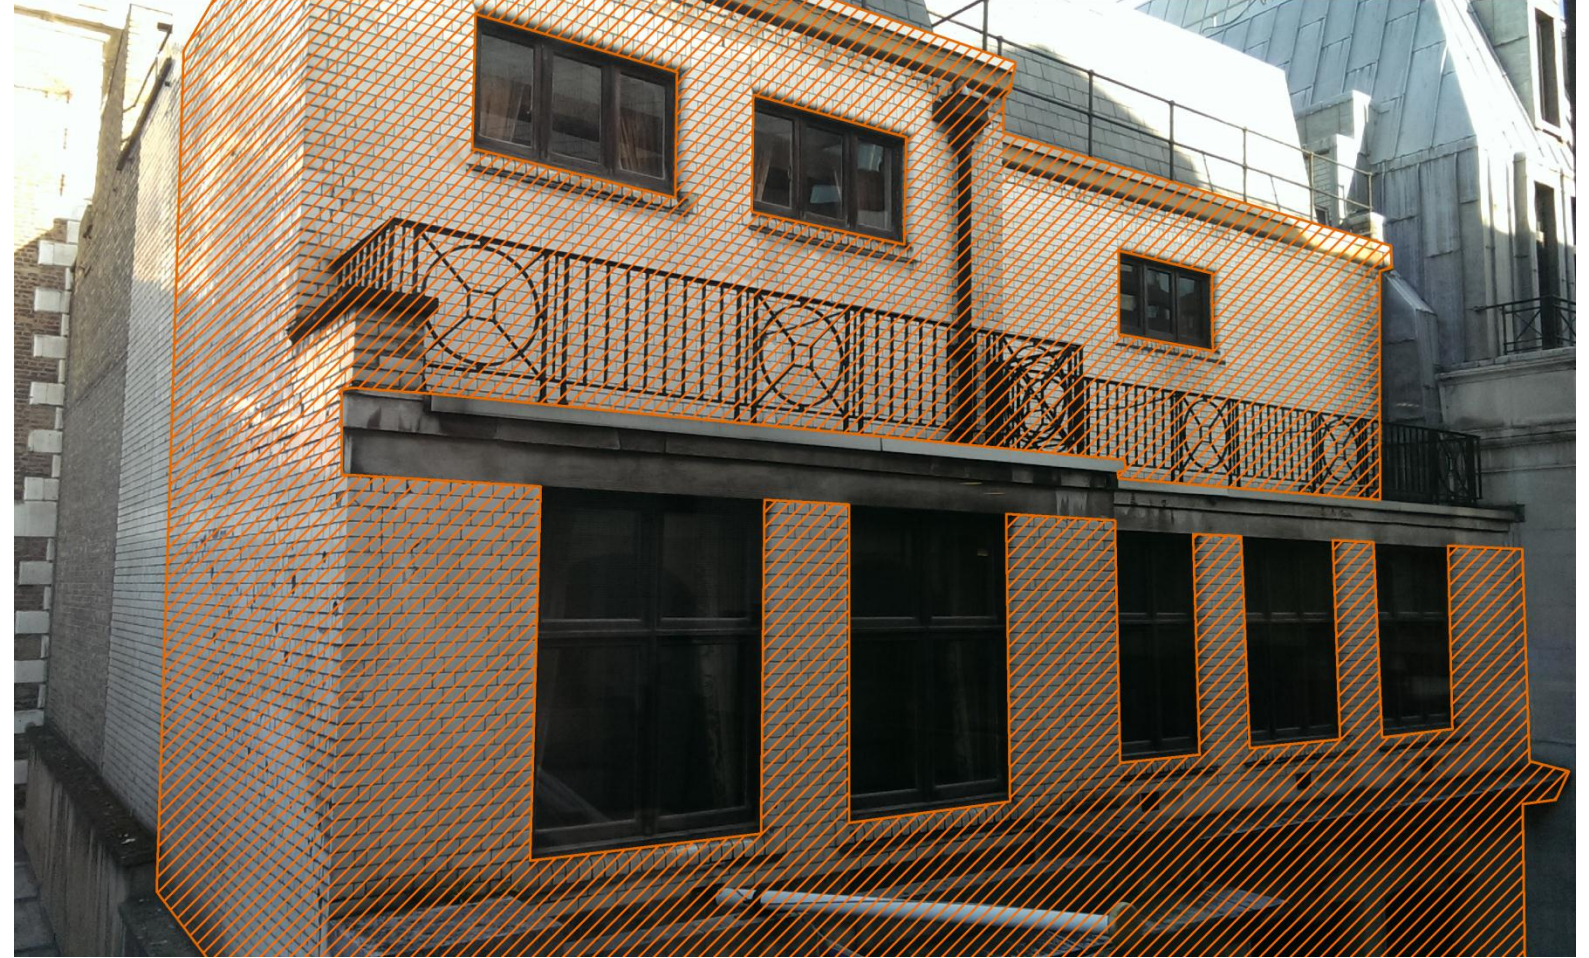
Appendix 8: Areas to be affected by protective works

Hatching denotes areas of stone and brickwork which may require protective works following survey
