Transport for London

London Rail

Final Investigation Report into the incident at Bridge LTN/1-19 (generally known as GE19) that occurred on 28th May 2008.

Version 1.3

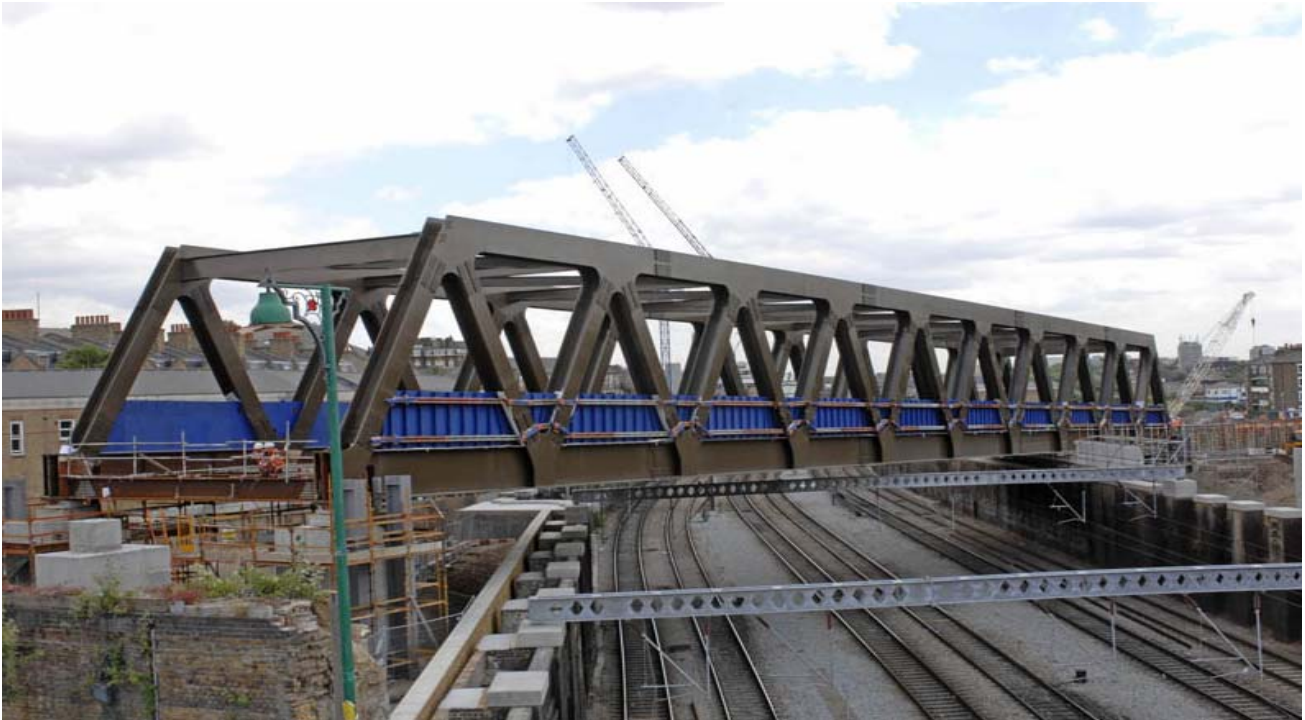
GE19 in position across Network Rail tracks outside Liverpool Street Station shortly after its launch

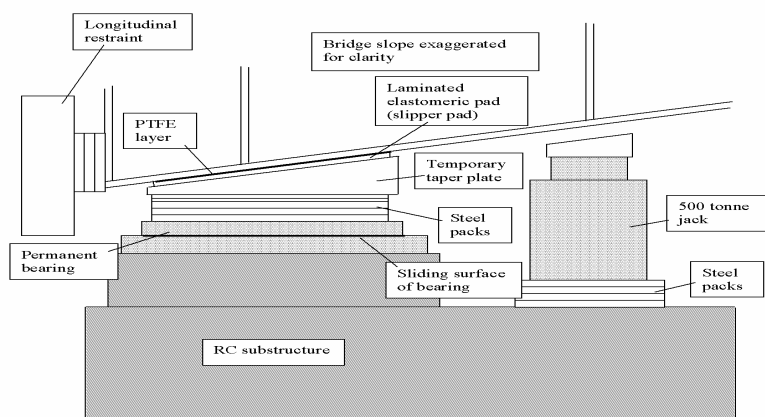
Figure 3 : Bearing arrangements at east abutment on the night of the incident

Figure 3 below shows the packing arrangement at both the north and south bearings on the east abutment, on the evening of the incident. PTFE slipper pads are in place (see appendix A). It should be noted that the diagram is exaggerated: on site the slope of the tapered plate is barely noticeable.

7.1 The Inquiry Panel are satisfied that the immediate cause of this incident related to the incorrect positioning of PTFE on the sloping surface of the taper plate. Due to the fact that PTFE was placed on a slope, the vertical load of the bridge generated a horizontal force. The presence of a second slip plane within the permanent bearing plates, allowed the taper plate and the support packing materials between the PTFE surface and the fixed bearing surface to be ejected. It is believed that a small movement in the structure, perhaps 2-3mm, as the result of temperature change during the evening of 28th May, resulted in the initiating movement of the bridge, such that the coefficient of friction between the PTFE and the packing plates changed from static to dynamic. The dynamic coefficient of friction of PTFE is significantly less than that in its static state.
