Date: 22 January 2018

Item: Tram Overturning at Sandilands, Croydon on 9 November 2016 – RAIB and TfL Investigations – Update

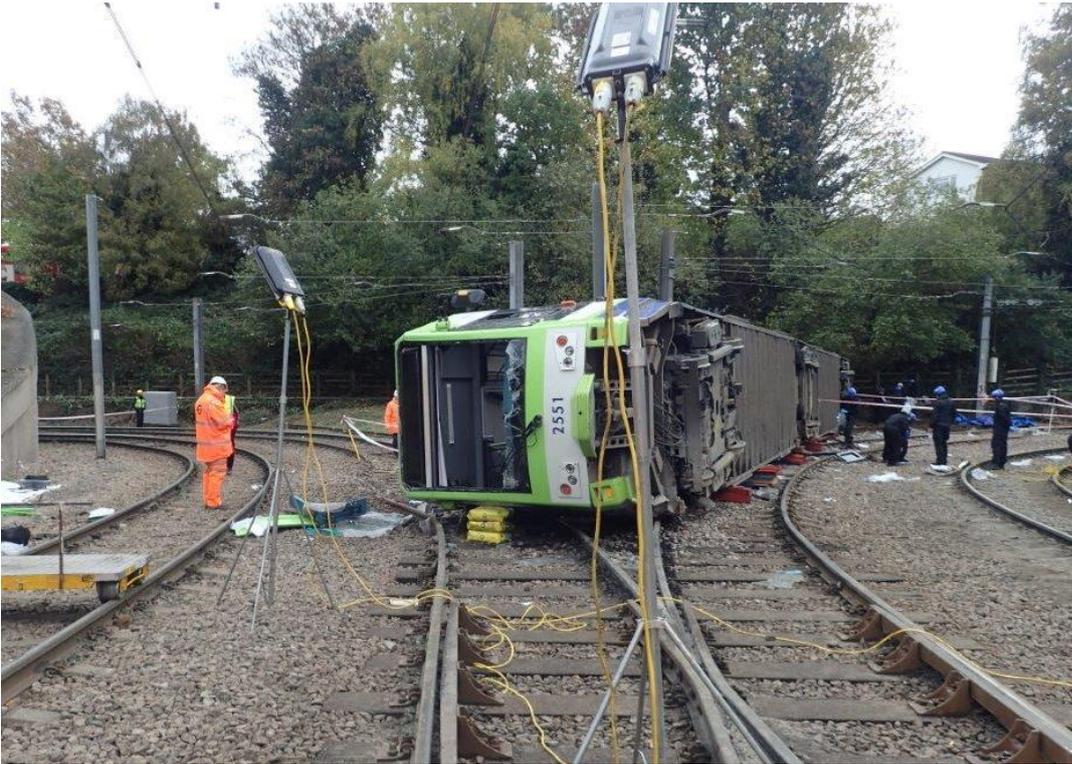
The overturned tram itself impacted an overhead electricity stanchion, lineside equipment cabinets as well as rails being stored nearby (see Figure 1 and Figure 2). Significant damage was sustained to both the tram and the adjacent infrastructure. Work is ongoing as a part of a separate workstream to investigate the performance of the tram structure during the overturn.

Figure 1 - Tram 2551 overview of resting position on adjacent tracks

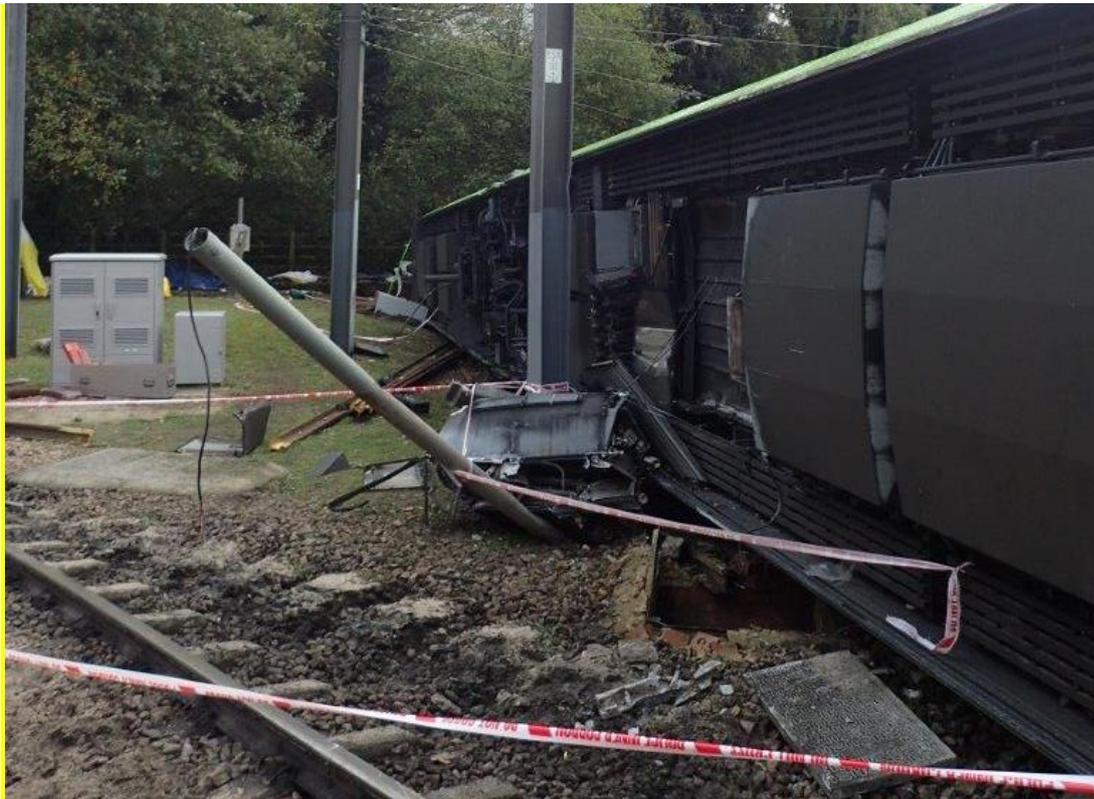
Figure 2 - Tram 2551 roof against infrastructure

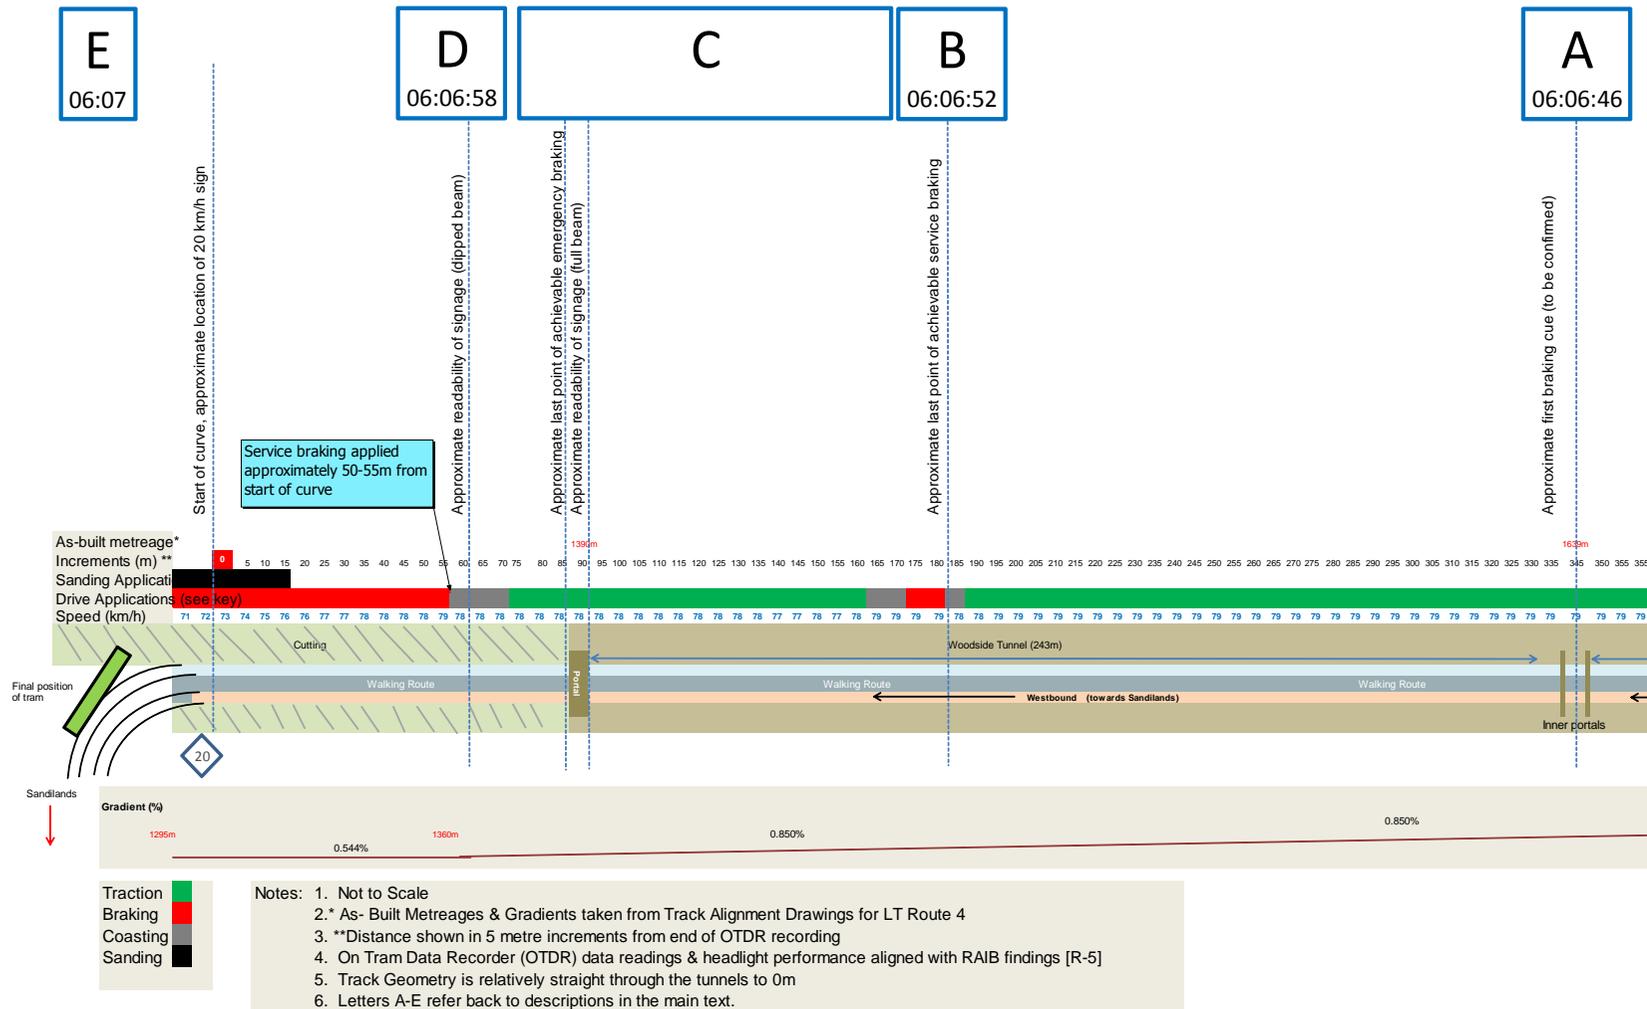
Figure 4 - Extract of Appendix A Sequence of events (schematic) over final 15s/330m (approximation) before curve.

- 06:06:58 [denoted "D" on diagram] The tram braked, with a rate of retardation in line with that of a normal service braking applied by the driver (around 1.3 ms^{-2}), with the sanding system being initiated (either automatically by the wheel slip/slide protection system, or manually by the driver) at 06:06:59 until 06:07:01.

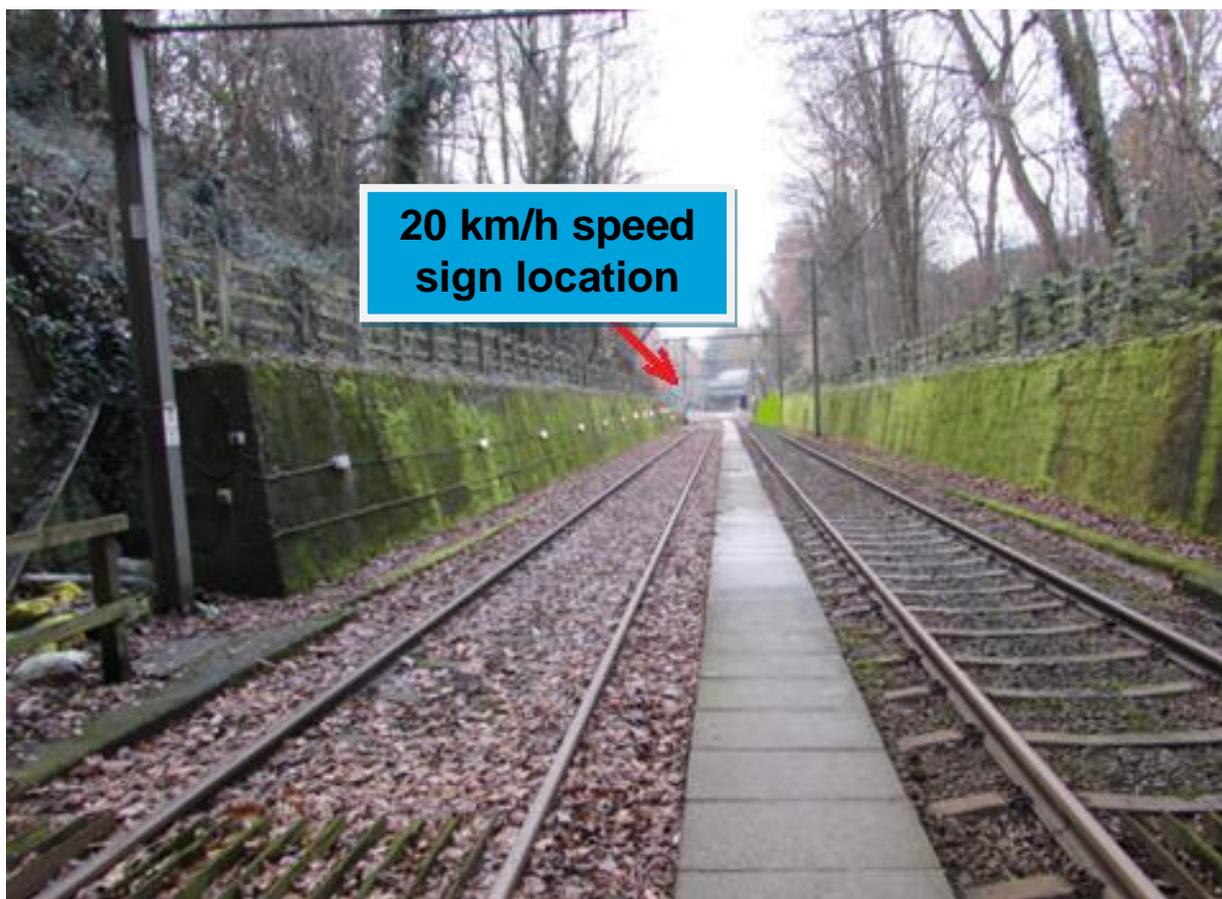
The reflective signage indicating the 20km/h PSR is readable (i.e. the numerals can be read) on a clear night, from the driving position of a tram driven at caution, from a distance of around 60m (dipped beam) and 90m (on full beam) [R-5]. This figure could be reduced by heavy rain, such as that experienced on the morning of the incident [R-5]. The ability of the driver to detect the signage will also be influenced by the tram speed, the driver's visual acuity, the local lighting as well as any other tasks that the driver was undertaking. See Figure 6 below.

Figure 6 - 20km/h board on exit from Woodside tunnel (photo taken around 85m from the start of the curve)

The incident has highlighted that there is no relevant signage that can be sighted from the required start of braking. Knowledge of the route and the next maximum permissible speed is therefore required and the ability to successfully complete this task is dependent on the driver correctly identifying the point for the start of braking.

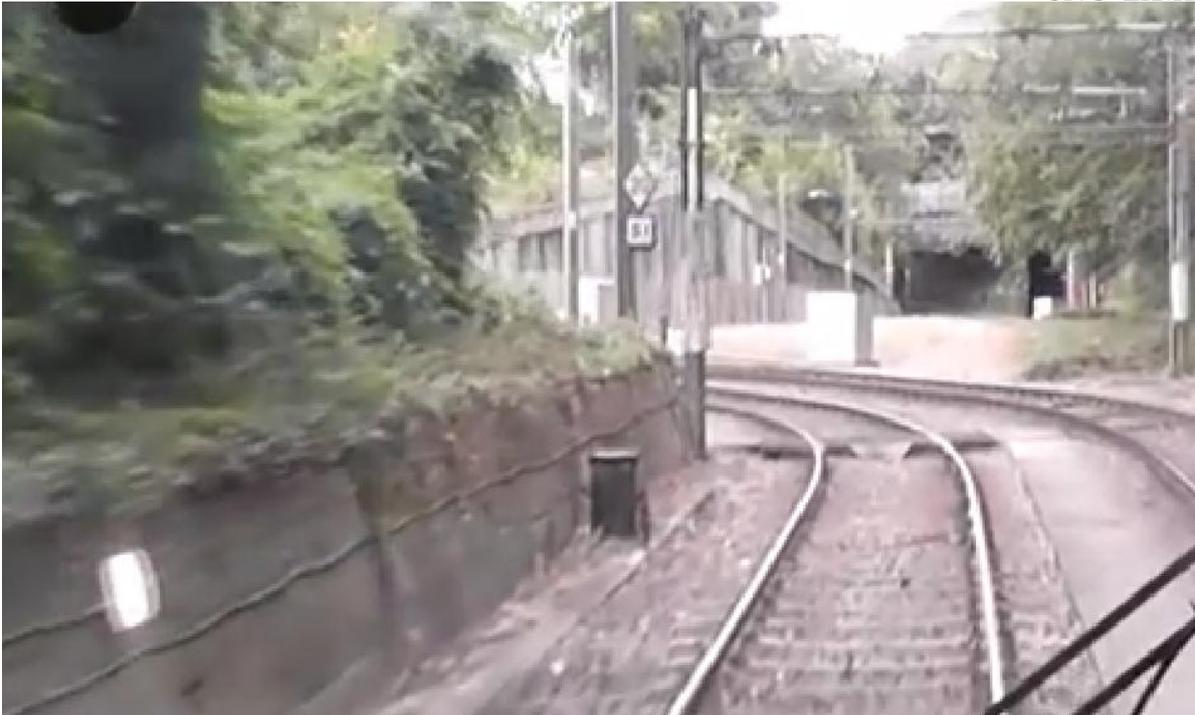
Figure 7 - 20 km/h PSR board on 30m radius curve, with the entrance to the Elmers End/Beckenham Junction branch line showing opposite
