Bank Station Capacity Upgrade

1-6 Lombard Street Heritage Statement

September 2014

In support of London Underground's
Listed Building Consent Application
for protective works

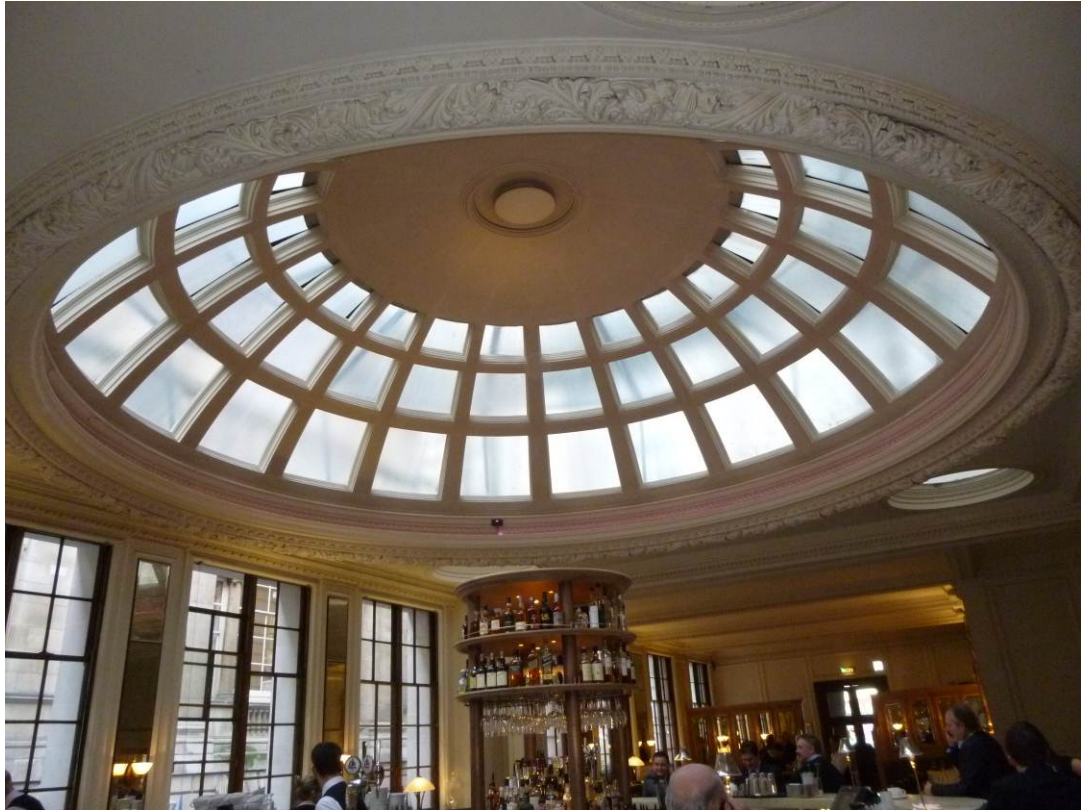
Photo 2: Dome of restaurant with decorative plaster enrichment

- 4.1.4 Internally, the building has two distinct sections. The ground floor to the north-west contains a restaurant with a large central dome, and heavy plasterwork decoration. Areas of the plaster are currently in poor condition. The rest of the building houses office accommodation, and is centred on a cantilevered staircase of stone with an iron balustrade, set against a stone curtain wall with a hexagonal timber skylight above. To each stair landing are stone columns with foliate capitals. There are additional, secondary stone cantilevered stairs to the southern range of the building. The south-eastern corner of the building contains a small panelled room with plaster cornice. The entrance foyer has a carved stone cornice around a central dome, the decorative detail of which

- 5.1.3 The geotechnical assessment has been combined with a heritage and structural assessment, which has highlighted sensitivities in relation to the building, particularly in areas of heritage significance. The differential settlement of 20mm from the edges to the centre of the building raise the potential of damage to fragile decorative plaster in the restaurant area (shown in photo 2),

particularly around the dome, and possible distortion on opening up (i.e. localised removal of internal finishes such as plaster or floorboards to expose the structure behind for inspection) around the central cantilevered stair (photos 3 and 4).

Sensitivity of the heritage
<p>There are two main areas of heritage sensitivity within the building. The first is concentrated on the decorative plaster ceilings and cornices of the restaurant area, which are also in poor condition. These surfaces are brittle, and may crack as a result of settlement, leading to loss of historic material and at worst failure of sections of surface plaster. The second is the stonework of the central stair and foyer, which currently show some fine cracks; the decorative elements of this stonework may be difficult to repair in the event of damage, and cracking as a result of the BSCU Works may lead to widening of existing cracks as well as within joints.</p> <p>The exterior cladding to the Mansion House Place façade is of high quality, but does not show the decorative detail of the Lombard Street elevation, which will experience smaller movements. Cracking of the stone masonry elements, whilst unlikely to cause loss of historic fabric and are repairable, risk a permanent impact on aesthetic value of the building.</p> <p>Score: 1 – Damage to the areas of heritage sensitivity, which are comprised of brittle finishes, may cause a permanent aesthetic impact, and there may be loss of historic fabric to the plaster of the restaurant area.</p>

Sensitivity of the condition
<p>In general the building is in good condition, excepting the interior finishes to the restaurant which show fine cracking and flaking, and some fine stone cracking to the central stair and externally on the façade.</p> <p>Score: 1 – the condition of the plasterwork within the restaurant exacerbates its fragility and sensitivity to the predicted movements</p>

- 6.1.5 Following non-intrusive survey to the decorative plaster ceilings of the restaurant, those areas that are at risk of damage due to their current condition and the level of predicted movement will be consolidated by securing loose enrichments. The consolidation will be enabled by utilising a variety of methods ranging from crack filling, localised grouting of voids to insertion of stainless steel fixings anchored to timber substrates. This will be a permanent work to the listed building.

- 6.1.7 The consolidation of the decorative plaster to the restaurant will have a beneficial impact to the significance of the listed building, as the plaster is currently in poor condition. Should anchors be necessary to secure plaster enrichments, there will be a permanent change to the materials of the building, but these will not be detectable on completion of the works, and will not detract from the significance of the building. In addition, there will be a short term aesthetic impact while repair works are undertaken. Overall, it is considered that the proposed works will secure the continued historic value of the decorative plaster and therefore be beneficial.

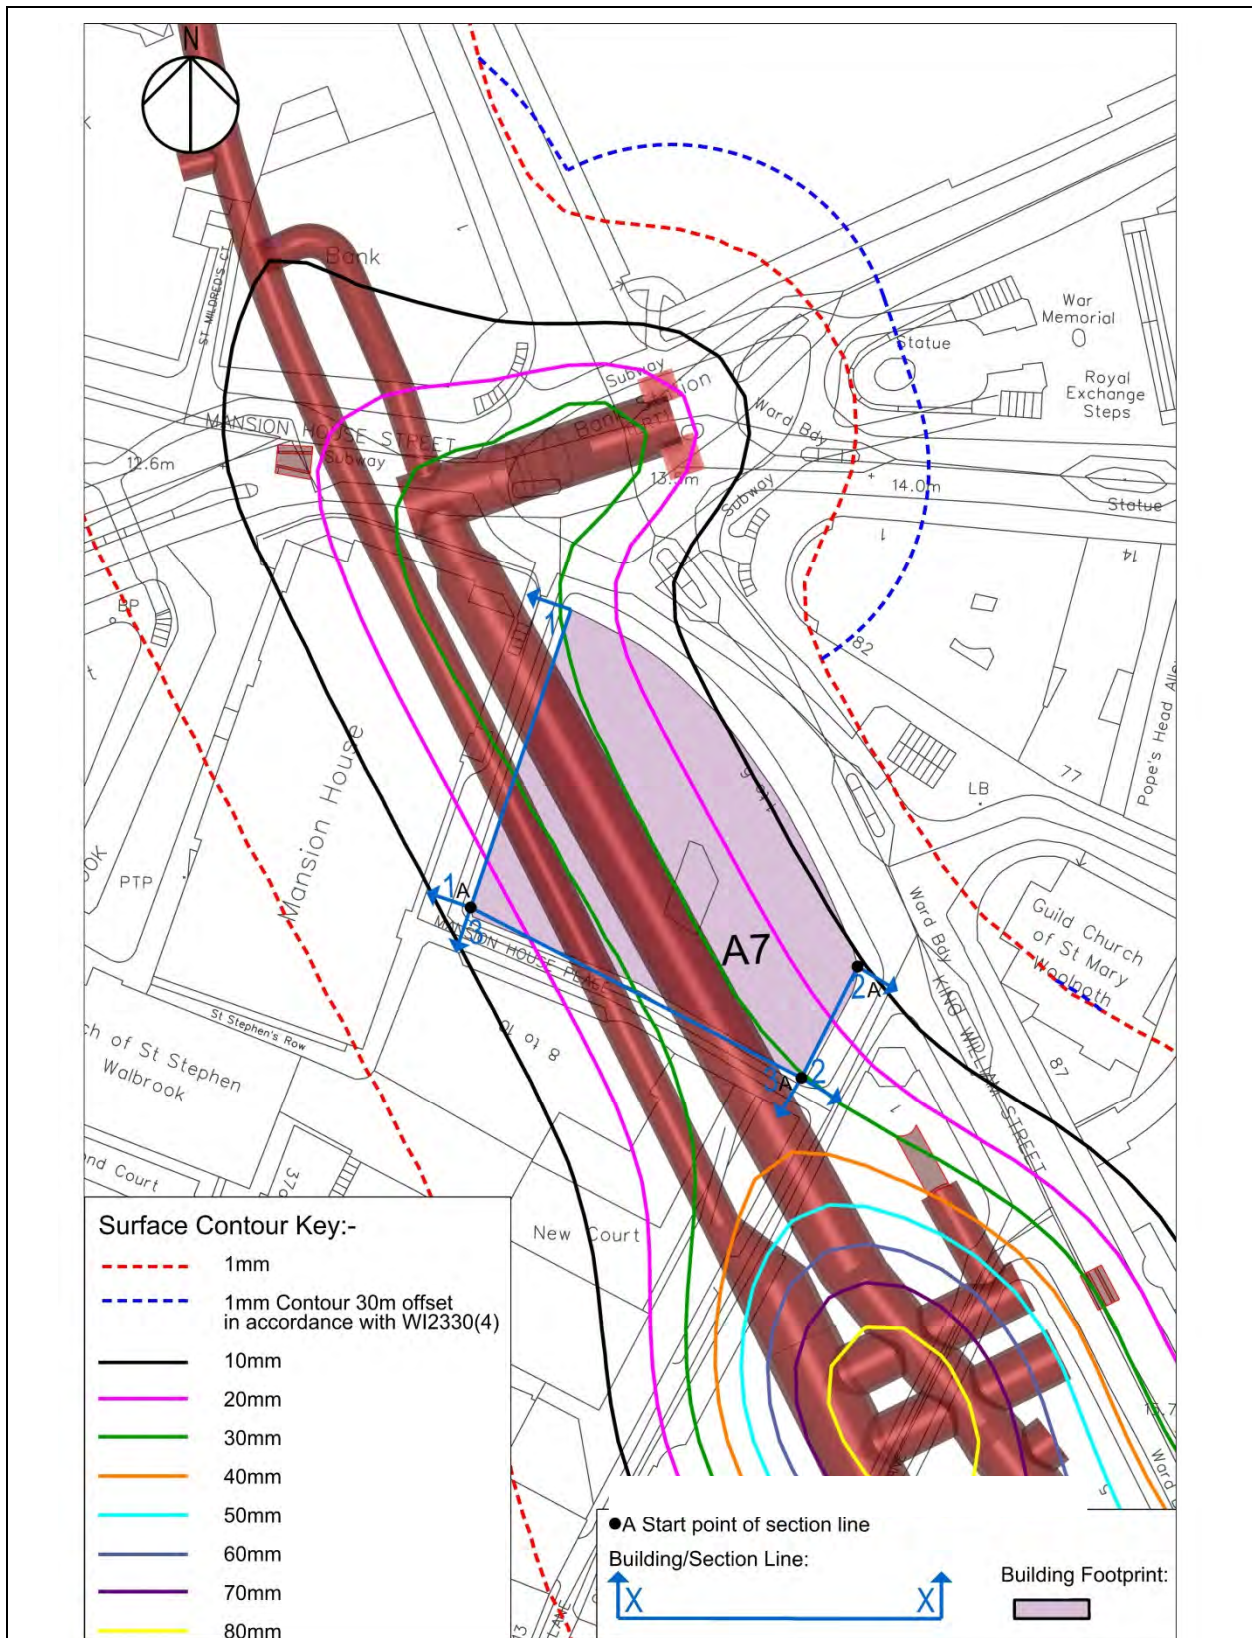
Figure 3: Building location, sections analysed and Settlement Contours at stage of worst case for tensile strains

5.1.6 The Stage 2 Building Damage Assessment report concluded that predicted settlement is high along the Mansion House Place and rear elevations, with differential settlement highest at the centre of the building and reducing to its edges. It is likely that cracks will be concentrated on the particularly sensitive areas of the building, the cantilevered stair and restaurant decorative plaster. In particular distortion due to differential settlement may loosen the structural members of the stair, causing minor separation at the joints. The restaurant plaster is currently in poor condition, which may exacerbate its sensitivity to movement causing existing areas of damage to worsen.

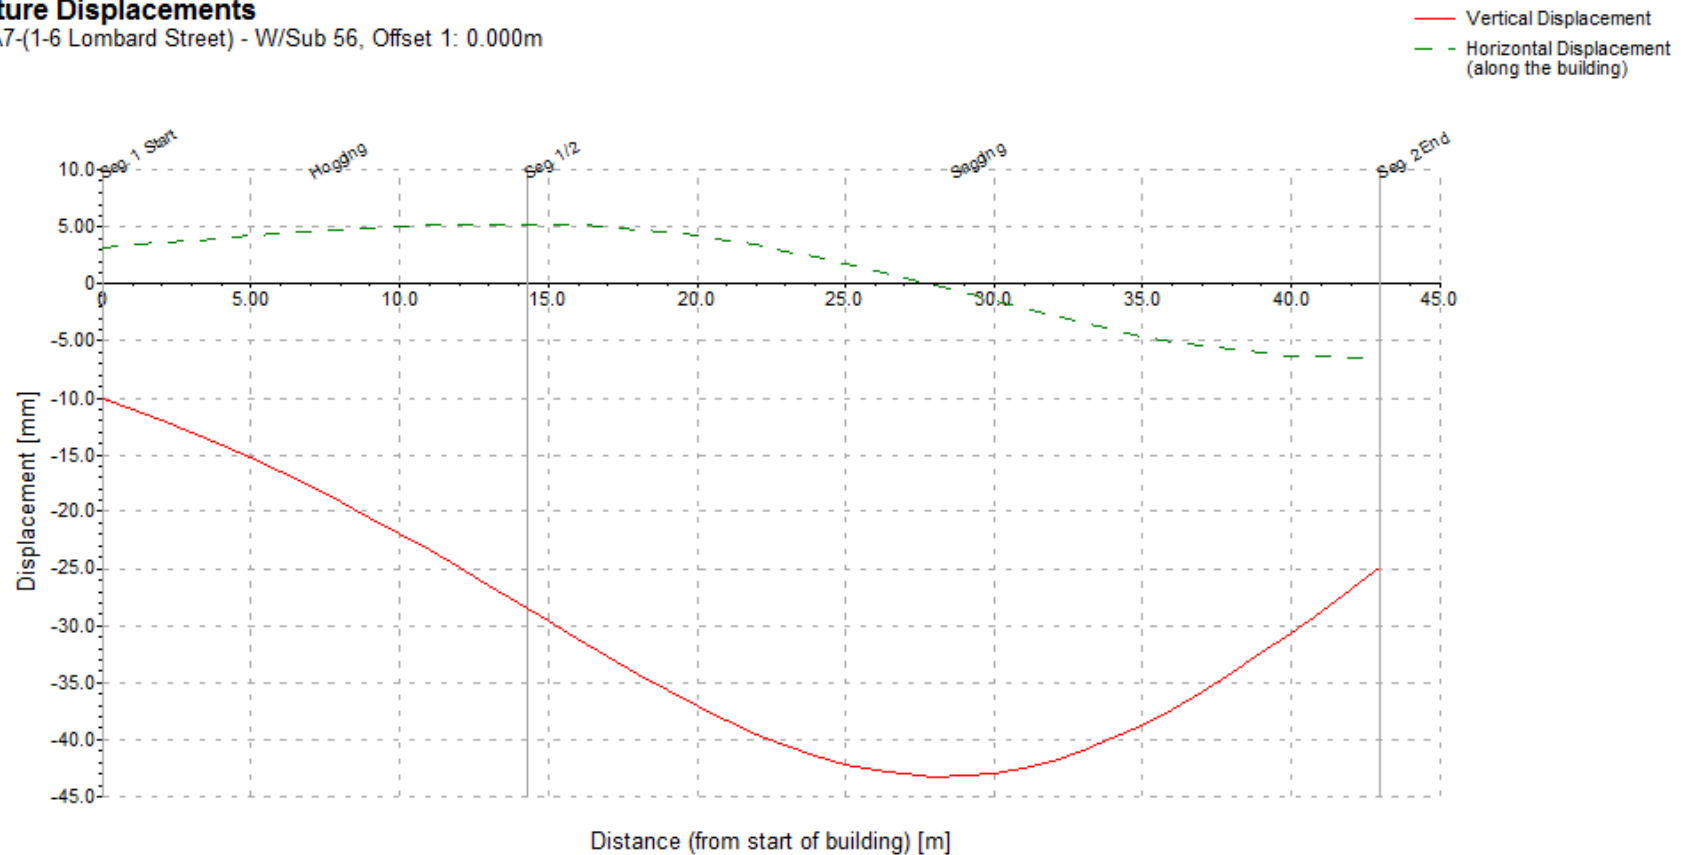
Figure 4: Building displacement at founding level at stage 3 (line 1) of worst case for tensile strains

The Stage 2 engineering assessment has predicted that the maximum tensile strain falls within damage category 0. This corresponds to negligible damage in accordance with Table 2.

The maximum settlement of the building at foundation level at the end of construction is 43mm.

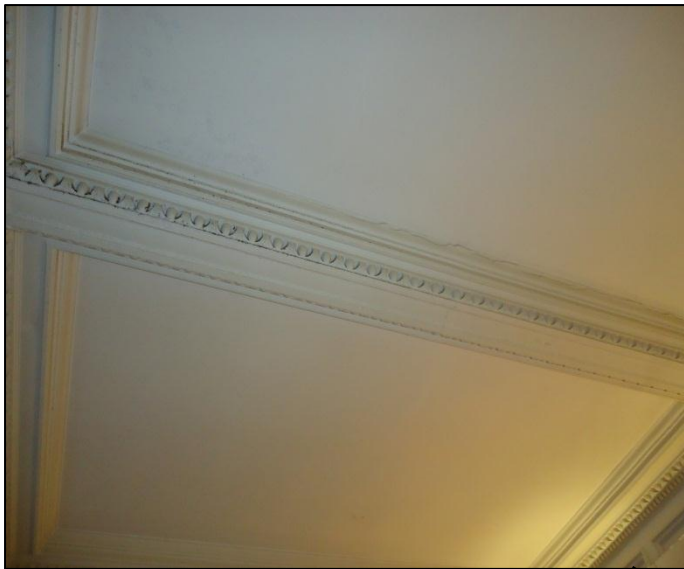
Decorative ceiling plaster within restaurant

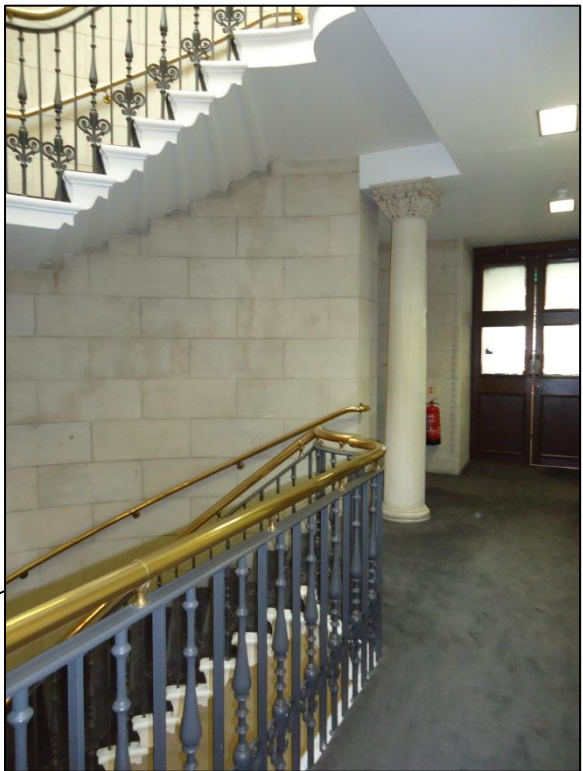
Typical stair landing detail, showing stone wall and shallow stair treads

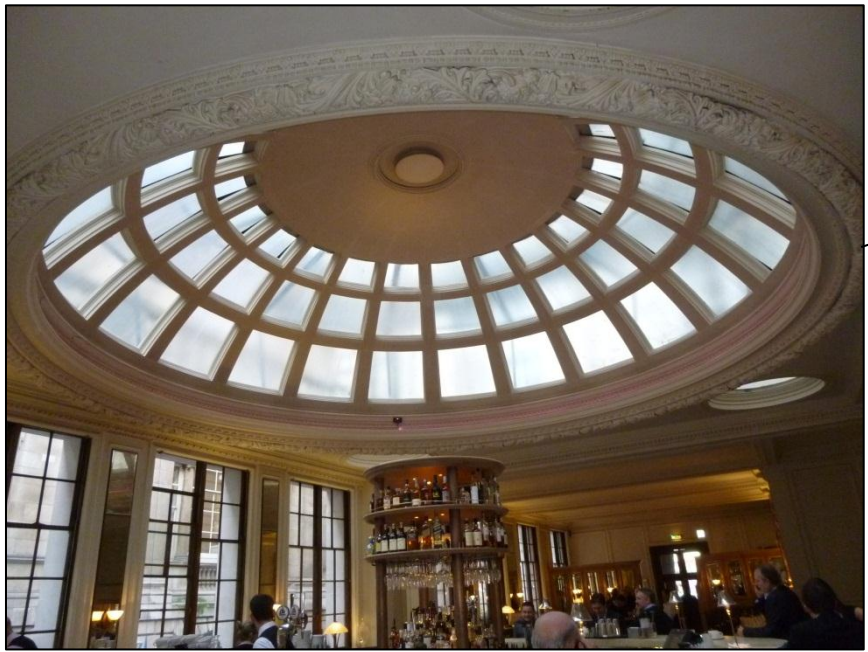
Large dome in restaurant with plaster enrichments to rim, in poor condition
