**CLIENT: LONDON UNDERGROUND LIMITED**

**NORTHERN LINE EXTENSION**

**MAIN WORKS CONTRACT**

## **Battersea Passive Air Quality Monitoring – Monthly report**

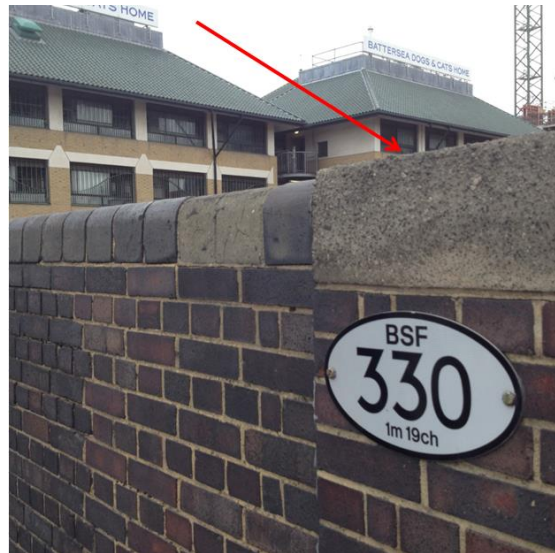
*Figure 5 – Glass Slide 1*

Glass Slide 1 – GS1

**Location:** side wall of Battersea Dogs & Cats Home

**Receptor:** Battersea Dogs & Cats Home

GLASS SLIDE RESULTS			
Slide Number	Fortnightly Soiling Unit (SU) Objective	Soiling Units (SU) measured during period 02/02/2018 – 15/02/2018	Nuisance (Y/N)
GS1	<50	9.0	N
GS2	<50	1.0	N
GS3	<50	4.4	N
GS4	<50	5.4	N
GS5	<50	10.0	N
GS6	<50	-*	N/A

GLASS SLIDE RESULTS			
Slide Number	Fortnightly Soiling Unit (SU) Objective	Soiling Units (SU) measured during period 15/02/2018 – 05/03/2018	Nuisance (Y/N)
GS1	<50	50.4	Y
GS2	<50	20.1	N
GS3	<50	35.6	N
GS4	<50	33.6	N
GS5	<50	30.9	N
GS6	<50	55.6	Y

The guidance criterion of 25 SU per week (i.e. 50 SU per fortnight) set out by the Environment Agency was exceeded at GS1 and GS6 during the second of the fortnightly periods in the surroundings of the Battersea site. The soiling units recorded at GS1 and GS6 show that both are slightly over the nuisance threshold. The soiling units recorded at the other locations suggest that dust nuisance would have been unlikely at sensitive receptors during the monitoring period.

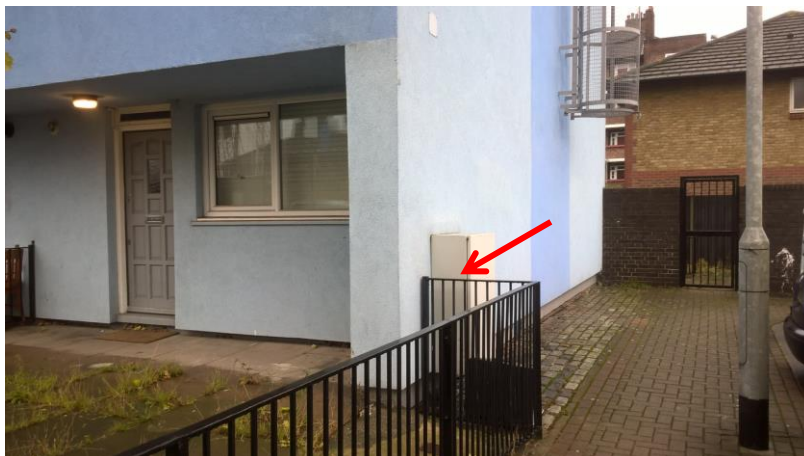
*Figure 6 – Glass Slide 2*

Glass Slide 2 – GS2

**Location:** Railing by Battersea Park Road, 113

**Receptor:** residents of Battersea Park Road

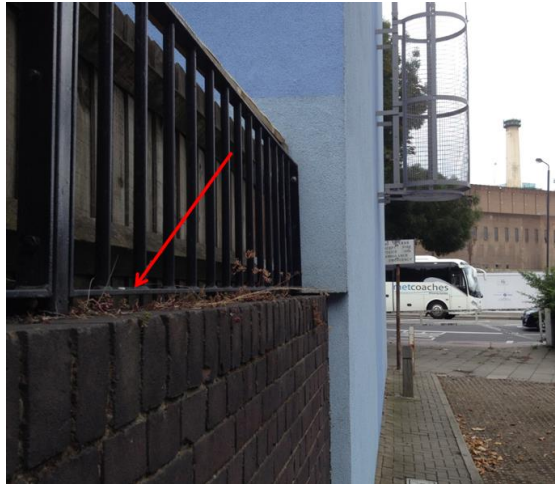
Figure 7 – Glass Slide 3

Glass Slide 3 – GS3

**Location:** rear wall of Savona Street

**Receptor:** residents of Savona Estate

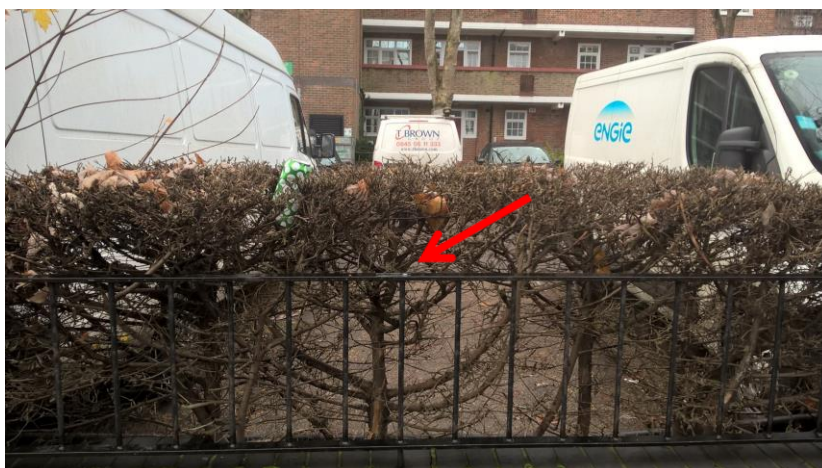
Figure 8 – Glass Slide 4

Glass Slide 4 – GS4

**Location:** wall on Thessaly Road

**Receptor:** residents along Thessaly Road

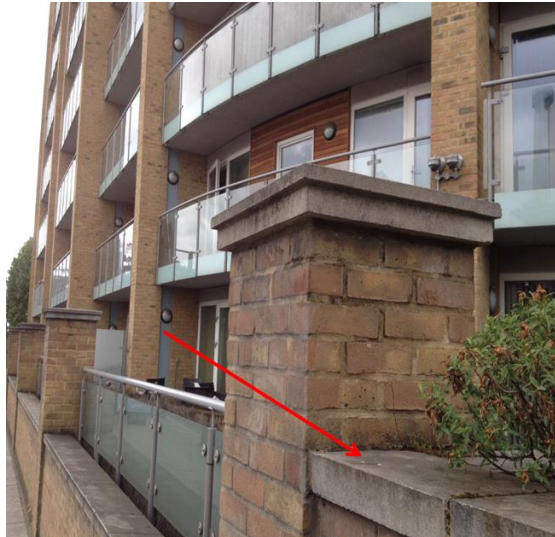
Figure 9 – Glass Slide 5

Glass Slide 5 – GS5

**Location:** wall opposite Viridian Apartments

**Receptor:** residents at Viridian Apartments

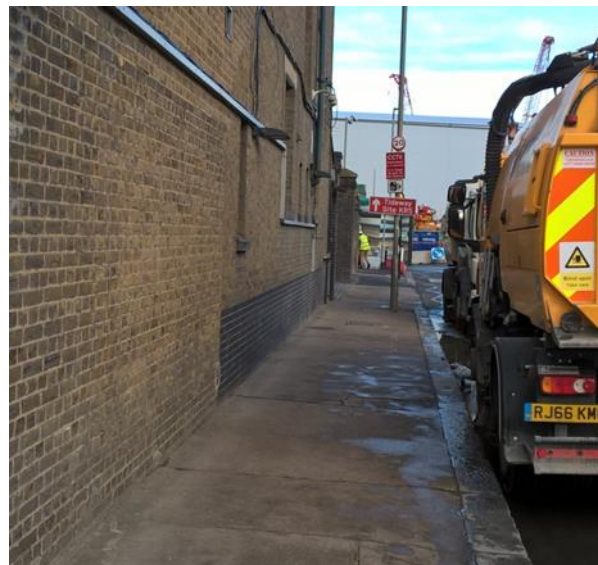
Figure 10 – Glass Slide 6

Glass Slide 6 – GS6

**Location:** top of post on Kirtling Street

**Receptor:** commercial and residential receptors on Kirtling Street

\*Slide missing
