**THE FUTURE
OF TRANSPORT**

**PUBLISHED PROJECT REPORT
PPR992**

**The Transport for London (TfL) Bus
Safety Standard: Occupant Friendly
Interiors**

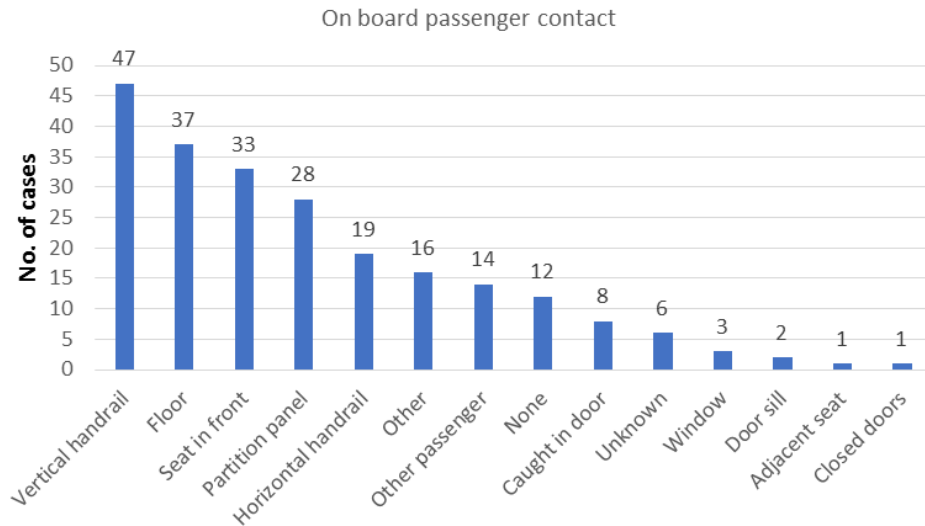
Figure 2-11 shows the frequency with which different parts of the bus interior were the first significant object that an occupant collided with. The vertical grab rails were hit most frequently, followed by the floor. Because many people fell off the seat onto the floor, approximately the same number of standing and seated occupants hit the floor, (17 standing, 14 seated) and 6 boarding and/or alighting the bus.

Figure 2-11: Bus interior part contacted (227 cases)

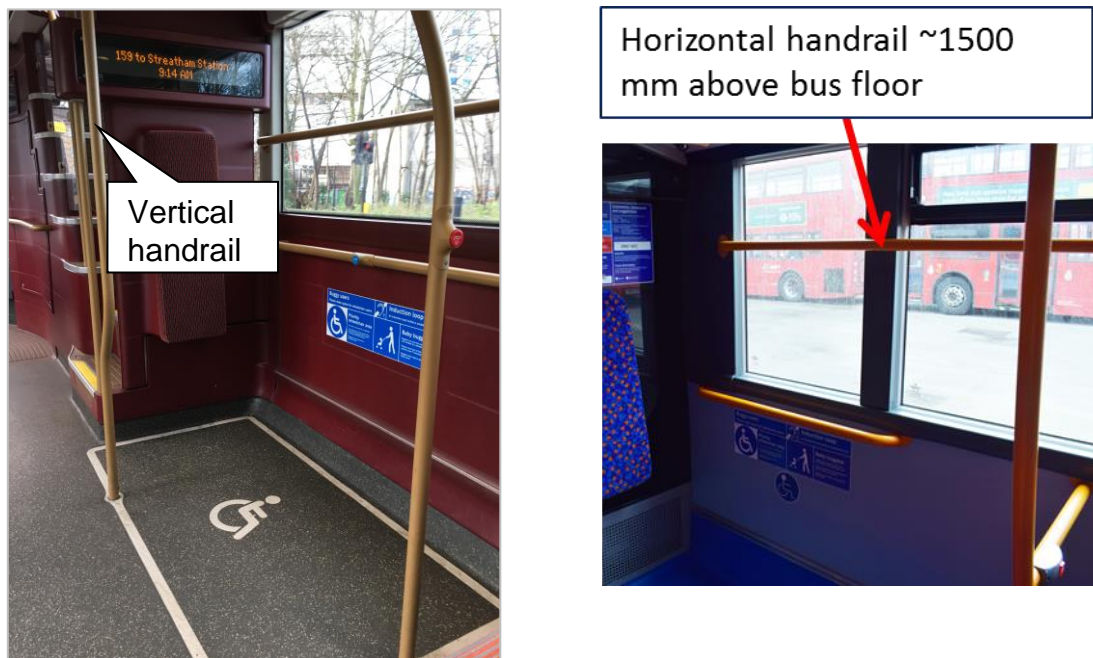
- Handrails in head impact zone, i.e. at the height of a standing passenger's head. These have been seen to be impacted in the CCTV incident analysis. Examples include horizontal and vertical handrails in the wheelchair area.

Figure 2-27: Vertical and horizontal handrails in head impact zone in wheelchair area

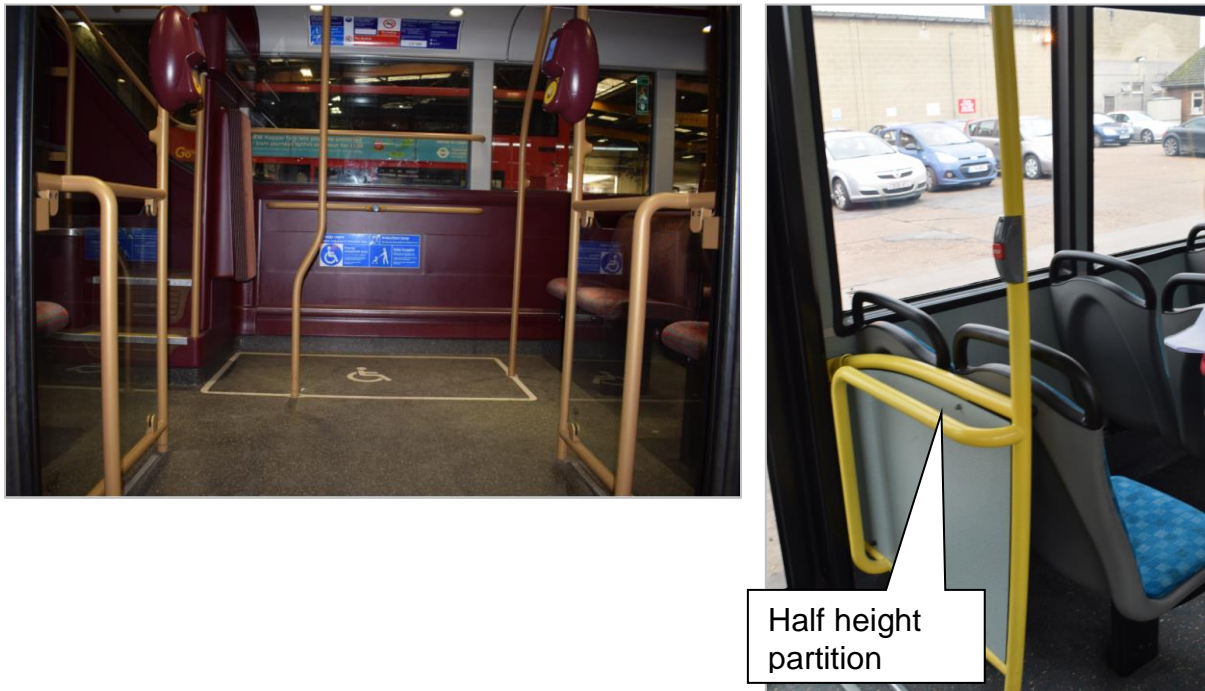
- Partitions which do not compartmentalise, i.e. half height partitions which a passenger can be propelled over during harsh braking or a collision.

Figure 2-28: Half height partition to left of middle doors

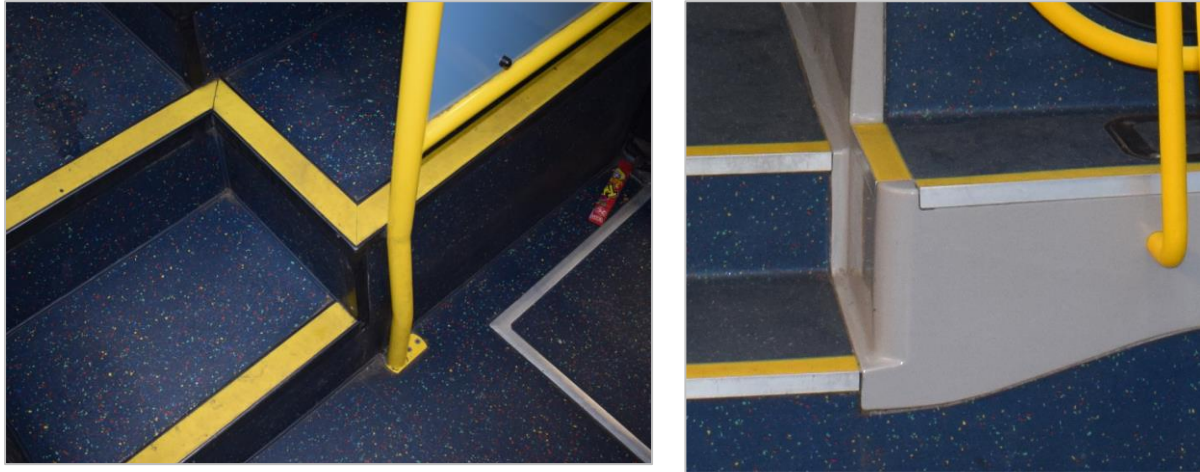
Based on rail interior design guidance notes (Railway Group, 2011) GN95, it was proposed that the assessment procedure be developed to encourage removal of protrusions and that edges / corners of rigid features (i.e. those with a shore hardness rating greater than 60) should have radii of circa 5 mm minimum and higher (ideally 20 mm minimum) for head impact.

Figure 2-29: Sharp step corner (left); rounded step corner (right)

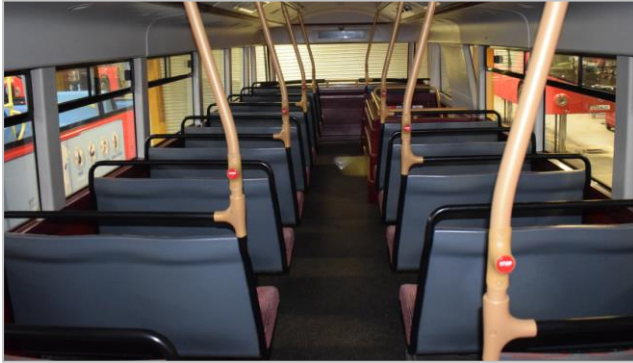
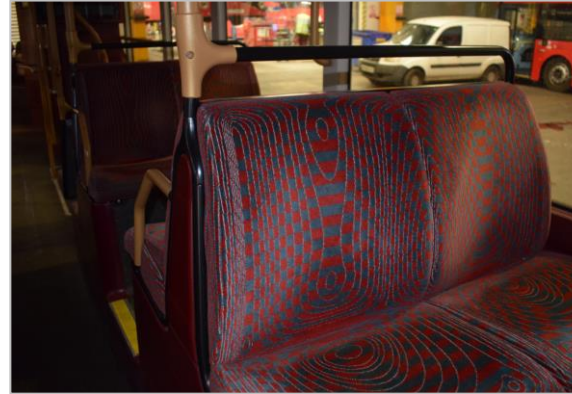
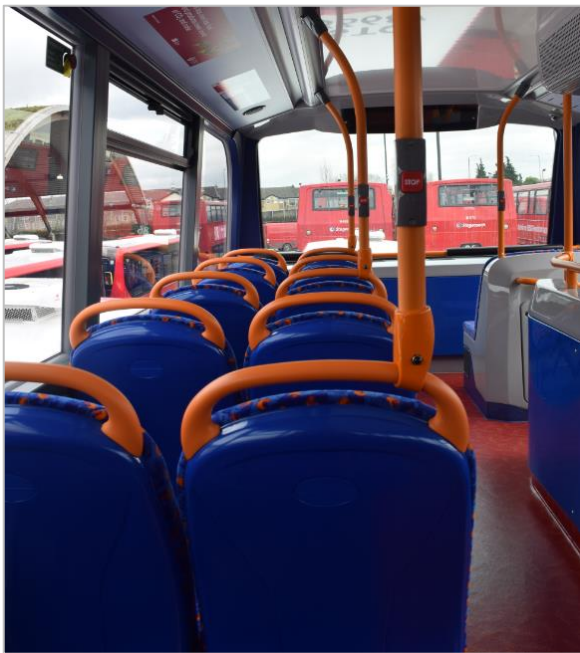
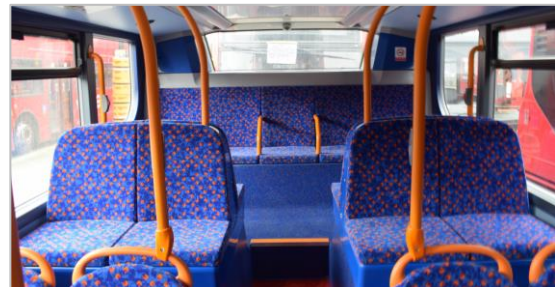
- Handrail on top can be an impact hazard for passengers, especially shorter persons, e.g. children, seated behind because in alignment with likely trajectory of passenger.
- Rear facing low backed seats do not provide support for head and neck in frontal impact or harsh braking events.

Figure 2-31: Example of low backed seat, handrail on top can be impacted by passenger seated behind (left) and if rear facing provides no support for head/neck of passenger (right)

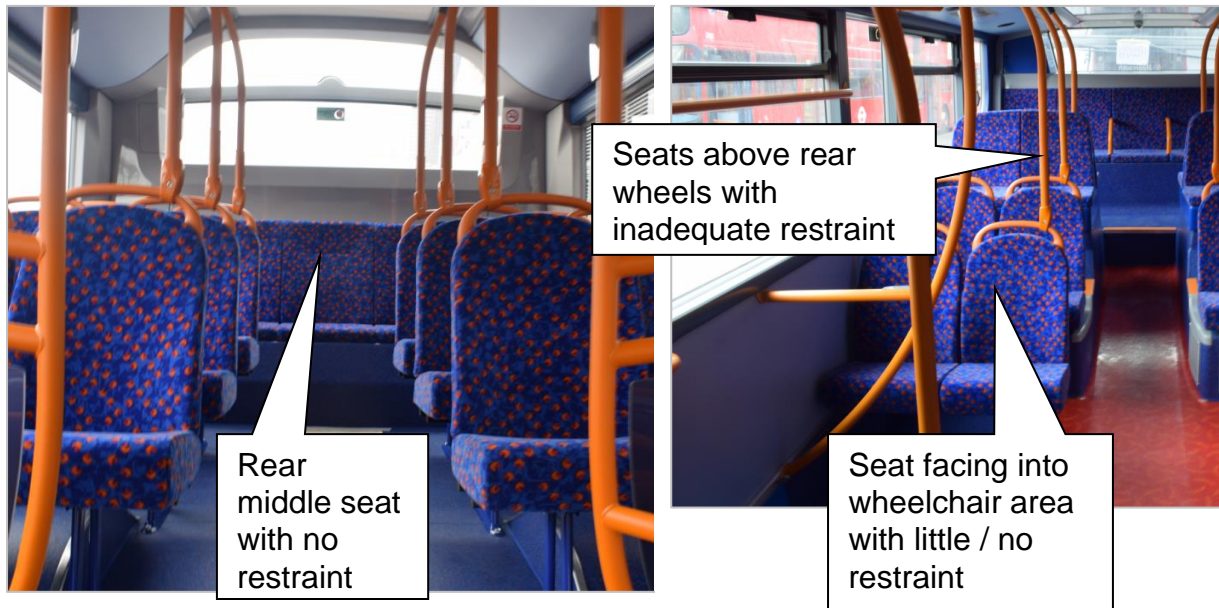
- Inadequate restraint for higher seats (above rear wheels) because passenger positioned high above low backed seats in front of them

Figure 2-32: Little / no restraint of passengers on middle seat on back row (left) or seat facing into wheelchair area (right). Also, inadequate restraint for higher seats (above rear wheels) with inadequate restraint from low backed seats ahead of them

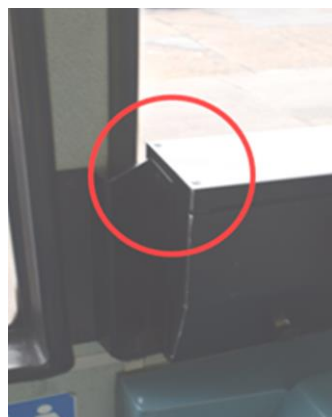
As for standing passengers, it was proposed that the assessment procedure be developed to encourage removal of protrusions and that edges / corners of rigid features should have radii of circa 5 mm minimum and higher (ideally 20 mm minimum) for head impact.

Figure 2-33: Sharp corners on passenger information display by priority seats

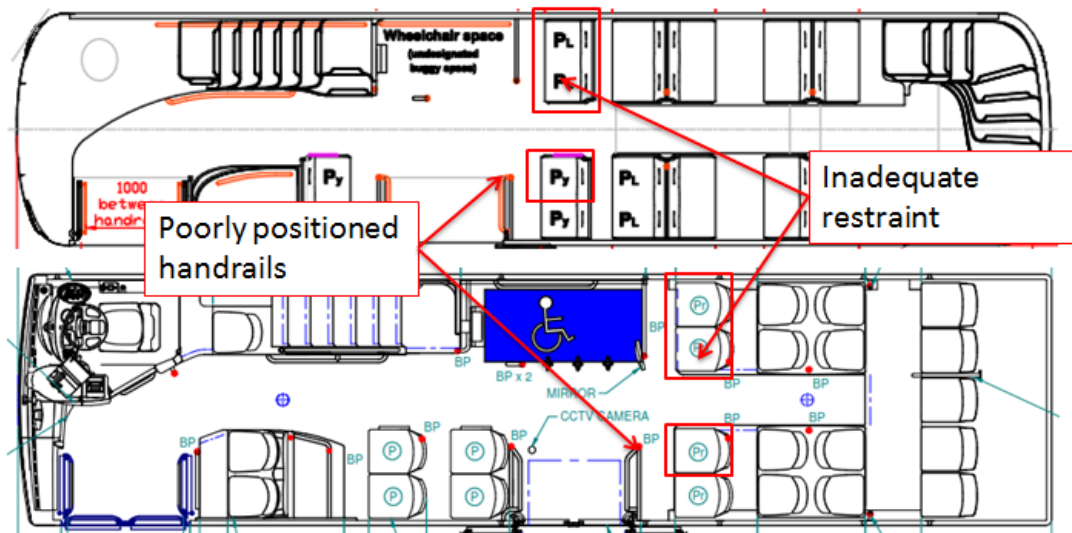
Figure 2-34: Poorly positioned handrails and inadequate restraint for seats behind middle doors and wheelchair area

It is interesting to note that the seats positioned behind the wheelchair area and middle doors often have features associated with high injury potential, in particular inadequate restraint and handrails in alignment with passenger trajectories. This correlates with the area identified in the CCTV analysis as having the highest proportion of seated passengers who were injured (6%) - see Section 2.2.3.3 above, Figure 2-26. Confirmation of the problems in this area of the bus is shown below in Figure 2-34, Figure 2-35, and Figure 2-36.

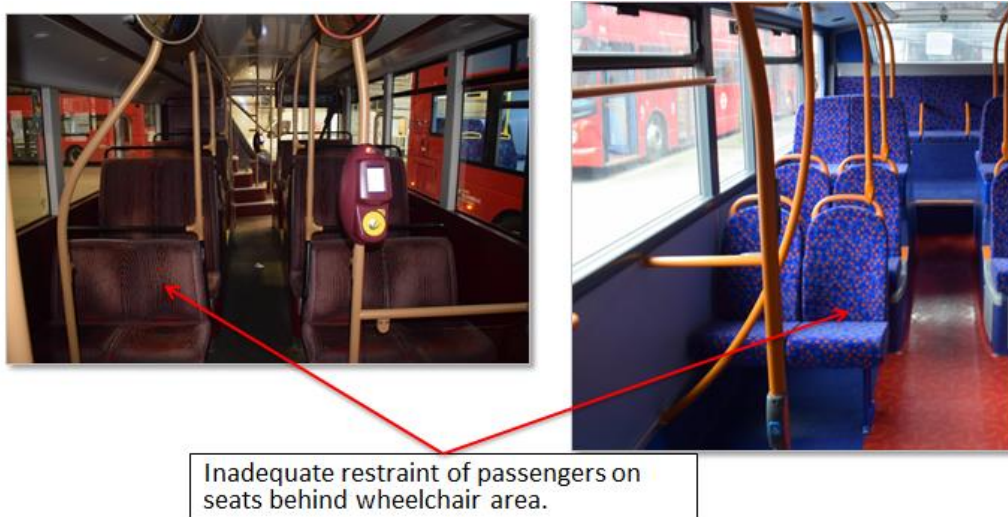
Figure 2-35: Inadequate restraint of passengers on seats behind wheelchair area

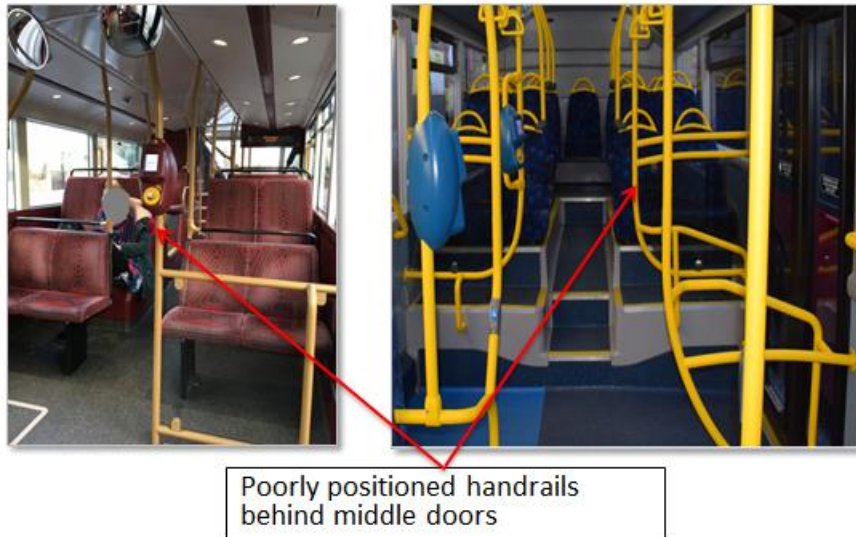
Figure 2-36: Poorly positioned handrails for seats behind middle doors

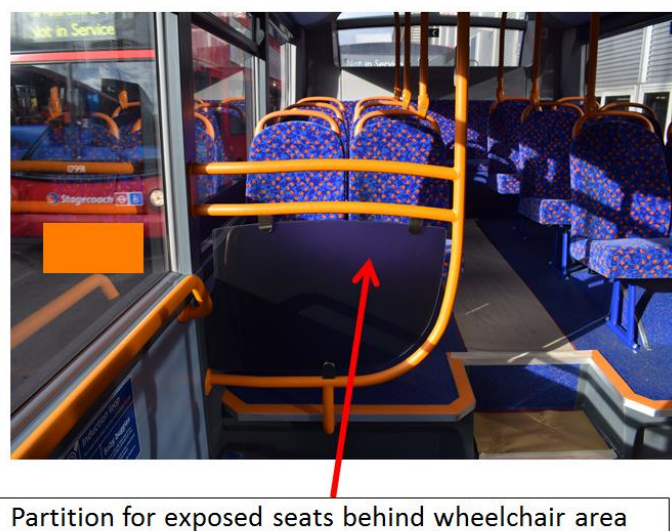
- Partition in front of exposed seat behind wheelchair area

Figure 2-37: Example of partition installed to improve passenger restraint for exposed seats behind wheelchair area

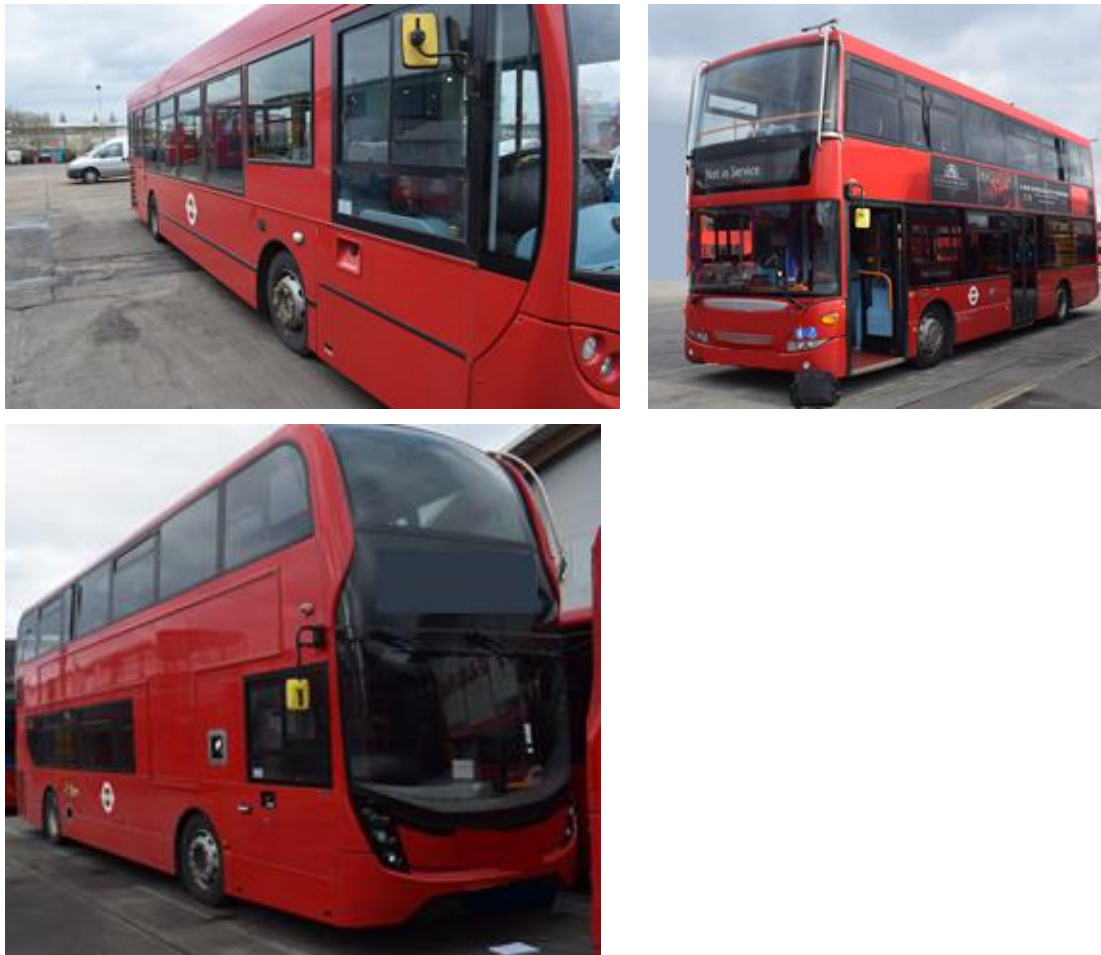
Generally, the exterior of a bus presents flat surfaces with protrusions such as indicators well rounded. Items such as filler points are recessed and/or covered with a hinged flap (Figure 2-40). Vents for engine cooling present surfaces with no protrusions likely to cause injury, and are mounted on the offside or rear, so that hot air is not directed at passengers on the kerb who are about to embark or have just disembarked. So overall, the exterior of a bus presents no features that have a potential to cause injury to a embarking or disembarking passenger or passer-by. The exceptions to this statement are the wiper blade driver posts on some buses and the mirrors, some of which are mounted at a height at which they could strike a pedestrian. Further details are given in the bullet points below.

Figure 2-40: Views of bus exterior showing generally flat surfaces with no significant protrusions with the exception of mirrors and wiper driver posts on some buses

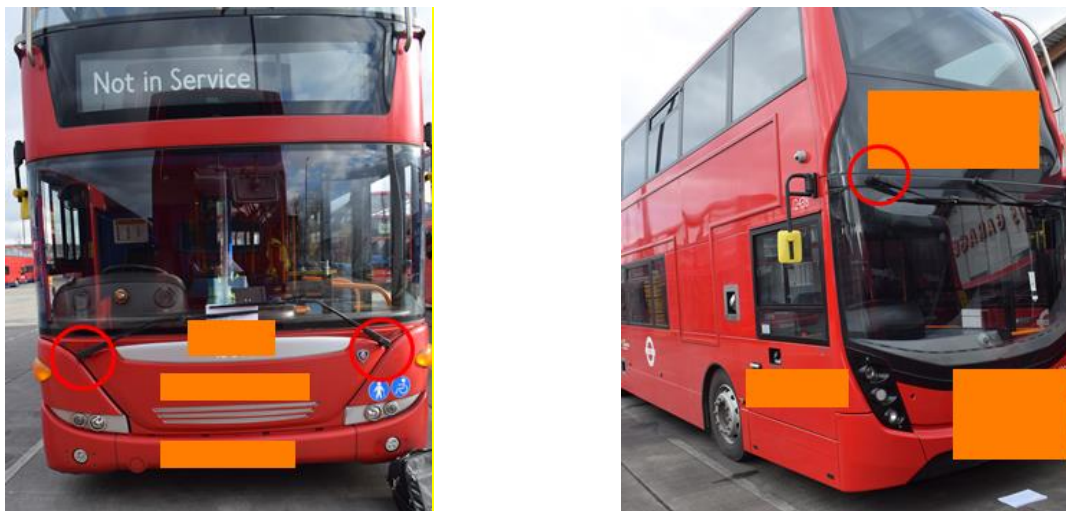
On some buses, it was noted that wiper driver posts that protruded were positioned in the pedestrian impact zone and therefore present an increased injury potential risk. On some buses, this issue was solved by positioning the wiper driver posts above the top of the windscreen and above the pedestrian impact zone. This issue is being addressed as part of the work for the 'VRU crashworthiness' safety measure which considers counter-measures for impact protection, run-over protection and mirror strikes.

Figure 2-41: Protruding wiper driver posts positioned in pedestrian impact zone (left) and above pedestrian impact zone (right)

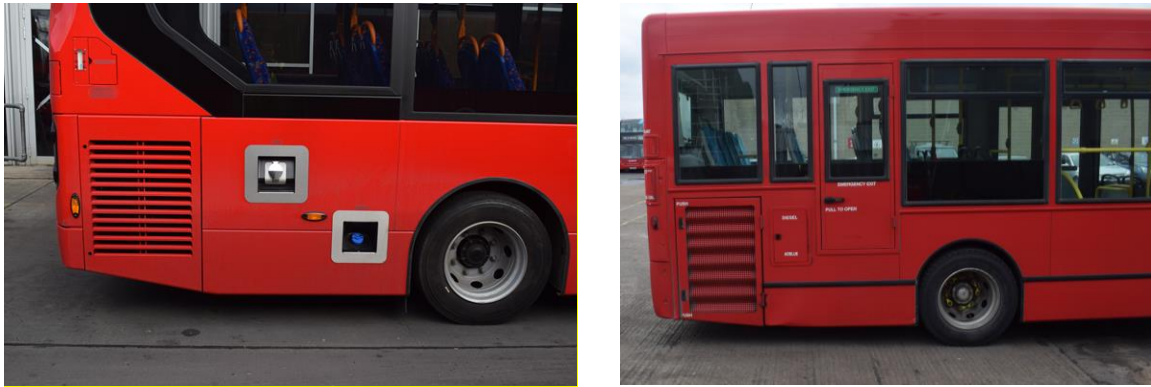
Filler points for fuel and Adblue are recessed and sometimes covered with a hinged flap. It was noted that the flap could open easily. However, it was judged that this should not cause a significant problem because it was hinged on the right side which means that bus forward motion should help it close and the driver will be able to see if it is open in the mirror.

Figure 2-42: Filler points recessed (left) and covered with hinged flap (right)

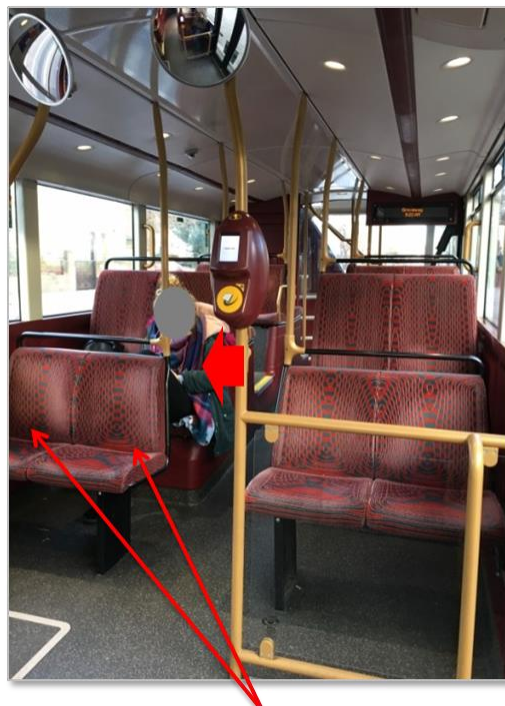
Fit guard (partition) in front of these seats

Figure 5-5: Exposed seats behind wheelchair area. Solution level 1 proposes to fit guard (partition) in front of these seats. Solution level 2 proposes to extend guard and move handrails further into aisle

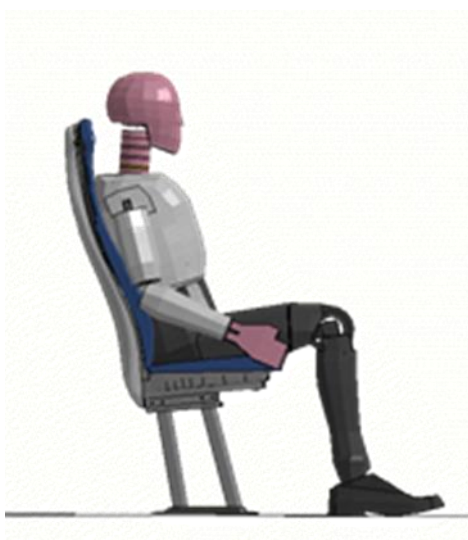
Figure 5-10: 50th percentile Hybrid III dummy sat in bus seat with ‘high back’ showing that seat back is not high enough to support head fully if occupant propelled into their own seat

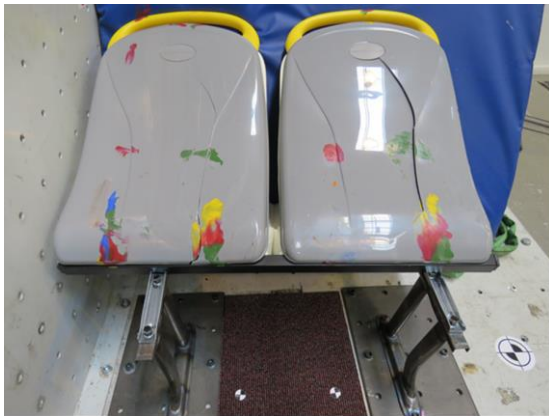
Low backed seat: splitting of rear panel in area where dummy legs impacted

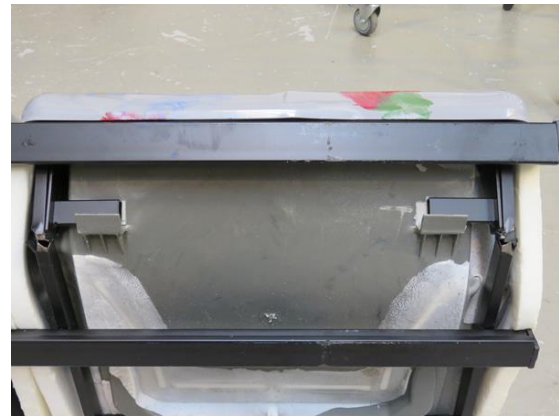
Low backed seat: failure causing detachment from pedestal legs

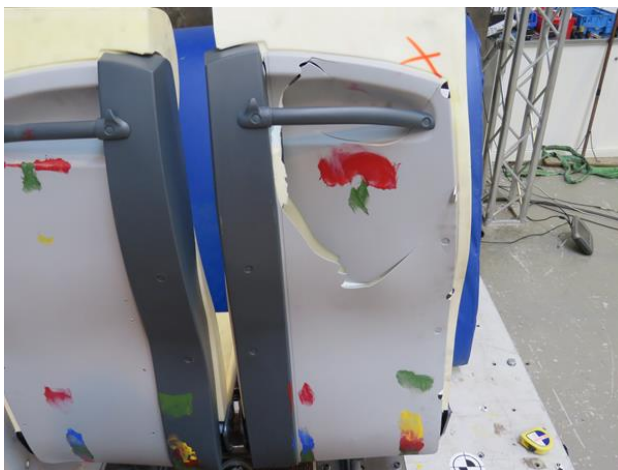
High backed seat: failure (splitting) of rear panel in area where dummy head impacted

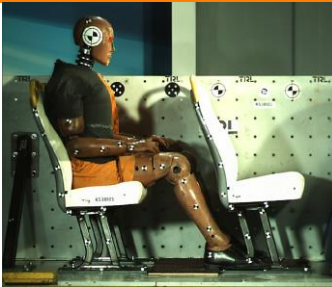
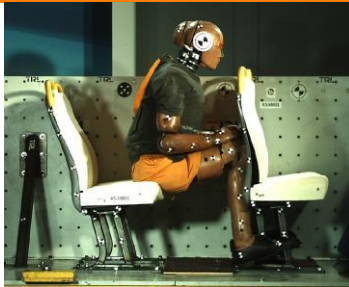
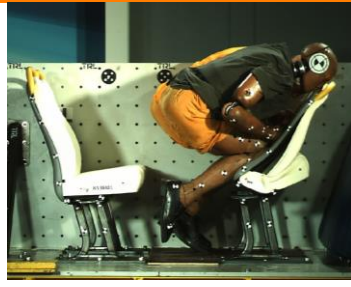
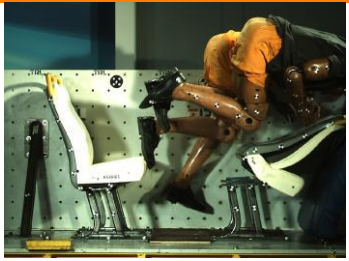
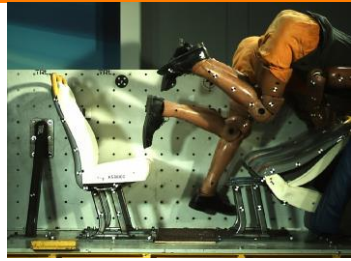
Low backed (test)

Table 5-20: Comparison of dummy kinematics and restraint for low and high backed seats in tests to assess seat structural performance, for crash deceleration pulse

0 msec	100 msec	200 msec

300 msec	400 msec	500 msec	
	High backed (test)

A comparison of kinematics of the dummies and the restraint offered for low and high backed seats is shown in Table 5-20 for the crash (regulation 80) deceleration pulse. It is seen that the high backed seats provided much better restraint than the low backed ones. Part of the reason for this was the structural failure of the low backed seat between the seat structure and the supporting pedestal legs, which could have prevented containment of passengers in a crash. However, in typical bus a bodyside connection is usually used, which would have likely prevented this structural failure.

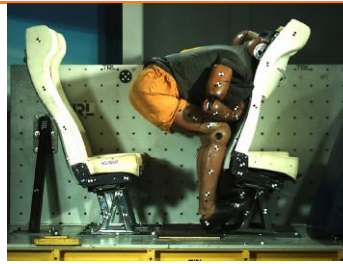
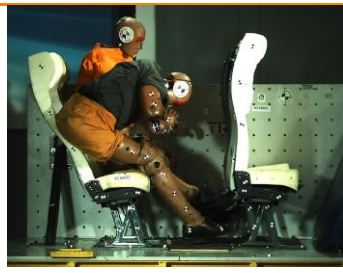
0 msec	100 msec	200 msec

300 msec		400 msec	500 msec

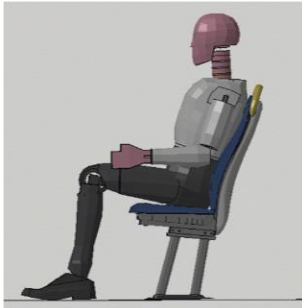
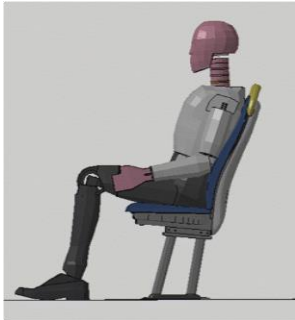
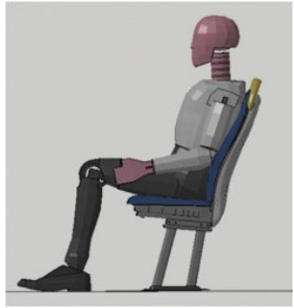
Seat type	0 sec	0.5 sec	0.94 sec
Low backed (sim)

Table 5-21: Comparison of kinematics of H3 dummy propelled rearwards into own seat in front for low, medium and high backed seats – braking pulse

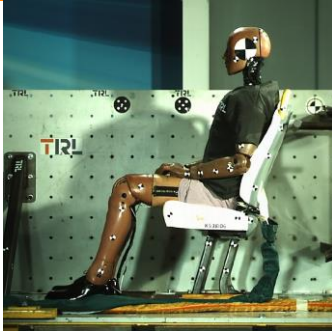
Low backed (test)

The differences in kinematics for the collision pulse (for simulations and tests) are shown in Table 5-22 below for the low, medium and high backed seats. For all the seats, to prevent the seat back collapsing and the occupant sliding backwards out of the seat, a bar was positioned behind the seat back to represent a supporting structure such as a partition or another seat. The reason the seat backs bend without support is that they are designed to bend when impacted from behind to absorb energy and help mitigate occupant injury for collisions in which the occupants are propelled forwards. Substantial neck extension (rearward motion) is seen for all the seats, even for the high backed coach seat. This is because the high backed coach seat has a recess behind the head to allow a passenger to rest their head and sleep (Figure 5-23). To investigate the effect of supplying better support for the head, simulations were performed with the head restraint part of the seat modified with this recess filled in (Figure 5-24). With this modification much less neck extension was seen (Table 5-22).

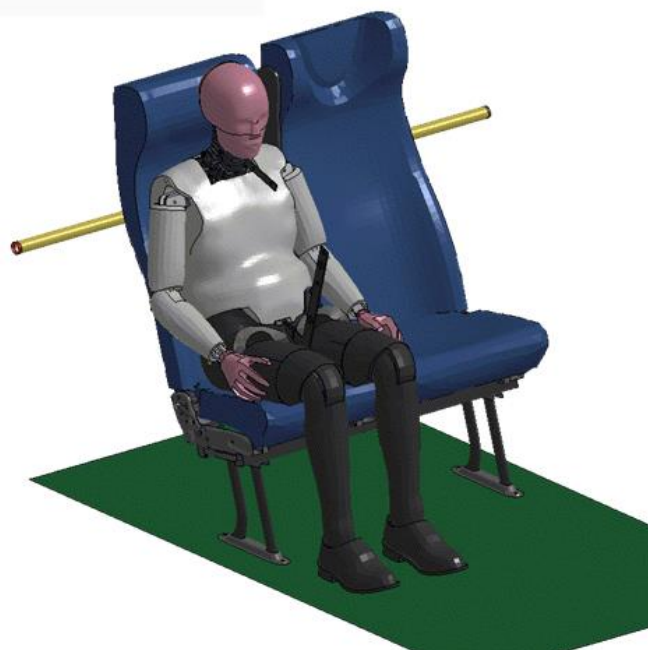
Figure 5-26: Iso view of BioRID II dummy in high backed (coach) seat with modified head restraint foam (recess filled in) to improve support for head rearward motion
