CLIENT: LONDON UNDERGROUND LIMITED

CONTRACT REF: TLL 7917

NORTHERN LINE EXTENSION

**Kennington Green Passive Air Quality Monitoring – Four
weekly report**

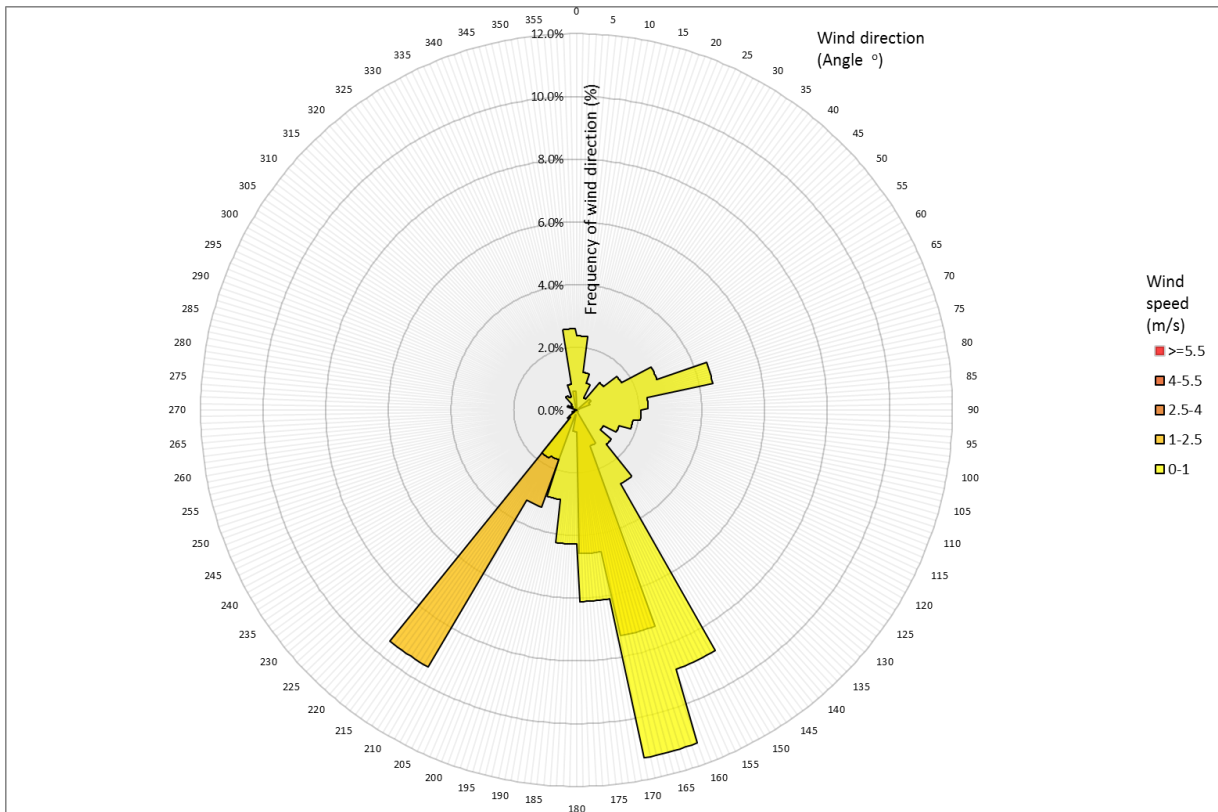
Figure 1. Wind rose from the Kennington Green sonic anemometer KG1W. Period 1.

Figures 1 and 2 show the wind rose from the KG1W sonic anemometer during the relevant period. Data was downloaded via the Sigicom integrated monitoring system.

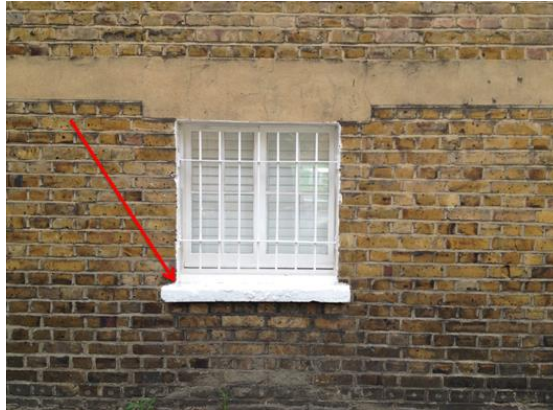
Figure 4 – Glass Slide 1

Location: front window of 3 Montford Place

Receptor: residents of Montford Place
