## Increasing Longevity: King's Scholars' Pond Sewer Repair Trial

TfL Lane Rental Industry Publication

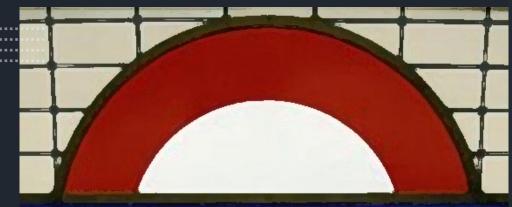
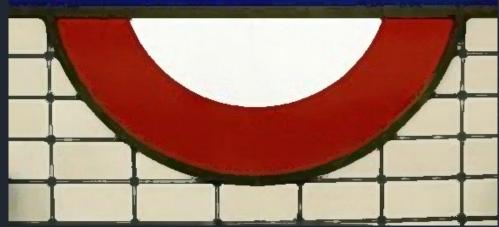
BAKER STREET

While undertaking a routine inspection, there was evidence of significant internal degradation and deterioration, with cracks visible within the brickwork. Given the location of the sewer, the preferred option was for remediation to be carried out from within the sewer and possible solutions were investigated.

After thorough investigation, the chosen method was to construct a modular duplex steel Vierendeel truss with an associated glass fibre reinforced plastic (GFRP) liner, designed to be carried through the existing manhole, and once in situ, bolted together to form a permanent bridge
