Bank Station Capacity Upgrade

15 Abchurch Lane Heritage Statement

September 2014

LUL Document Reference:
LUL-8798-STT-G-002114

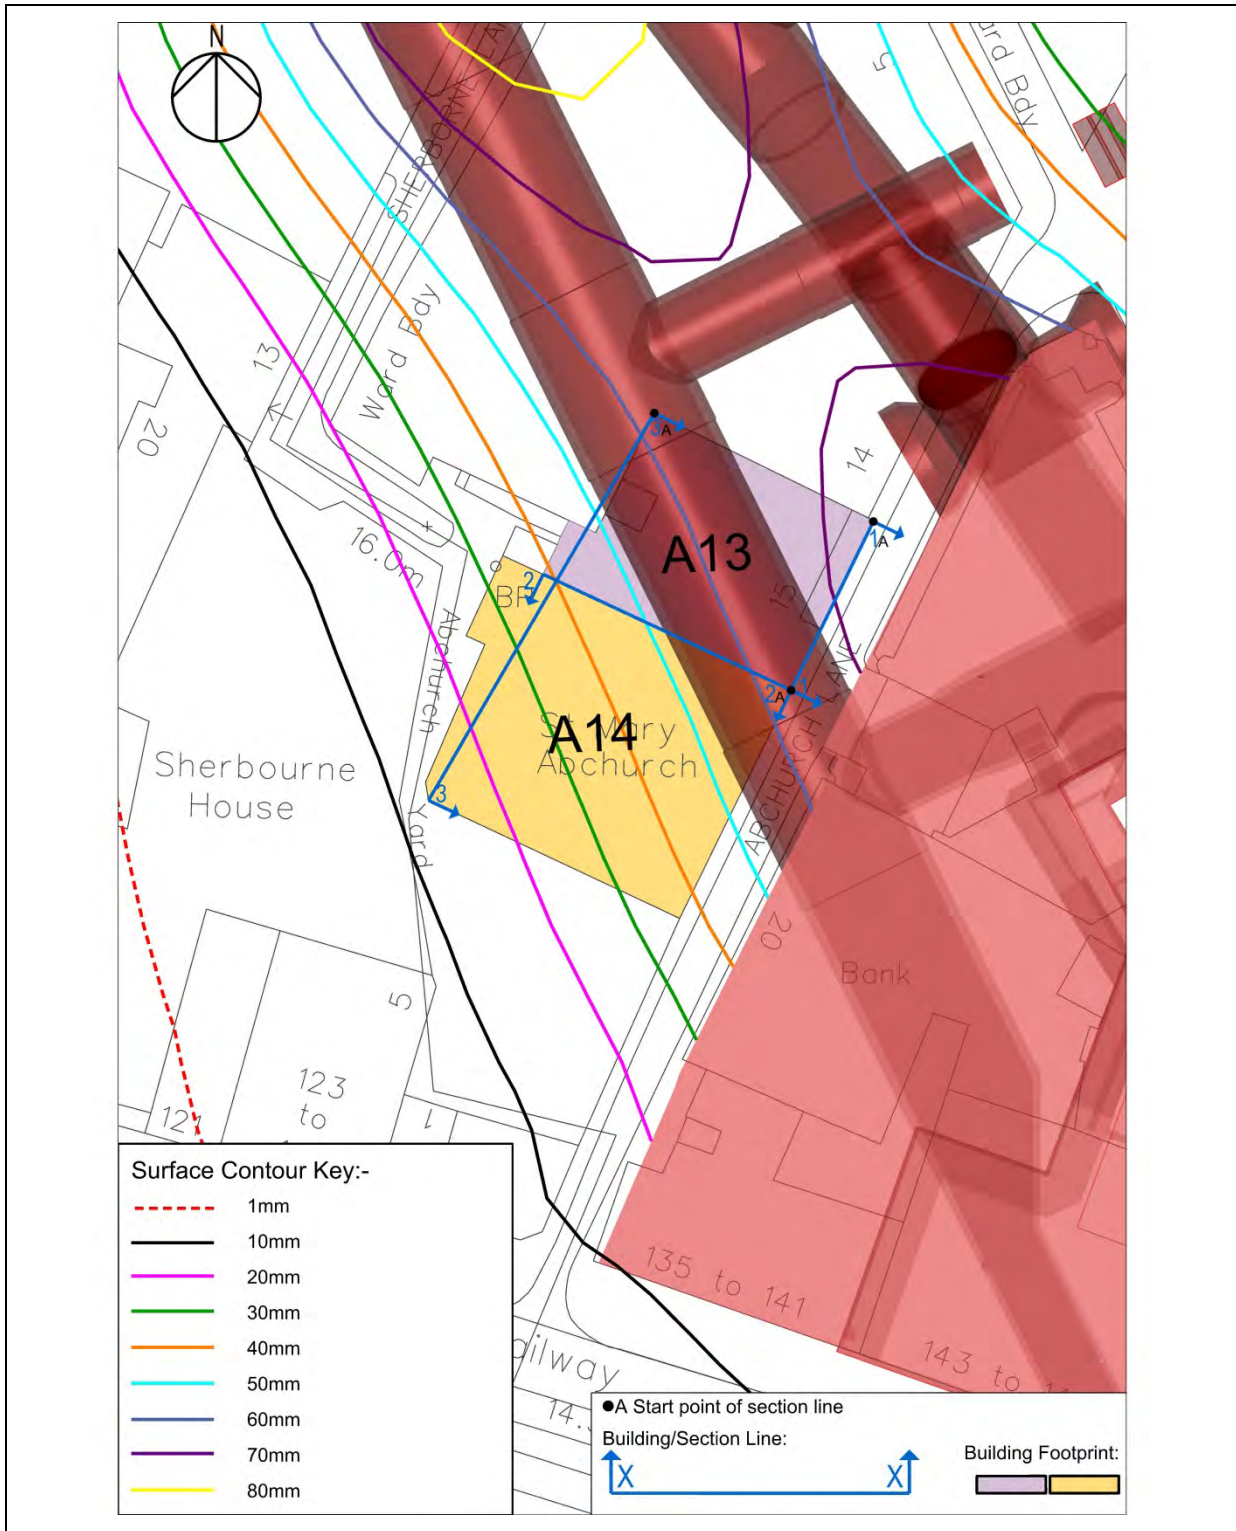
Figure 3: Building location, sections analysed and Settlement Contours at stage of worst case for tensile strains

The results of the assessment show that the intermediate construction Stage 2 is the critical stage for this building where line 1 experiences the most onerous combined tensile strain. The orientation is shown in Figure 3. The vertical and horizontal Greenfield ground movements along the section of the building are shown in Figure 4. The relative position of the building and tunnels along section (line 1) is shown in
