Date: 22 January 2018

Item: Tram Overturning at Sandilands, Croydon on 9 November 2016 – RAIB and TfL Investigations – Update

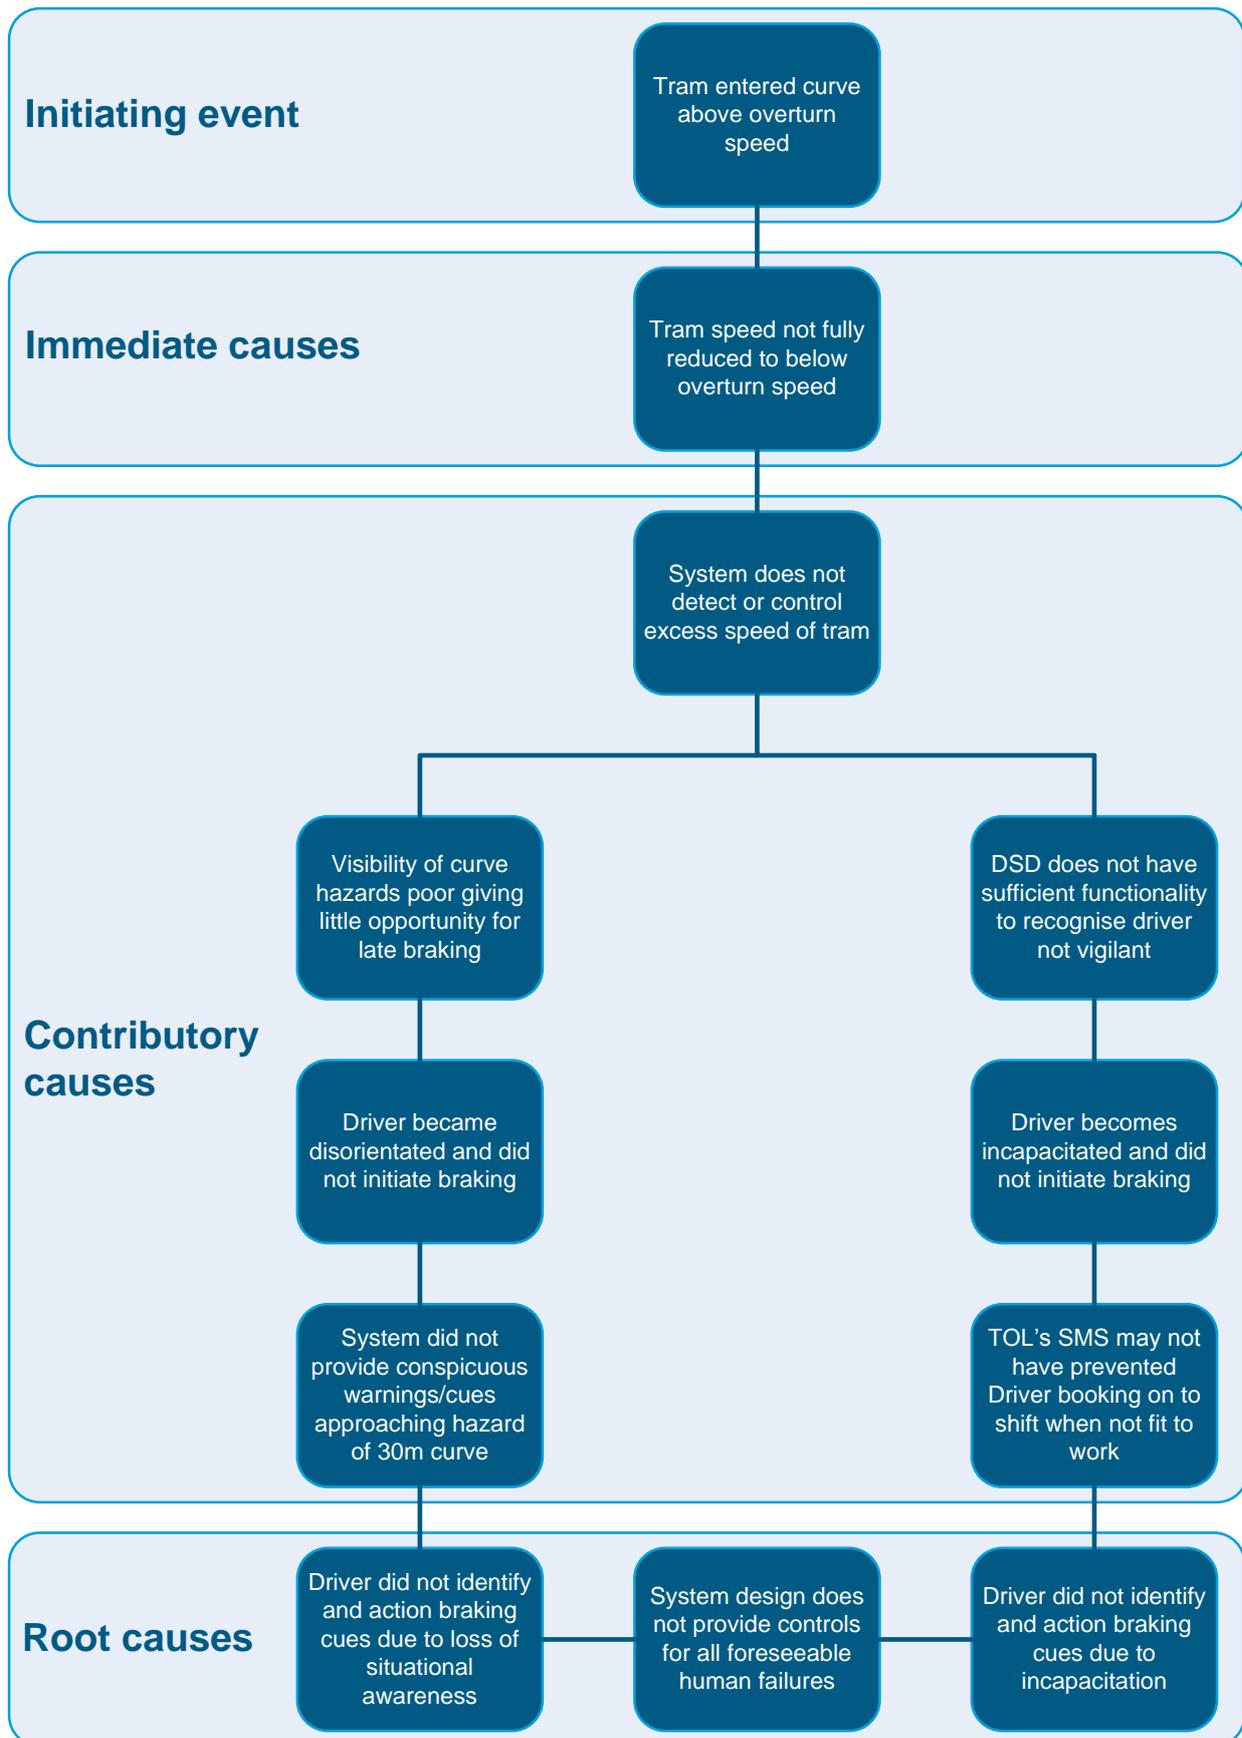
Figure 5 - Overview of Causal Chain

The causal chain (see Figure 5) described as two possible contributory chains. Completion of investigations may enable one to be eliminated or identified as more probable than the other, to confirm one as the most likely causal chain. This report describes the initiating event and immediate cause as shared conclusions, and then discusses both the probable contributory and associated root causes in turn.

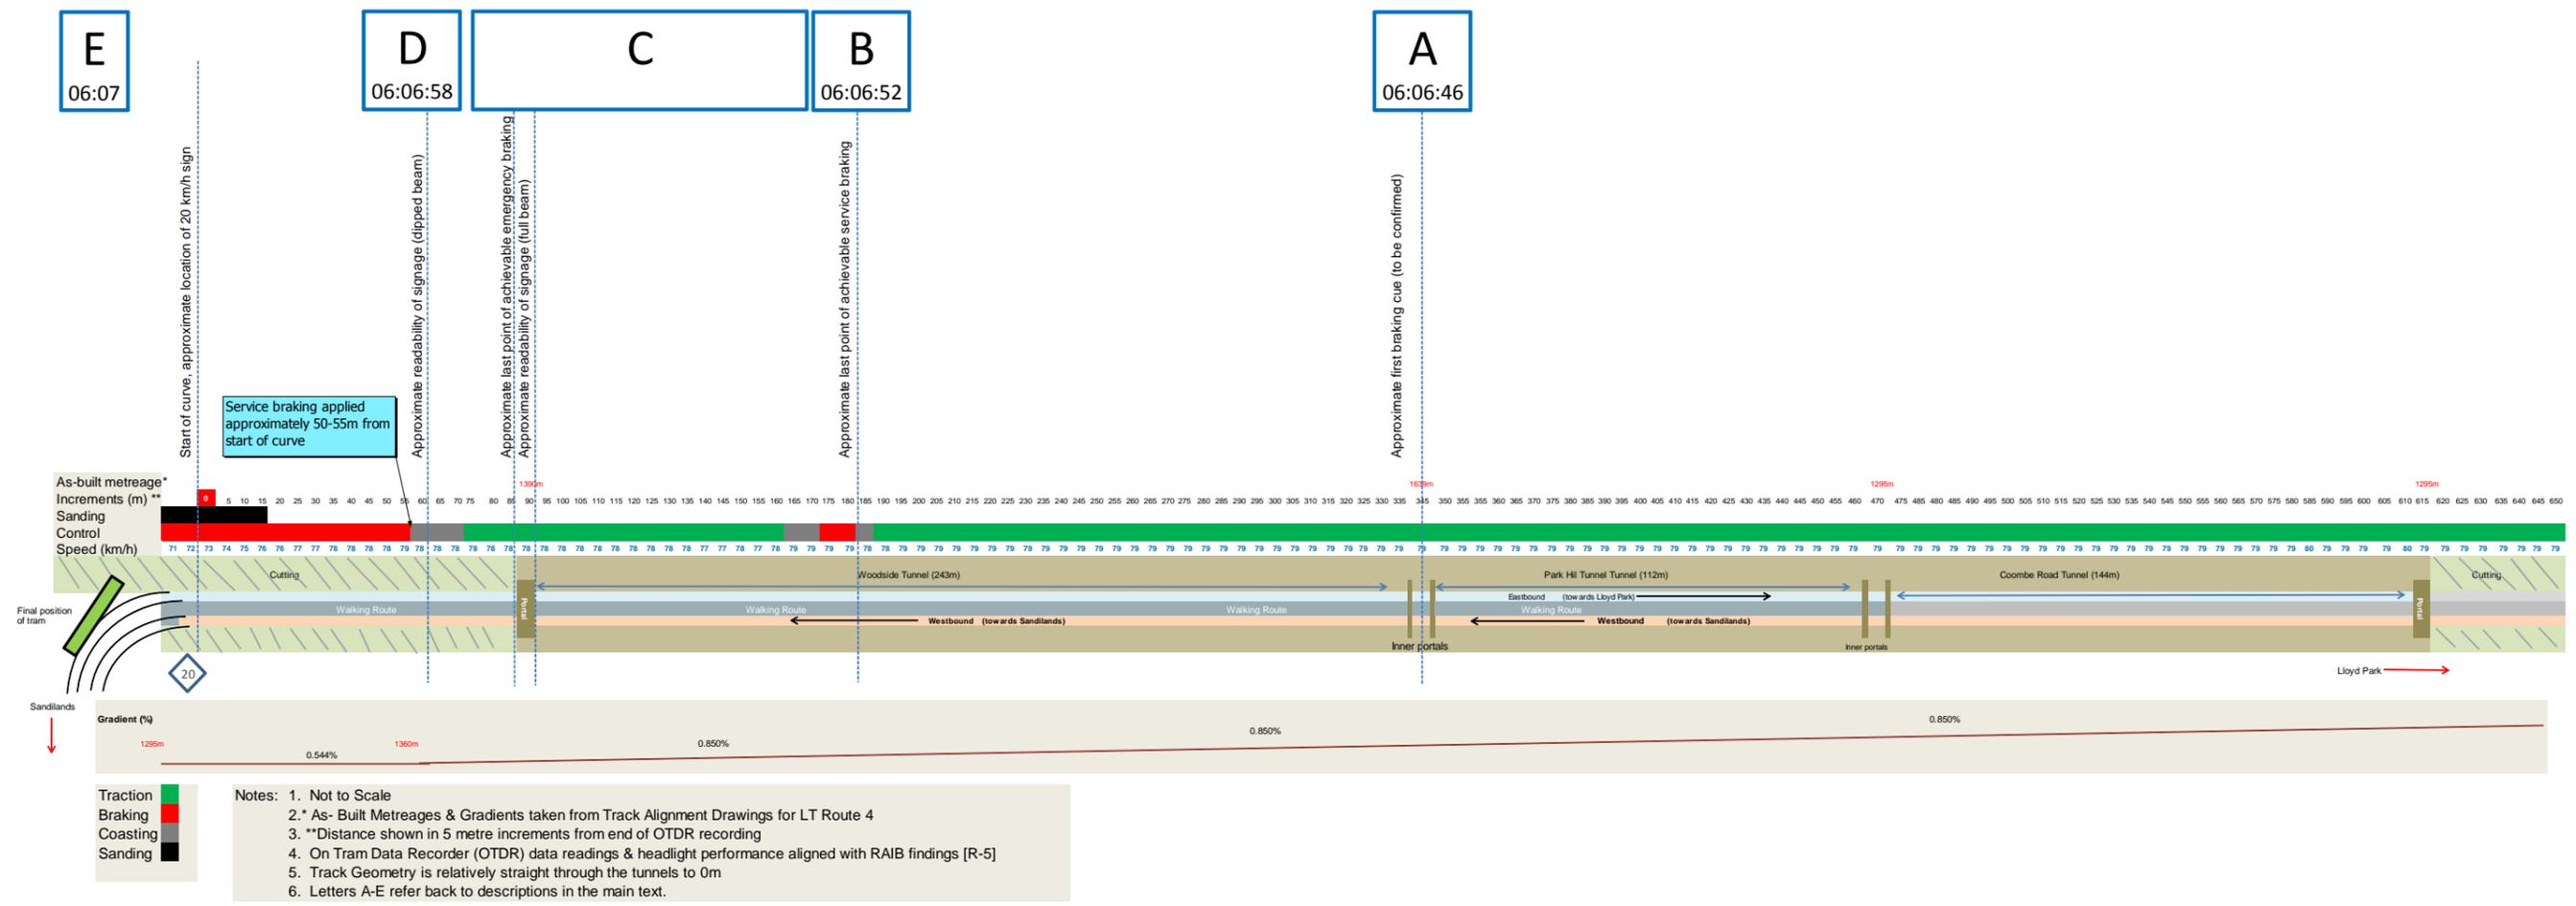
Appendix A Final sequence of events

The braking cue point (nominally towards the start of the Woodside tunnel, see Appendix A and Figure 4 for details), can be ambiguous in certain environmental conditions and is therefore a contributory factor to this theoretical causal chain (see section on human factors below)
