TfL: Northern Line Extension - Visual Receptor Schedule and Assessment of Effects

K3: Representative Views Analysis

Environmental Statement

Project Title
Northern Line Extension to Battersea TWA@ for TFL

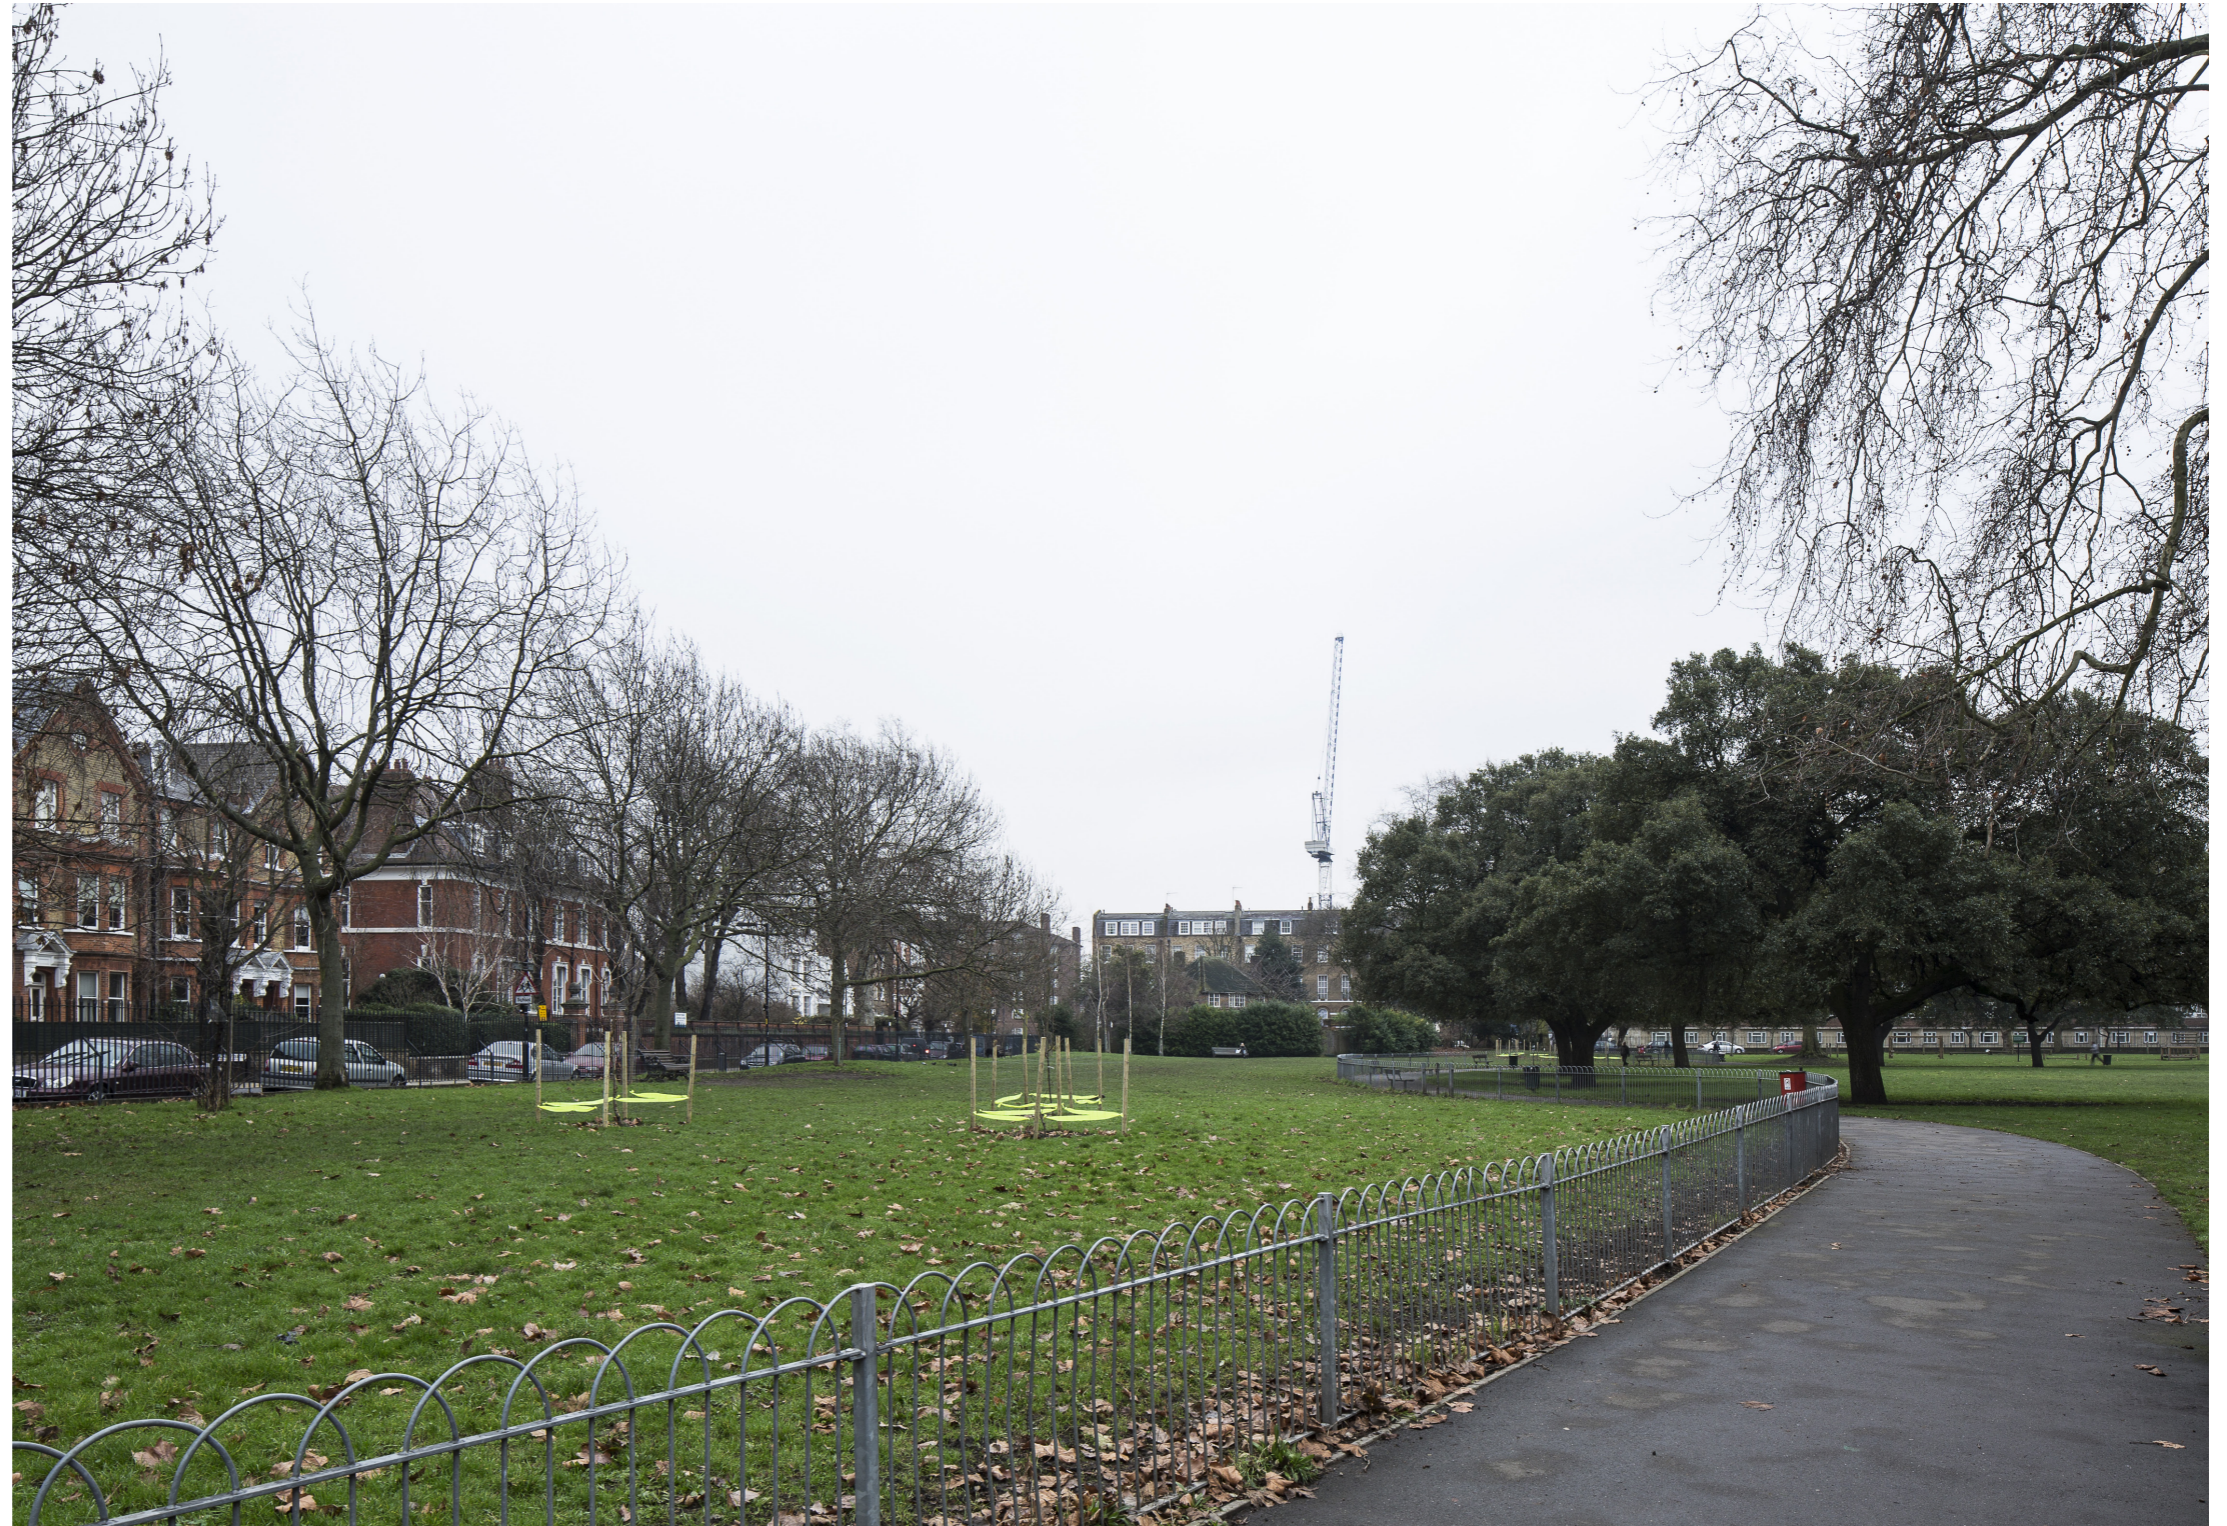
Figure 15 - 4

Kennington Park - Western side of park

Time 10/01/2013 – 14:32
 Lens Focal Length 24mm
 Lens Shift 5mm RF
 Image Direction 257°
 Height 1.60m
 Latitude 51° 29' 8.478" N
 Longitude 0° 6' 40.458" W

This view is from a point close to the war memorial at the north-western corner of the Grade II registered Kennington Park. The foreground comprises the beginning of a sweeping path which extends eastwards into the background. The foreground also takes-in a grassed, dog exercise area enclosed by railings to the north and a low bow-top fence to the south. This open area is lined by trees to the north which filter views of the two- to three-storey Victorian villas which front Kennington Park Place, some of which are listed. The background of the view includes the tops of earlier listed Georgian townhouses and the Kennington Park Lodge. The latter is substantially screened by dense vegetation within the lodge garden and park. There are also glimpsed views of the 20th century Conant House filtered by mature evergreen trees within the park.

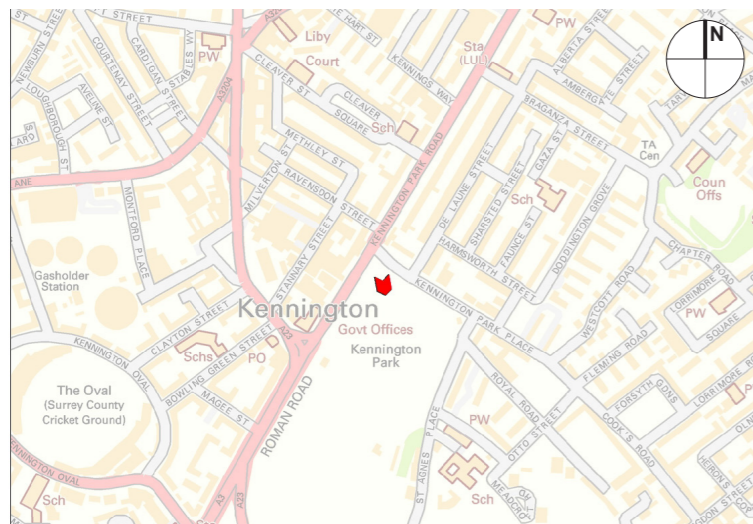
Existing View

The foreground of this view would be returned to a grassed area enclosed by a low metal fence. Longer grass would be established along the northern boundary of Kennington Park, extending into the middle-ground. This boundary would be reinforced by an avenue of new London Plane (*Platanus x hispanica*) trees and railings to match the existing. The proposed head house building would fall into the background of the view. The building would be located further to the right than the existing Kennington Park Lodge, and the roofline swept back to reveal a more extensive view of the Grade II listed properties No.s 1-7 St. Agnes Place and their attached railings. Only the louvered west-facing façade of the head house building would be visible, above a dense massing of flowering trees and shrubs which would provide its setting.

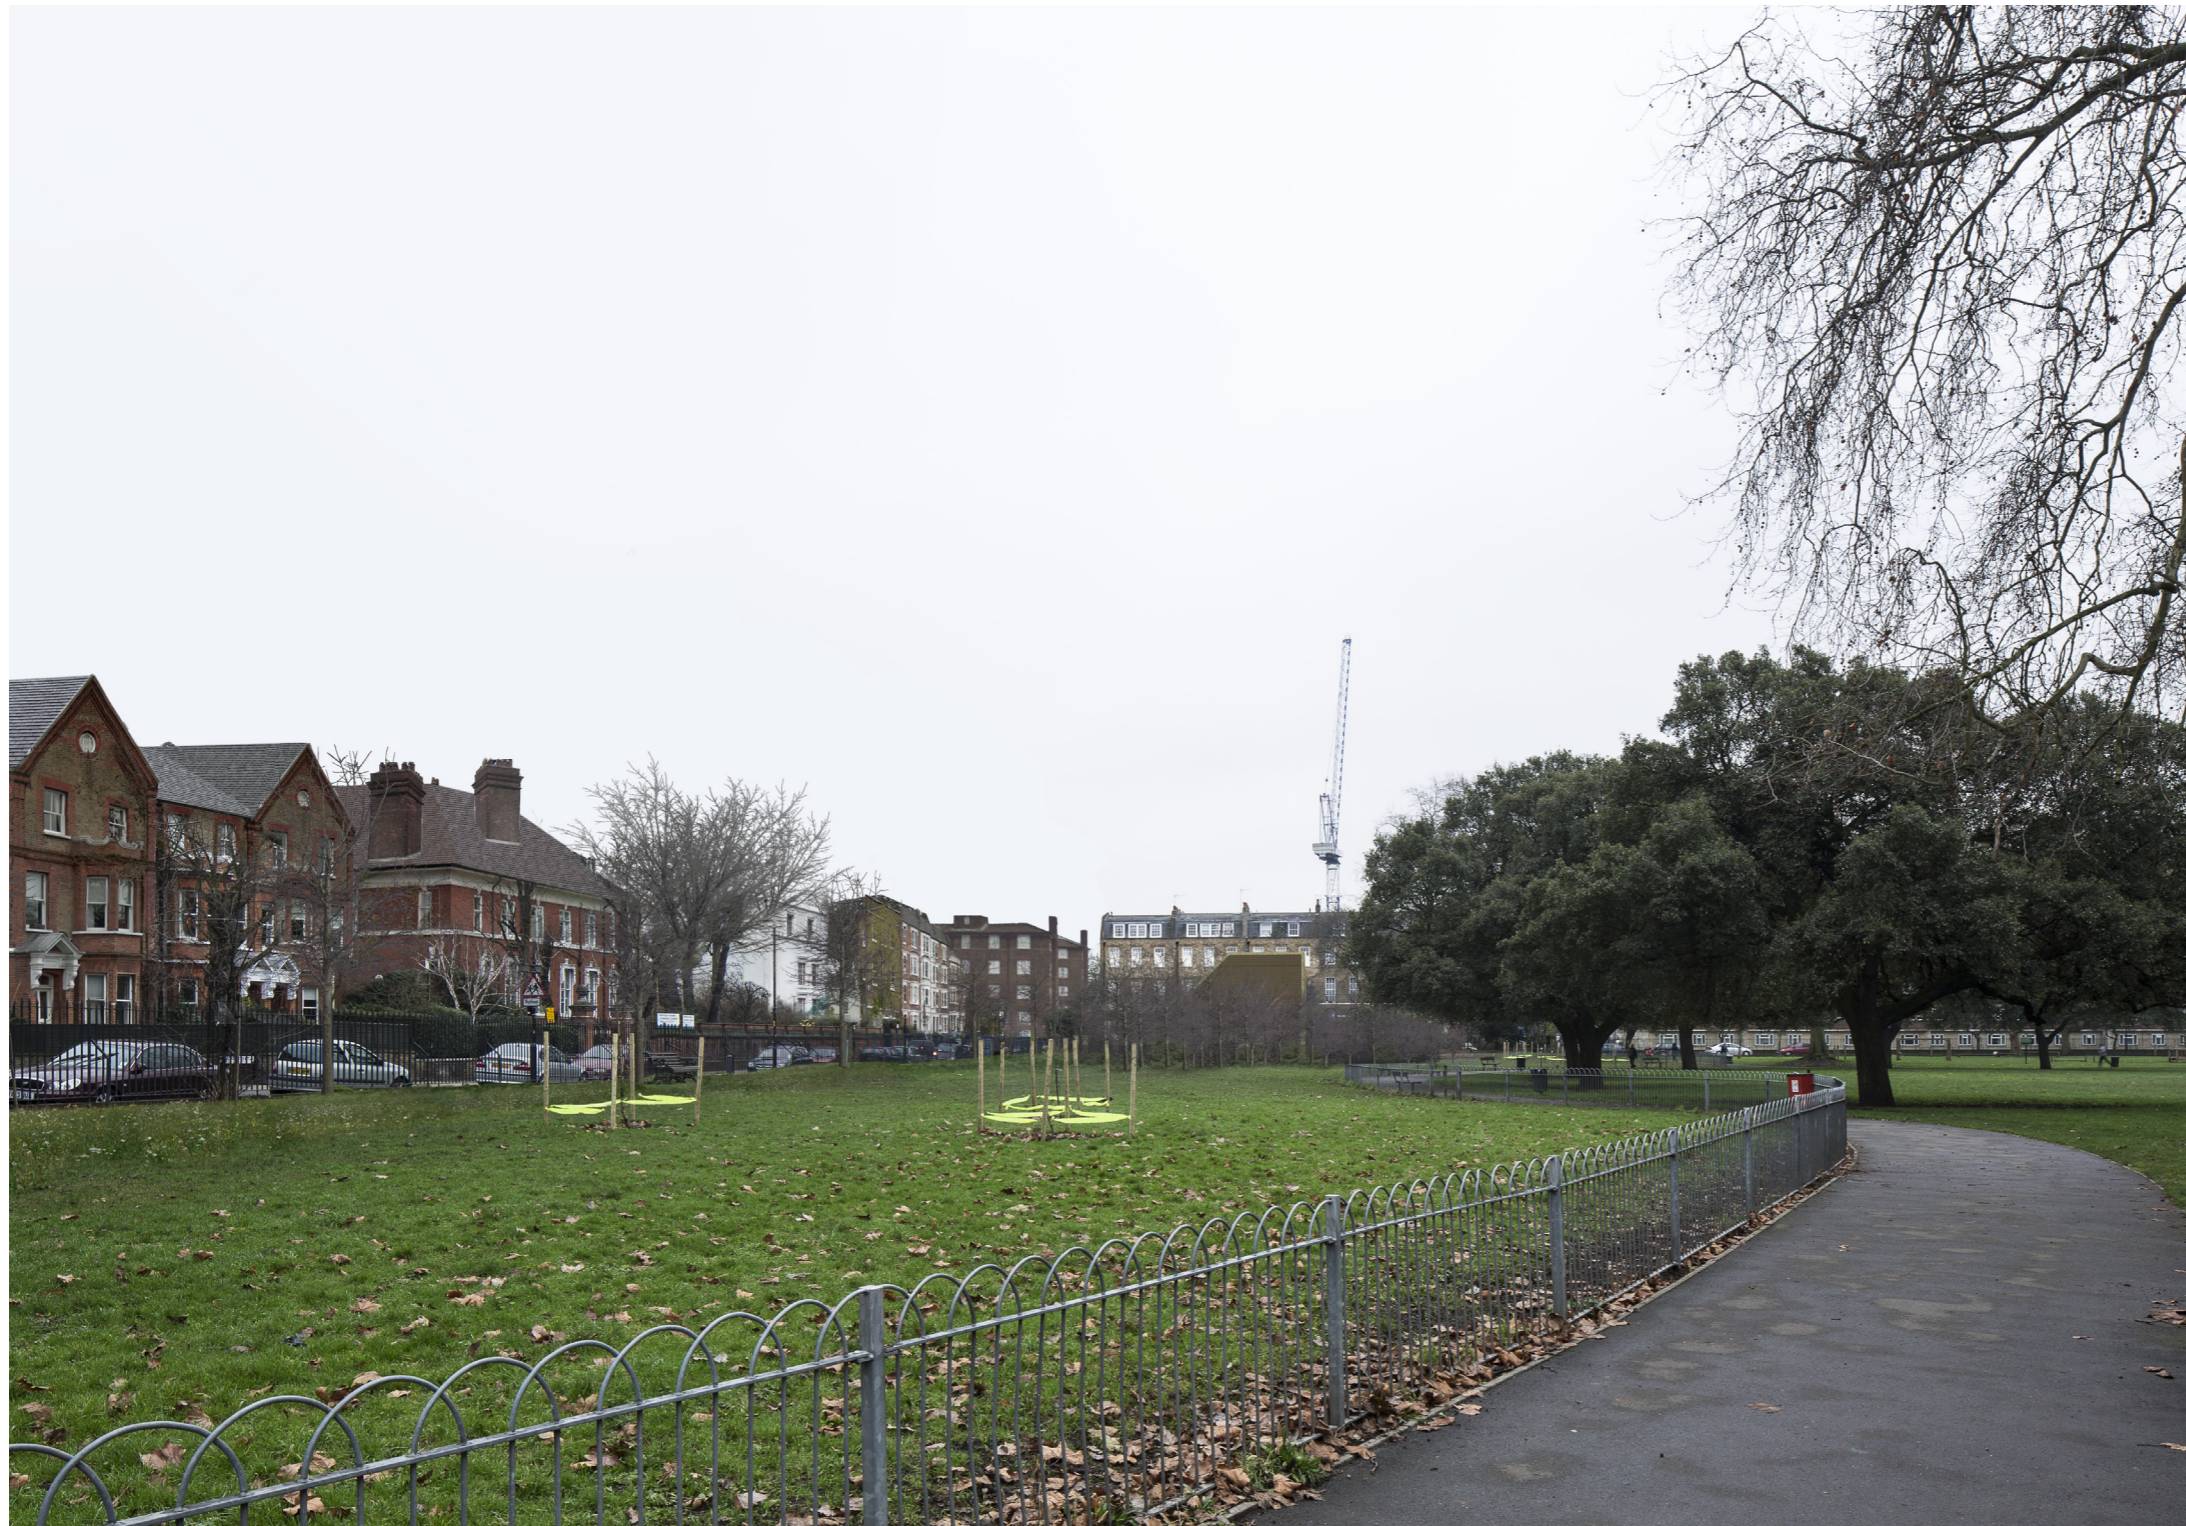
Figure 15 - 5

Kennington Park - Western side of park

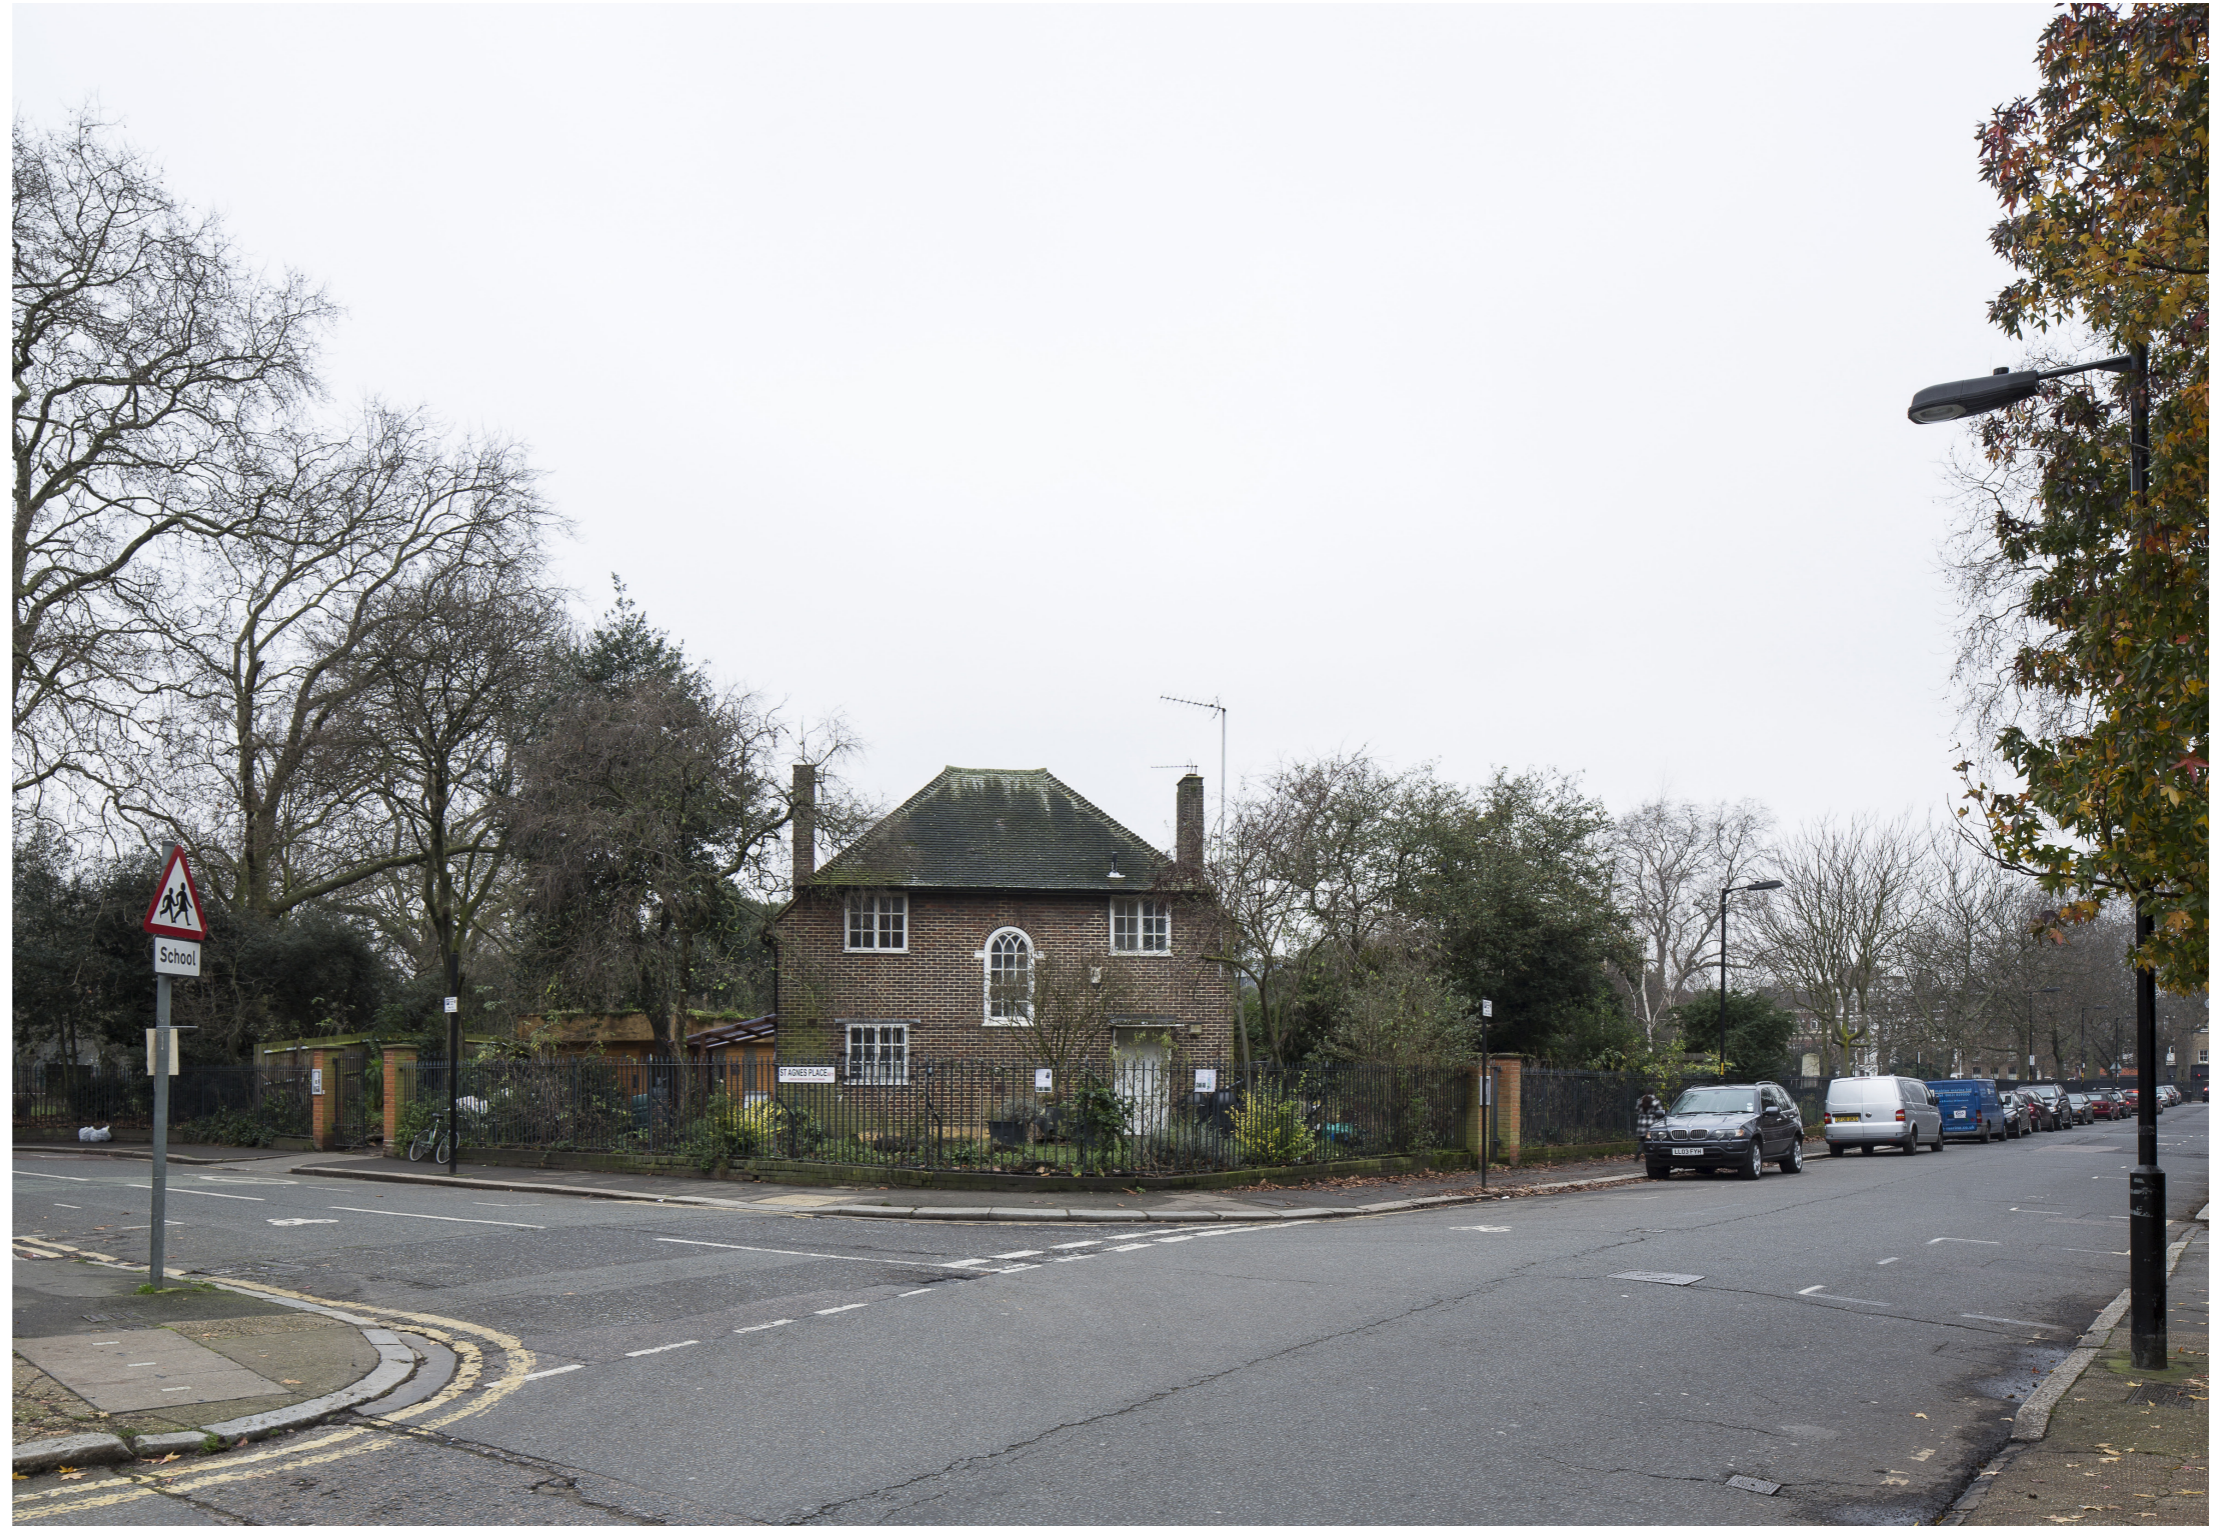
Figure 15 - 6

Kennington Park – Kennington Park Place / St. Agnes Place

Time	10/01/2013 – 11:28
Lens Focal Length	24mm
Lens Shift	5mm RF
Image Direction	256°
Height	1.60m
Latitude	51° 29' 5.658" N
Longitude	0° 6' 22.098" W

The foreground of this view is formed by the junction of Kennington Park Place and St. Agnes Place; residential streets are flanked by narrow pavements with granite kerbs. Kennington Park Lodge, an inter-war former park keeper's cottage, forms the focus of the view in the middle-ground. The modest two-storey house faces the corner of the street and is set within a garden enclosed by metal railings. Mature trees and shrubs form the background of the view, within the Grade II registered Kennington Park and to the rear of the lodge. The view to the west extends along Kennington Park Place as far as Kennington Park Road and takes-in the tree-lined northern boundary of Kennington Park.

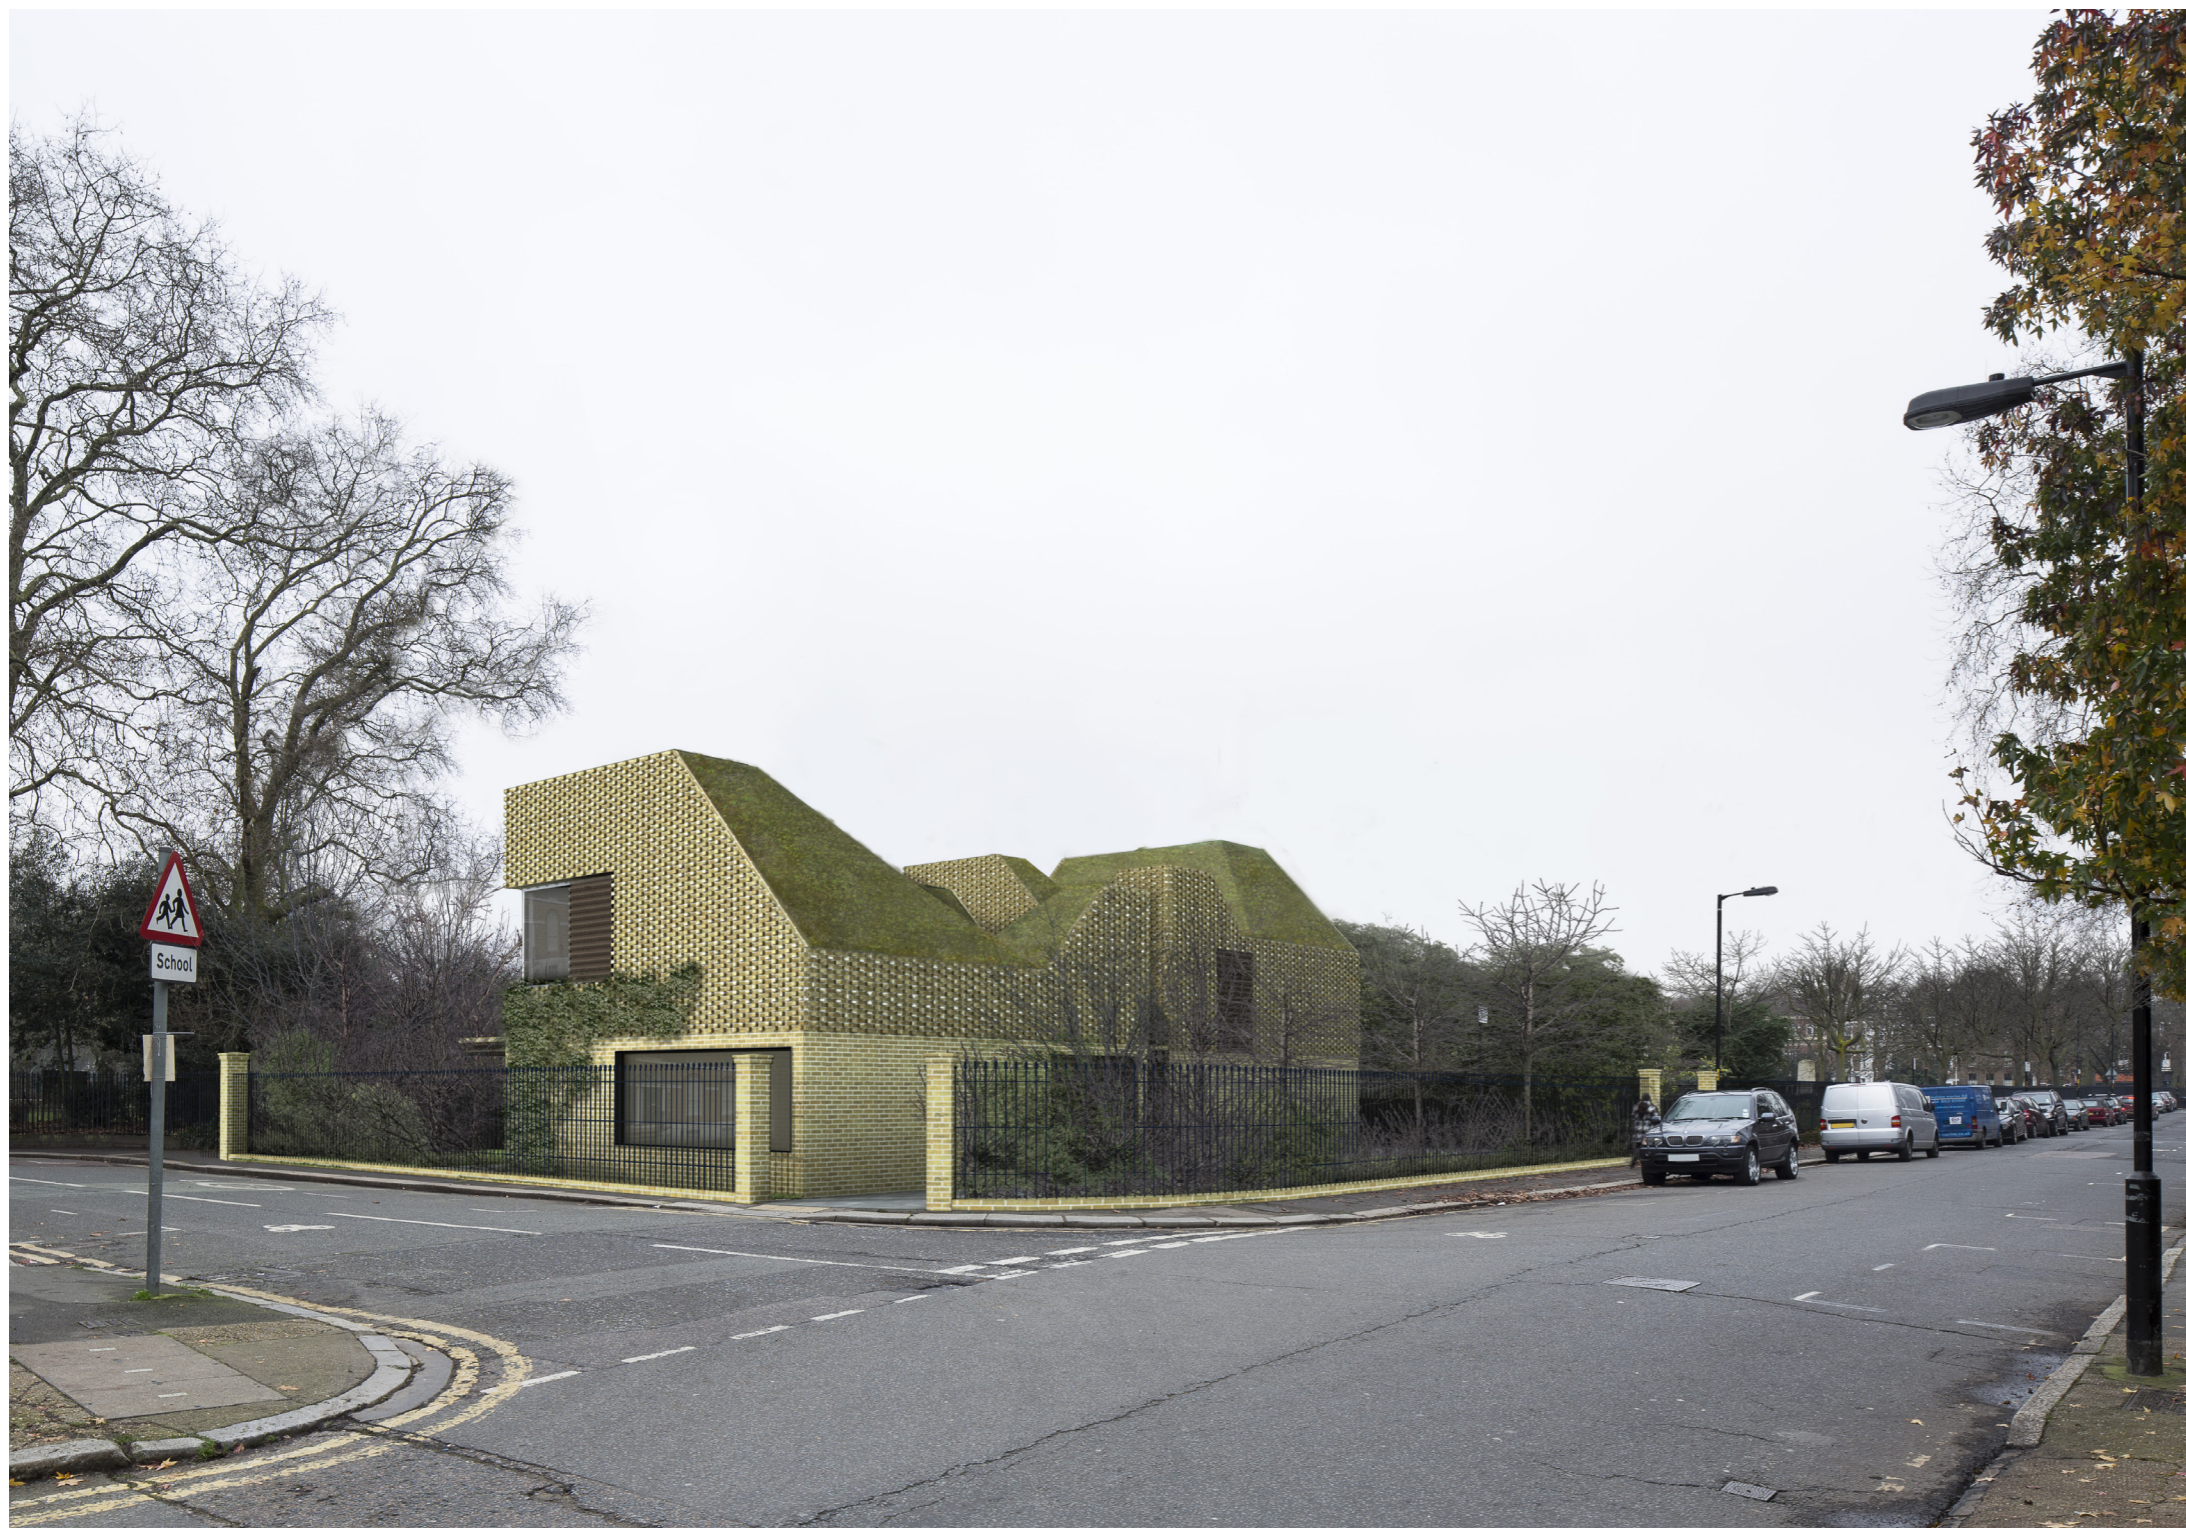
Figure 15 - 7

Kennington Park – Kennington Park Place / St. Agnes Place

The middle-ground of this view would be transformed by the proposed community building with the head house to the rear, in place of the existing Kennington Park Lodge. These new high quality buildings, which would be architecturally balanced and complementary in design, would form the focus of the view. Architectural details, such as the intricate green roof form, brick relief and large windows would be readily discernible. The view would be further enhanced by proposed flowering fruit trees, ornamental shrubs and climbing plants within the gardens surrounding the buildings. Plants have been selected to provide visual interest from the street throughout the year. Trees and shrubs within Kennington Park would form the background of the view, framing the proposed buildings. The northern boundary would also be reinforced by an avenue of new London Plane (*Platanus x hispanica*) trees and railings to match the existing.
