**CLIENT: LONDON UNDERGROUND LIMITED**

**CONTRACT REF: TLL 7917**

**NORTHERN LINE EXTENSION**

## **Battersea Passive Air Quality Monitoring – Monthly report**

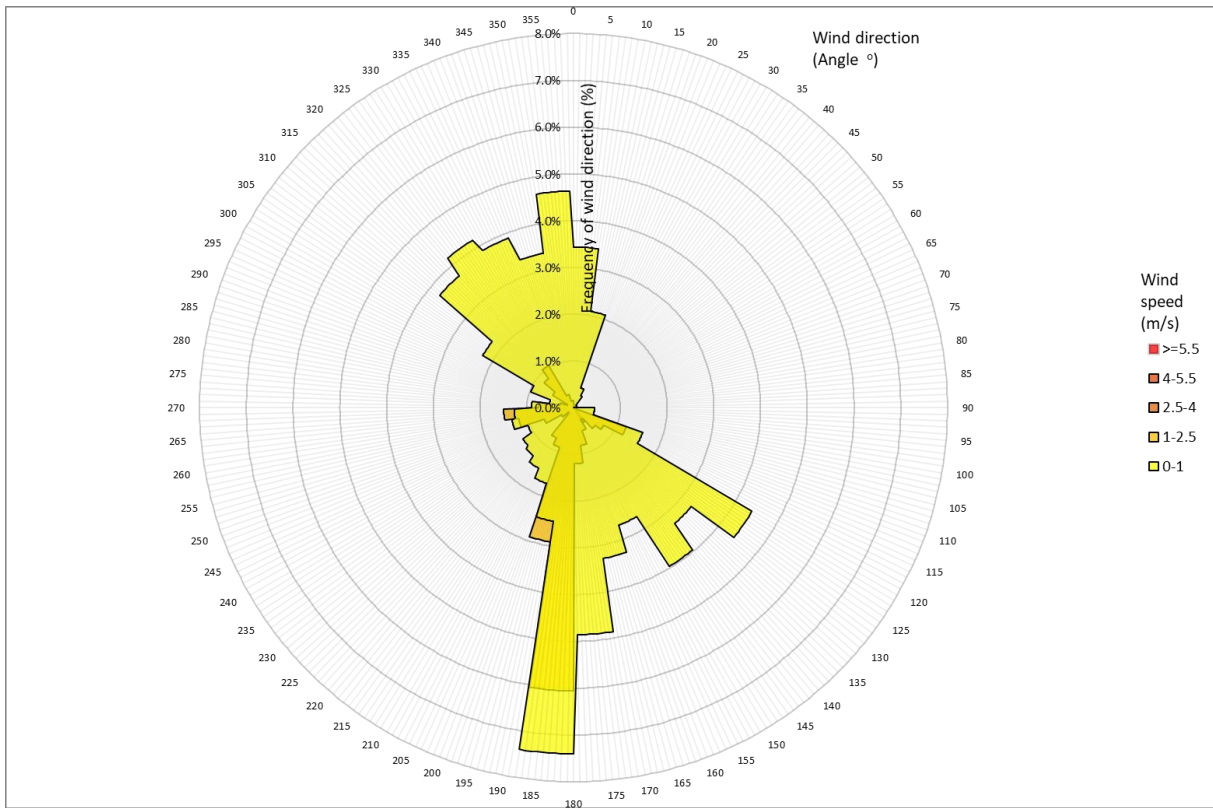
Figure 1. Wind rose from the Battersea sonic anemometer BN2W. Period 1.

**Figures 1 and 2** show the wind roses from the BN2W sonic anemometer during the relevant period. Data was downloaded via the Sigicom integrated monitoring system.

SAMPLING PERIOD AVERAGE WEATHER CONDITONS		
Period	Rainfall / mm / day	Mean Daily Wind Speed / mph (ms <sup>-1</sup> )
29/03/2018 – 12/04/2018	2.11	1.7 (0.8)
12/04/2018 – 26/04/2018	0.33	2.0 (0.9)

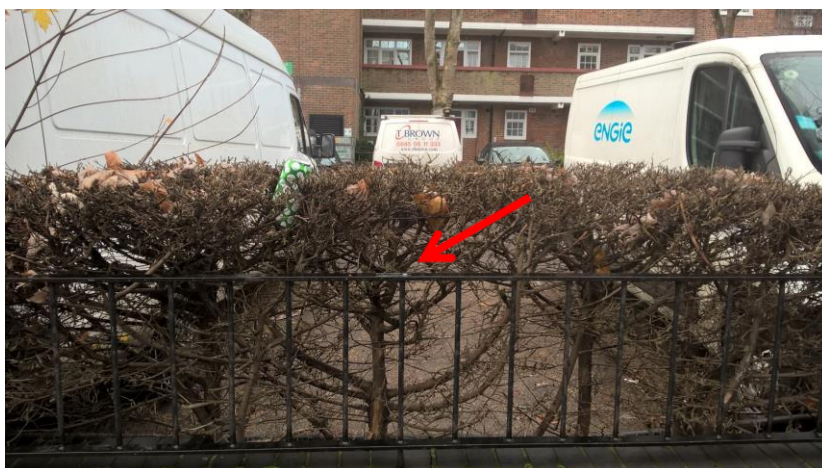
Figure 7 – Glass Slide 4

Glass Slide 4 – GS4

**Location:** wall on Thessaly Road

**Receptor:** residents along Thessaly Road

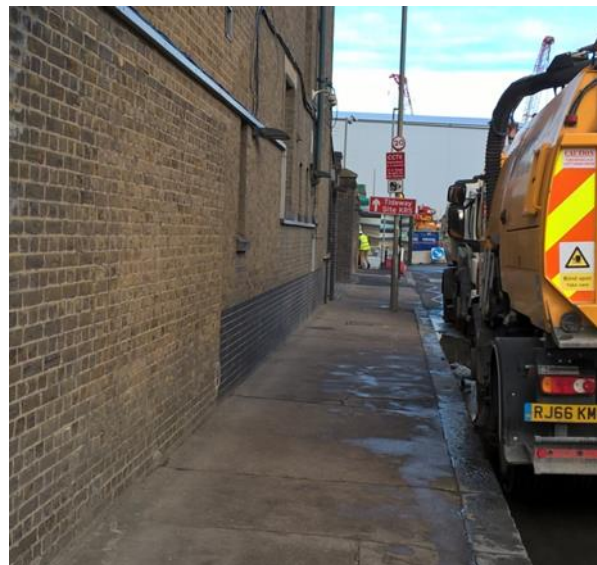
Figure 9 – Glass Slide 6

The guidance criterion of 25 SU per week (i.e. 50 SU per fortnight) set out by the Environment Agency was only exceeded at GS6 during the first of the fortnightly monitoring periods in the surroundings of the Battersea site. The soiling units recorded at GS6 show that it was slightly over the nuisance threshold. The soiling units recorded at the other locations, however, suggest that dust nuisance would have been unlikely at sensitive receptors during the monitoring period.

Glass Slide 6 – GS6

**Location:** top of post on Kirtling Street

**Receptor:** commercial and residential receptors on Kirtling Street
